DEMONSTRATION AT DEN HELDER

Written by Krista Van den Bergh (OCAS) and Sibö Buter (Endures)

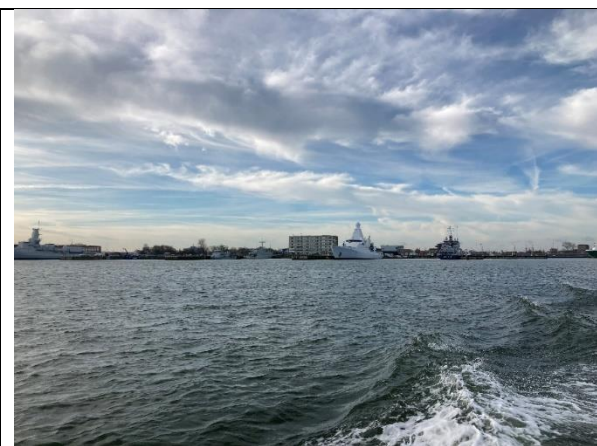
Figure 4. Location in the harbour of Den Helder.

The raft exposure facility in the harbour of Den Helder is only reachable by boat. The raft is a floating metal platform, used for corrosion and anti-fouling testing, as presented in Figures 4 - 9.

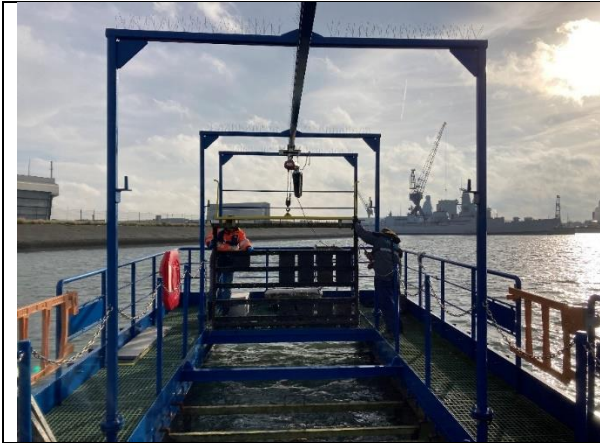
Figure 6. Metal framework on the raft to mount samples.

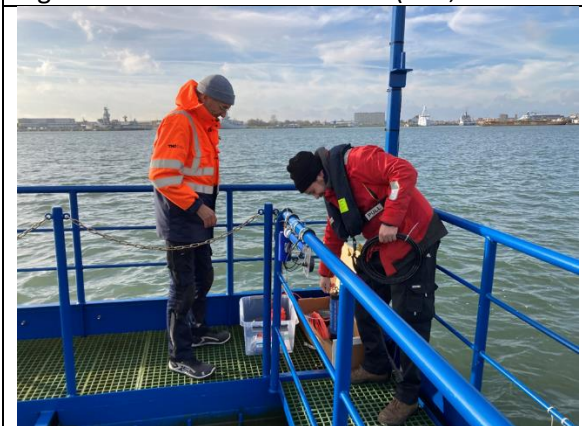
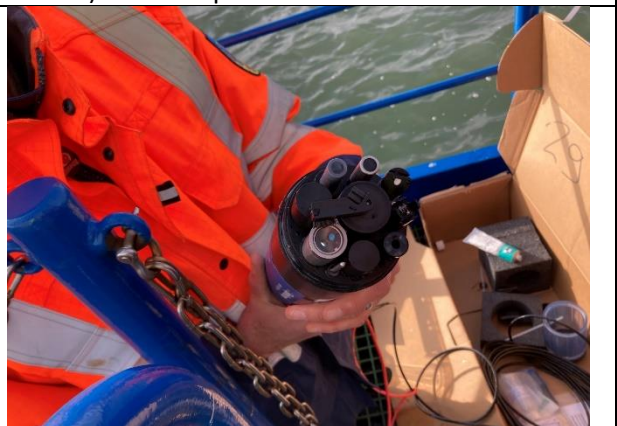
Figure 10 and 11. Positioning of the environmental sensor under the water line.

For the installation of the environmental sensor, the sensors hardware (battery and Wifi module) were deployed with connections to the railing of the raft and the sensor itself was positioned ~ 1 meter under the water line, at the same depth of the samples to test. The installation is presented in Figures 10-13.

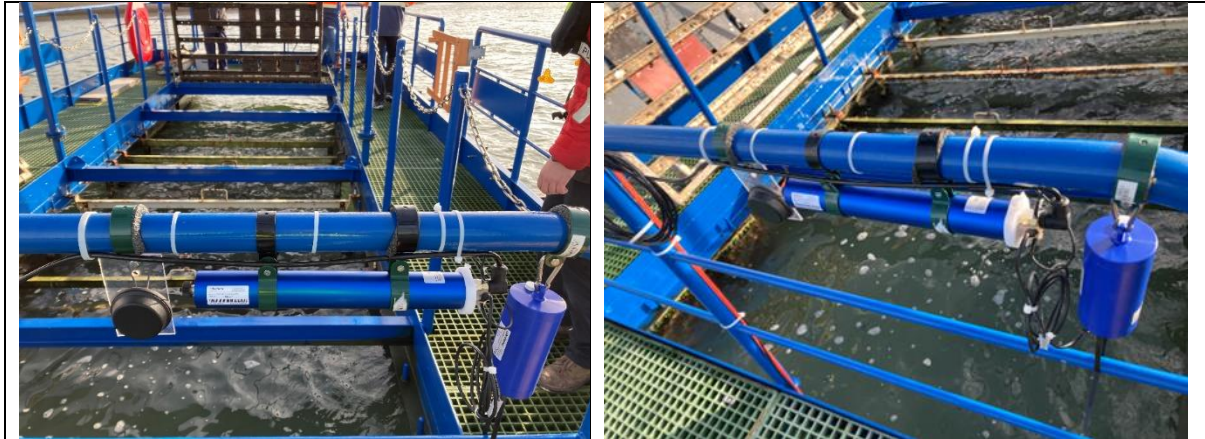
Figure 12-13. Mounting the battery pack and wifi module of the environmental sensor on the raft infrastructure.

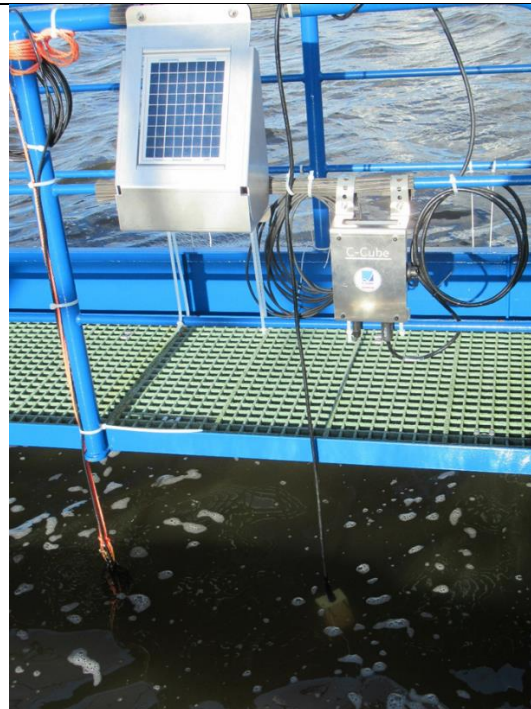
Figure 14. Installation of the corrosion sensor with solar panel at the raft exposure site.

Also the corrosion sensor is mounted at the same depth under the water line and the solar panel and data loggers of the corrosion sensor were secured to the raft side railing. The installation is presented in Figure 14.

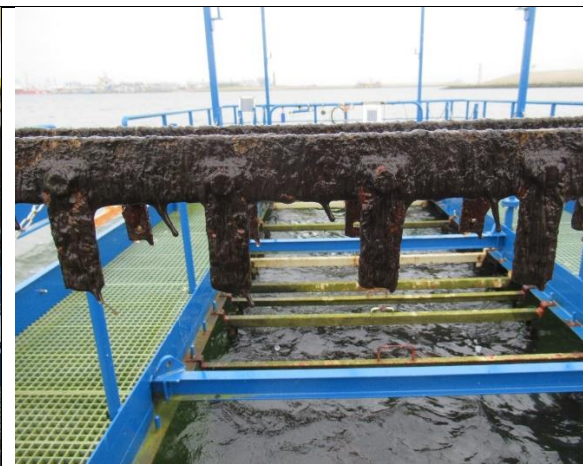
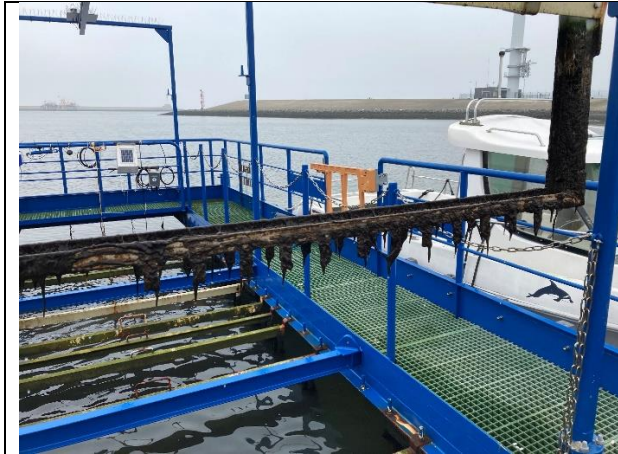
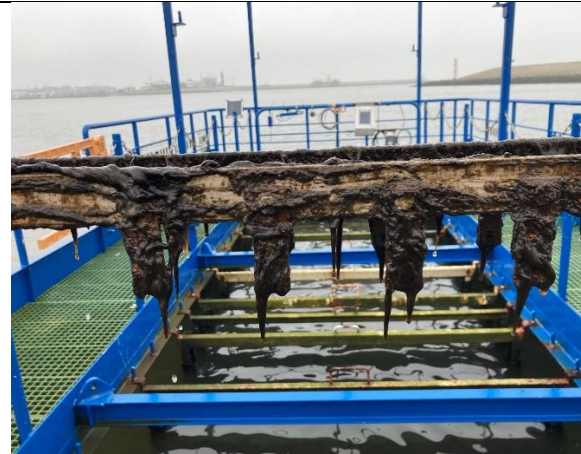
Figure 17. Rack mounted with metals after 2 months of immersion in the seawater at the raft.

Figure 18. Rack mounted with metals after 2 months of immersion in the seawater at the raft (detailed).

Figure 19. Rack mounted with metals after 3 months of immersion in the seawater at the raft

Figure 20. Rack mounted with metals after 3 months of immersion in the seawater at the raft (detailed).

Every month, the metal samples and sensors are evaluated. The metal samples are corroded and covered by biofouling organic matter, as seen in the figures 17-20, where the metals are presented after respectively 2 and 3 months of exposure 1 meter under the water line of the raft exposure site. The visual inspection and the corrosion data of the metal samples will be discussed in the next chapter Results.

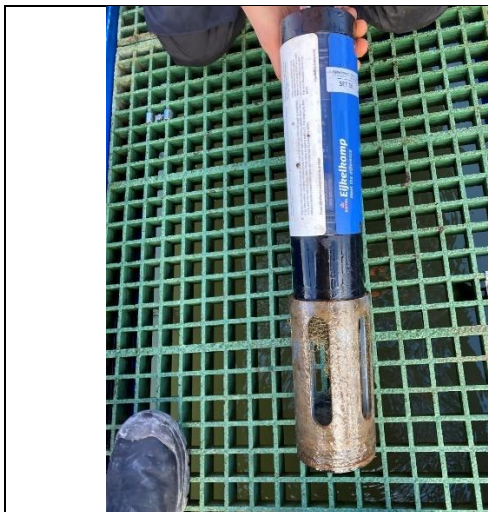
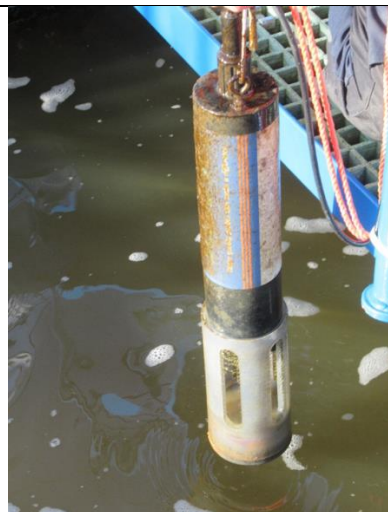
Figures 21 and 22. Environmental sensor after 2 months of exposure.

Also a continuous evaluation of the sensors degradation is performed during the project. In figures 21 and 22 the status of the environmental sensor can be observed after 2 months of exposure. The protecting capsule with Cu mesh is working fine and protects the sensor to biofouling.

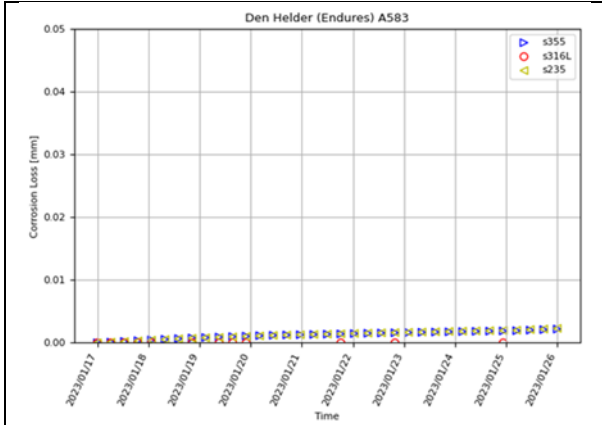
Figure 25. Corrosion Loss (mm) after 1 week of exposure.

Figure 26. Corrosion Loss (mm) after 4 months of exposure.

The corrosion loss (mm) is low the first week of exposure, as been be seen in Figure 25. During the first month of exposure, there is a steep increase in corrosion loss for S235 (Grade A) and S355 steel (Figure 26), where after 1 month of exposure the increase in corrosion loss is lower. After 3 months of exposure a stable corrosion rate is reached. Probably the corrosion loss will further increase in time. For 316L, the corrosion loss is nihil during the observed exposure time.

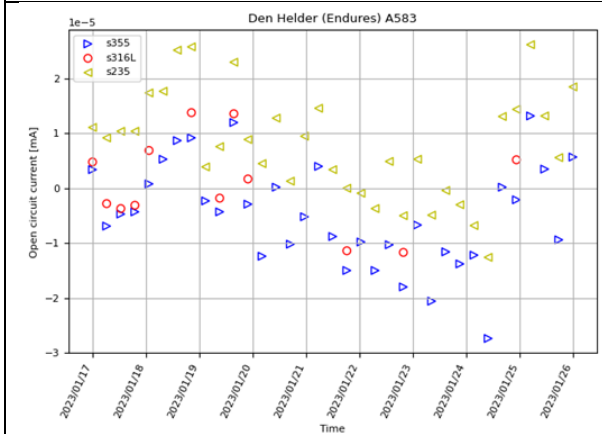
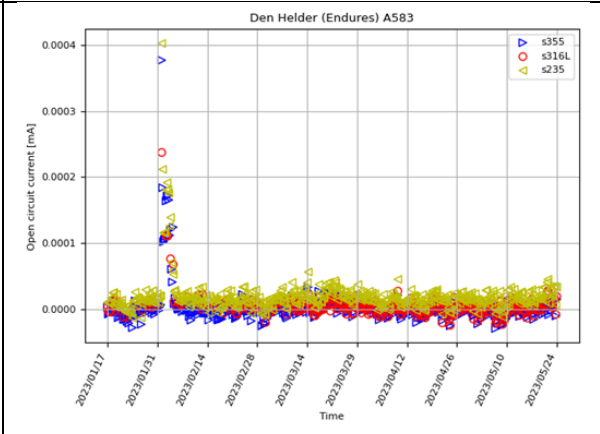
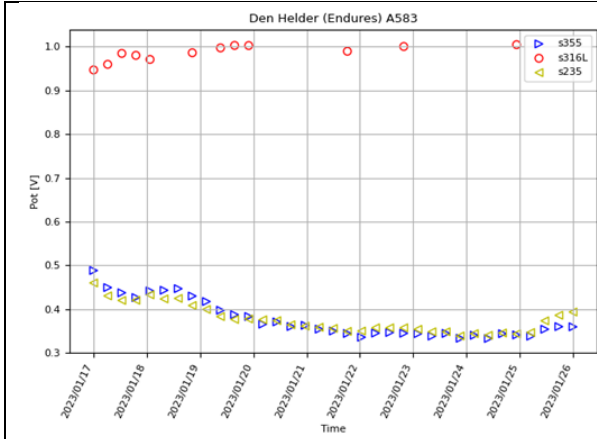
Figure 29. Open circuit current (mA) after 1 week of exposure.

Figure 30. Open circuit current (mA) after 4 months of exposure.

Figure 30. Potential (V) after 1 week of exposure.

Figure 31. Potential (V) after 4 months of exposure.

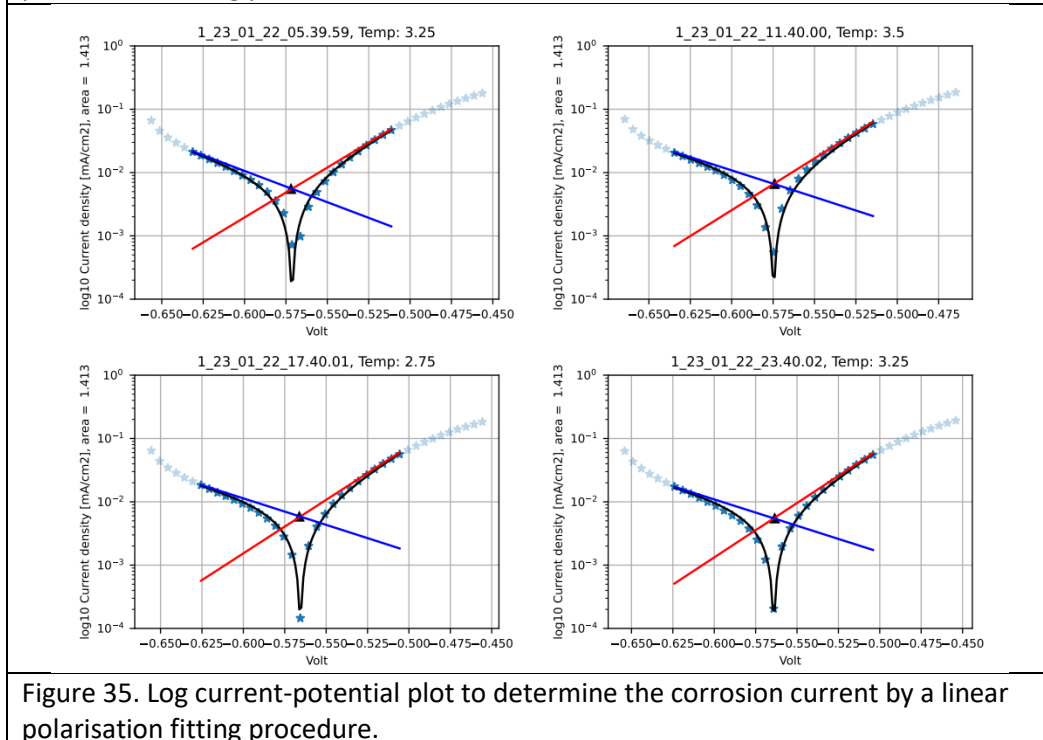
Figure 34. Current-potential plot to determine the corrosion current by a linear polarisation fitting procedure.

Figure 35. Log current-potential plot to determine the corrosion current by a linear polarisation fitting procedure.

The C-cube corrosion sensor is based on linear polarization (LP) to measure the corrosion rate of the metals. This is performed by applying a voltage of less than ± 30 mV vs E_{corr} to the metal. Within this voltage range, the resulting current response is linear if the anodic and cathodic regions are equal. This makes it possible to determine the polarization resistance (R_p), which is defined as the slope of the current-potential curve according to the Stern-Geary equation (Stern & Geary, 1957). The corrosion rate is the invers of the polarisation resistance. Important in this fitting procedure is the selection of the tangent of the anodic and cathodic polarisation curve. In the data output of the C-cube sensor the polarisation curves and automated fitting procedure can be observed, like presented in Figure 34 and 35. It is important to check the automated fitting procedures as a small change in tangent can cause huge errors in the determination of the final corrosion current.

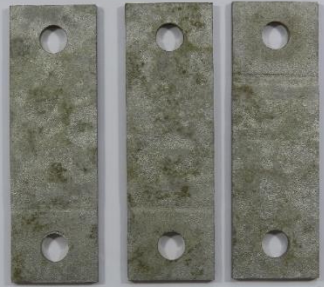
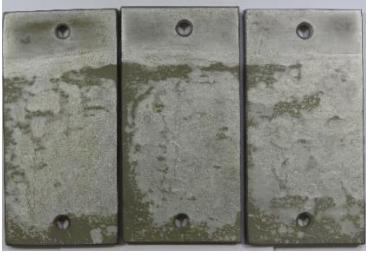
At each evaluation time the metals are taken out of the exposure site, the fouling is removed and the samples are rinsed with water. The images are presented in Figure 37. A clear corrosion behaviour with orange coloured corrosion products are seen for S235 and S355 steel. For 316L no corrosion is seen.

After evaluation the corrosion products are etched in order to determine the mass loss after corrosion exposure. In order to have reproducible results, 3 samples per test condition are performed. In Figure 38 the samples are presented after etching.

Metal samples after 1 month of immersion – after etching

S355 G10
Metal samples after 2 months of immersion – after etching

ss316L	S355G10
Metal samples after 2 months of immersion – after etching
