DEMONSTATION AT WASTEWATER TREATMENT PLANT

Baseline/starting situation

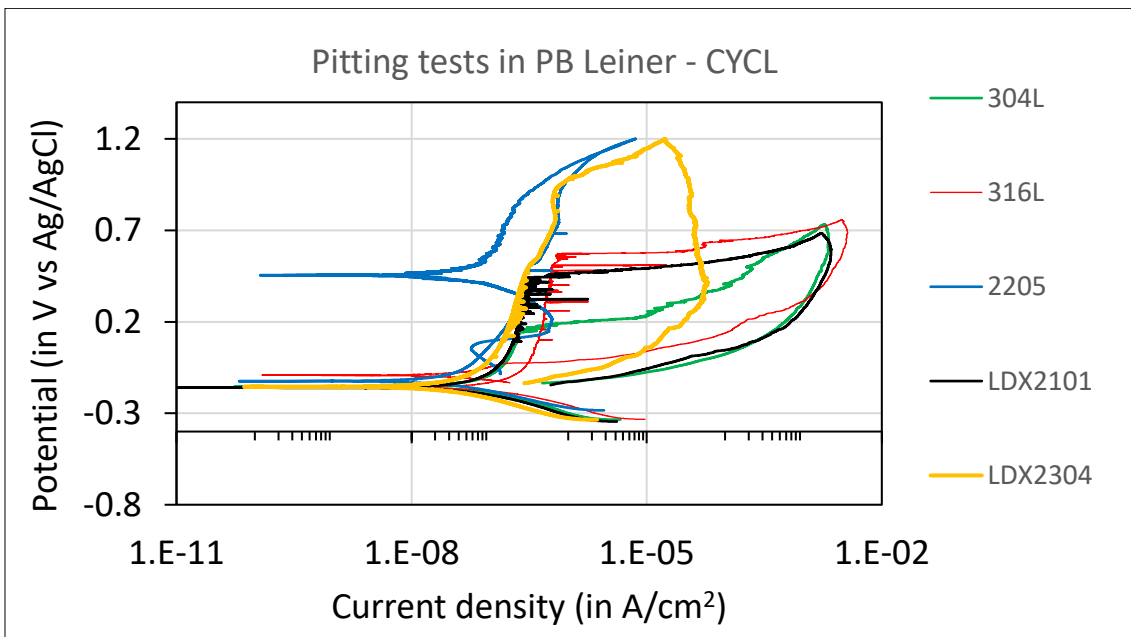
Figure: Cyclic polarization curves of commonly used stainless steels in the wastewater of PB Leiner.

The cyclic polarization plots of AISI 304 and AISI 316 show a strong increase in current density at a potential 160 and 577mV, respectively. It is therefore concluded that AISI 304 and AISI 316 stainless steel both show tendency to pit in the wastewater of PB Leiner. Even lean-duplex stainless steels (LDX2101 and LDX2304), a cheaper but more corrosion-resistant alternative for conventional stainless steels, also show problems towards pitting. The only tested material that doesn't have problems in the wastewater, is a regular duplex stainless steel (DX2205). Microscopic analysis on the tested samples was performed, the SEM images are shown in figure.

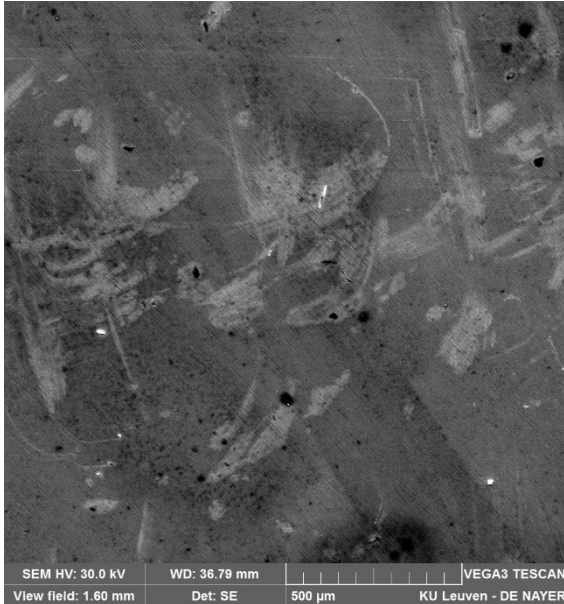
Figure: No pitting corrosion found after polarization in the PB Leiner wastewater for DX2205.

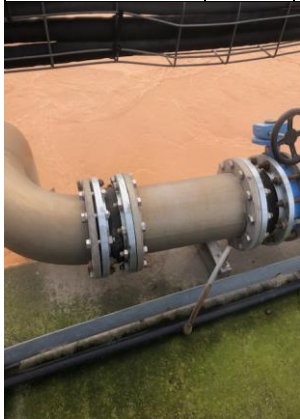
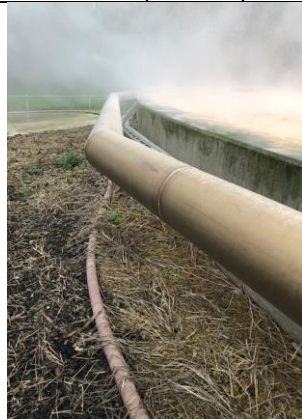
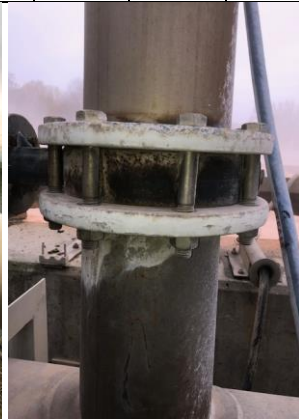
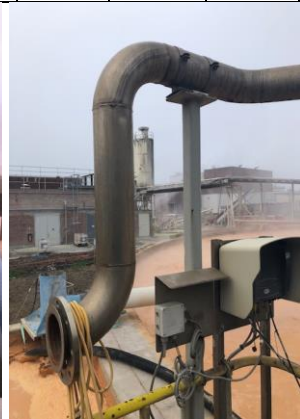
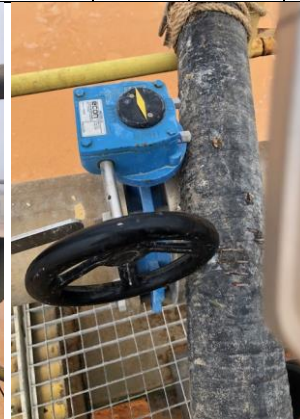
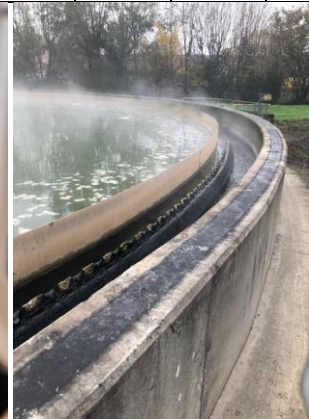
1	2	3	4	5	6
----------	----------	----------	----------	----------	----------

17 locations/parts of the wastewater treatment were analyzed, the measurements can be found in table. Pipelines for aeration (section nitrification/denitrification) and the filter belt press are made out of AISI 304 and AISI 316 stainless steel. Most of flanges, pumps and valves in the nitrification/denitrification section are built out of carbon steel (with blue paint to protect it for

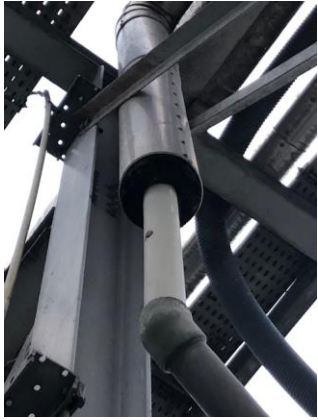
Pipeline with insulation	13	Aluminium 4XXX	0.3	0	0	0	0	8.7	0	91	0	0.009	0	0	0	0	0
Filter belt press – pipeline	14	AISI316	67.5	15.8	10.7	2.3	0.5	0	1.83	0	0.4	0	0	0	0	0	0
Filter belt press – valve	15	Brass	0.119	0	2.3	0	0	0.06	0	0	52.4	43.1	0	0	2.02	0	0
Filter belt press – flange	16	AISI316	46.7	7.5	8.8	6.3	1.77	16.9	0	0	0	0	0	7.9	0	0	0

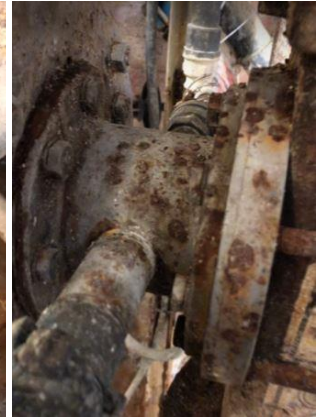
Filter belt press – socket	17	AISI316	59.5	12.1	10.2	4.4	2.88	0	0	0	0	0	1.75	0	0	0	0
-------------------------------	----	---------	------	------	------	-----	------	---	---	---	---	---	------	---	---	---	---

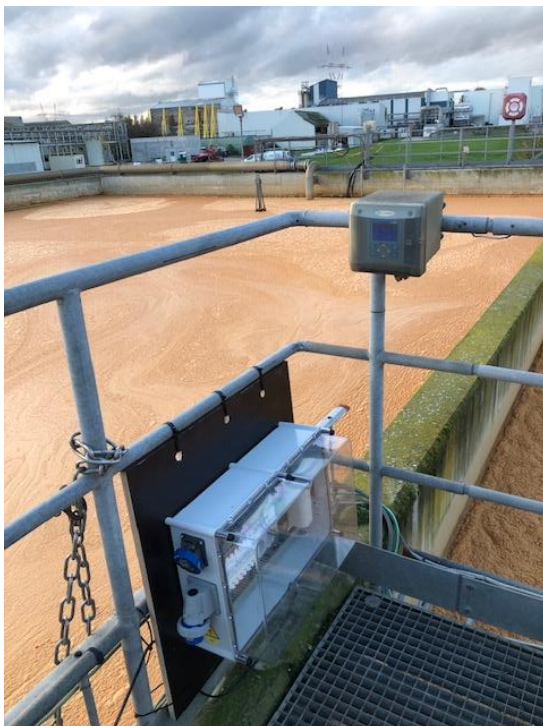
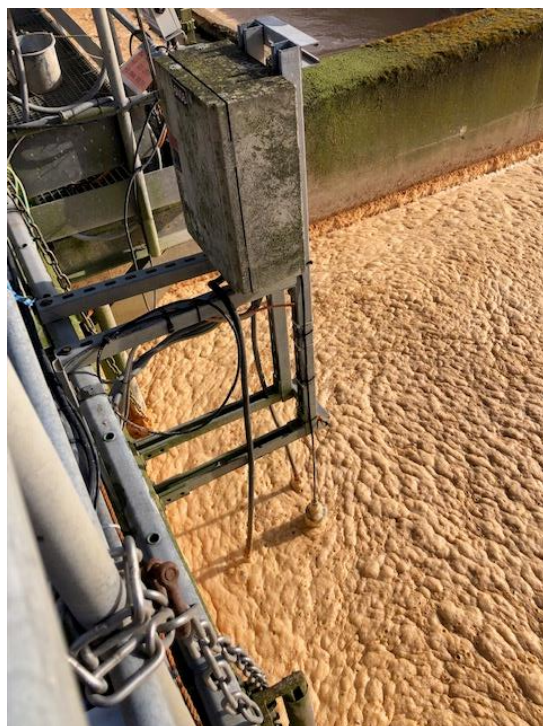
Figure: The electrical box of the environmental probe (Scuba 65).

Every 2 weeks, all sensors were checked for damage and/or contamination. If the sensor needed to be cleaned (perhaps when it was completely covered by sludge), it was rinsed with distilled water. The environmental probe was running fine for 2-3 months before it started to collect bad data. Dissolved oxygen was not measured at all (0 mg/L), conductivity was acting strange and the measured pH went from a value of 7 (= 0 mV) to unrealistic values (pH 11-12). The sensor was, with the support of Eijkelkamp, completely checked. Water found a way to the electrical connector, where the probe is connected to the data cable (and power cable, see figure). Moisture can affect the measurements. All pin connectors were cleaned with pressurized air and extra gaskets were installed to avoid similar situations in the future. Unfortunately, the sensor failed soon after, again because moisture affected the electrical connections. The sensor didn't run good for a while. It was changed by a new sensor and electrical box, that started to run well in April 2023.

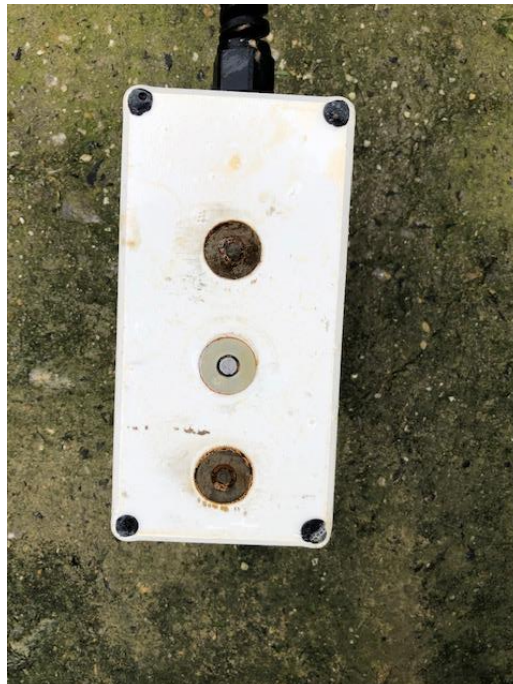
Figure: The C-Cube LPR probe after being in the wastewater of PB liner for 2 months without any cleaning.

phenomena as seen in the other demonstration site, the MBBR at the greenhouse. The electrodes of the LPR probe only showed little corrosion and required no cleaning (figure).

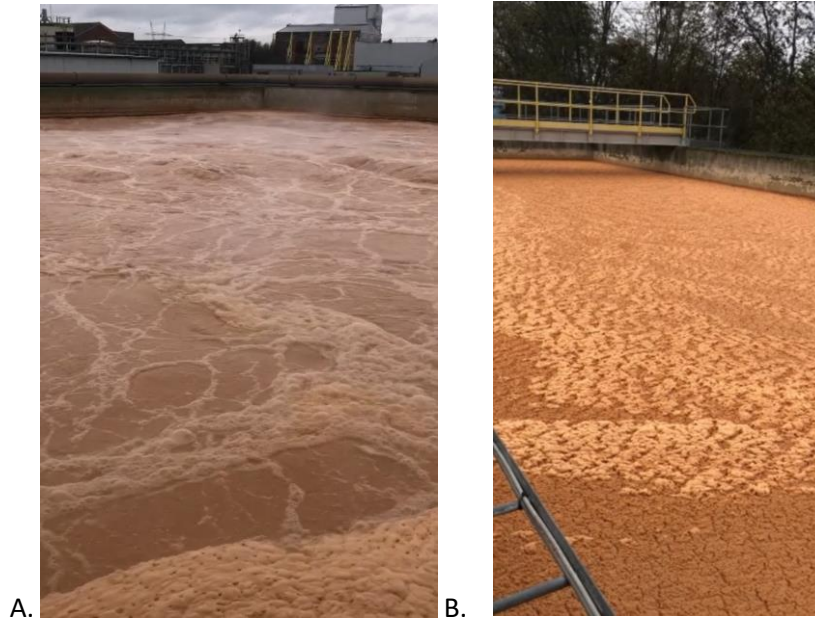
Figure: The basin of the PB Leiner wastewater treatment plant in A) nitrification modus and B) denitrification modus.

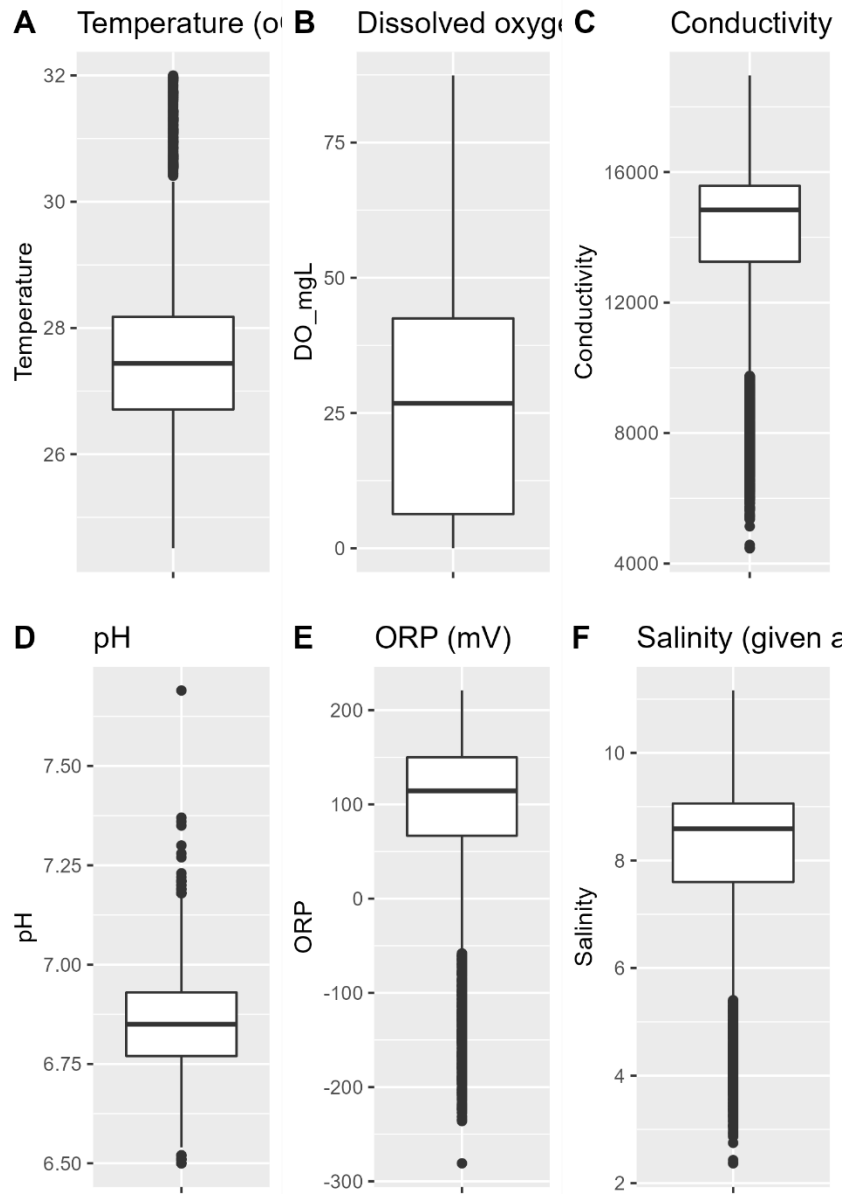
Figure: Boxplots of the environmental parameters in PB Leiner

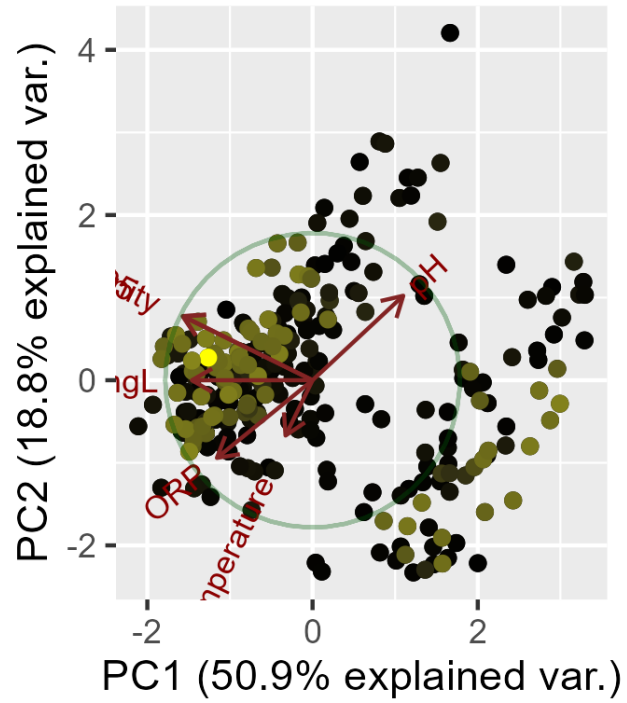
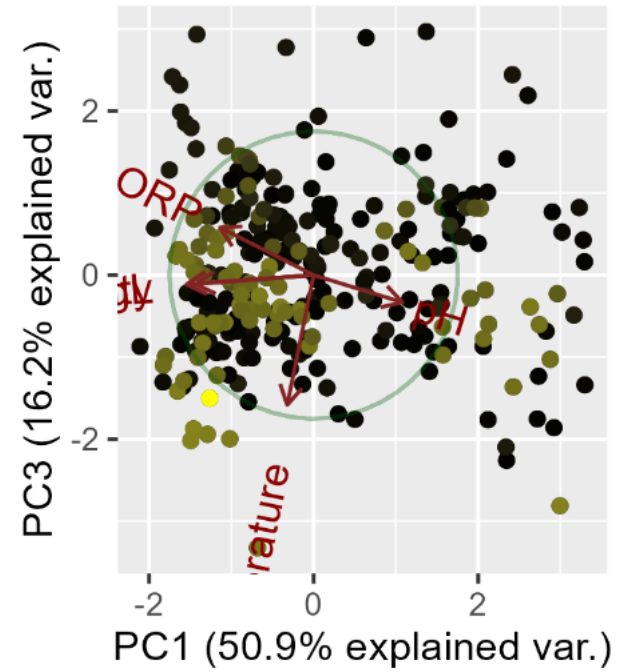
Figure: PCA plots of PC1/PC2 (left) and PC1/PC3 (right) – PB Leiner

A Screeplot was made with the data collected from PB Leiner. It is clear that the two first principal components (PC1 and PC2) can explain more than 70% of the total variance seen in the original dataset. If PC3 is additionally included, more than 85% of the variance is included. PC1, PC2 and PC3 are used to generate a PCA plot and are shown in figure. According to the PCA plot (FactoMineR package), only the temperature is correlated to the corrosion rate of grade A.

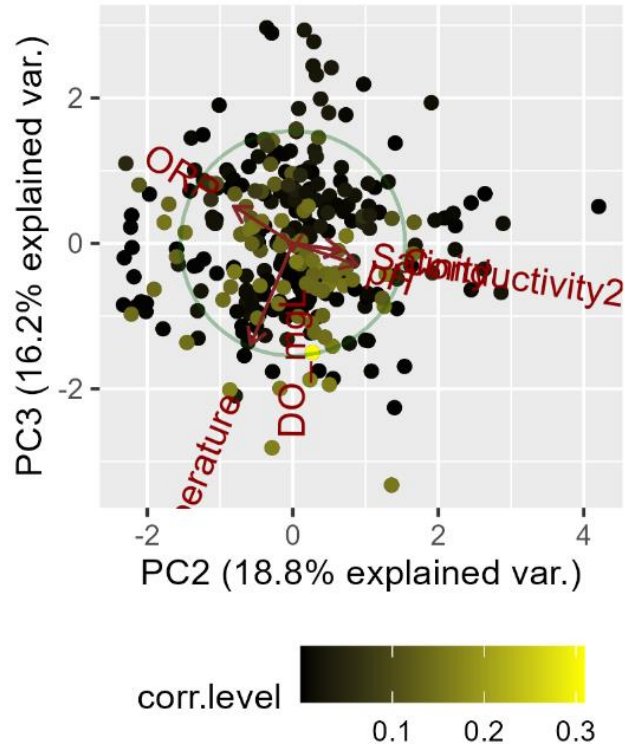
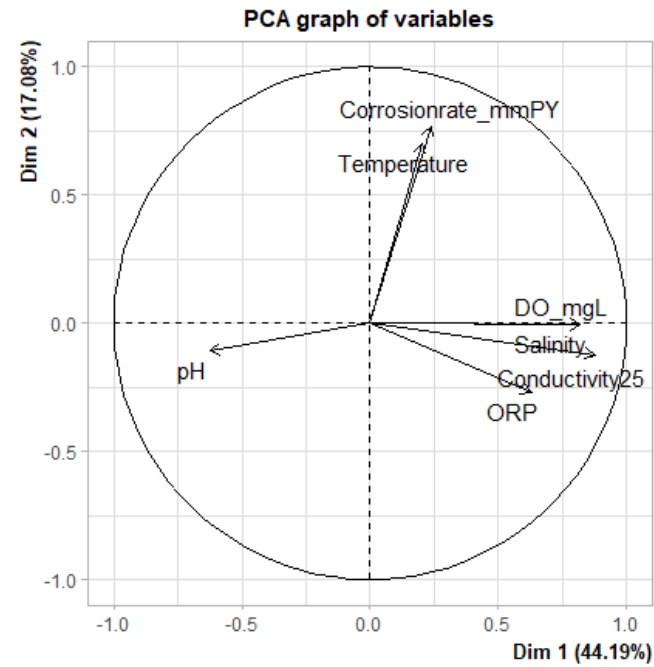
Figure: PCA plots of PC1/PC2 – FactoMineR package – PB Leiner (Material S235, Grade A)

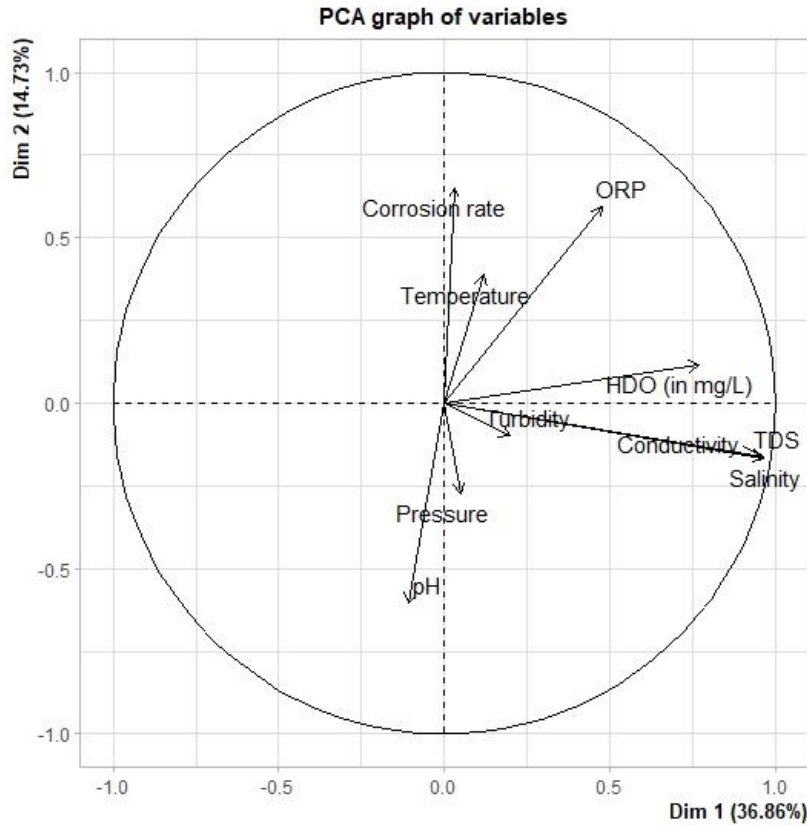
Figure: PCA plots of PC1/PC2 – FactoMineR package – PB Leiner (Material S355)

Next the Pearson test, a Principal Component Analysis was performed to study the correlations between the corrosion rate and the environmental parameters in a more visual way. It is clear that vector "temperature" and "ORP" have the same direction and sense and vector "corrosion rate". This means that both environmental parameters are proportionally correlated to the measured corrosion rate. This is in perfect agreement with the result found by the Pearson test. pH has the same direction as vector "corrosion rate", however, the sense is the opposite. The PCA predicts that pH is reversely proportional correlated to corrosion rate, what again agrees with the Pearson test. Why pressure is found to be correlated to corrosion rate, something that was not found by the Pearson test, is still unclear is needs to be studied in future work.

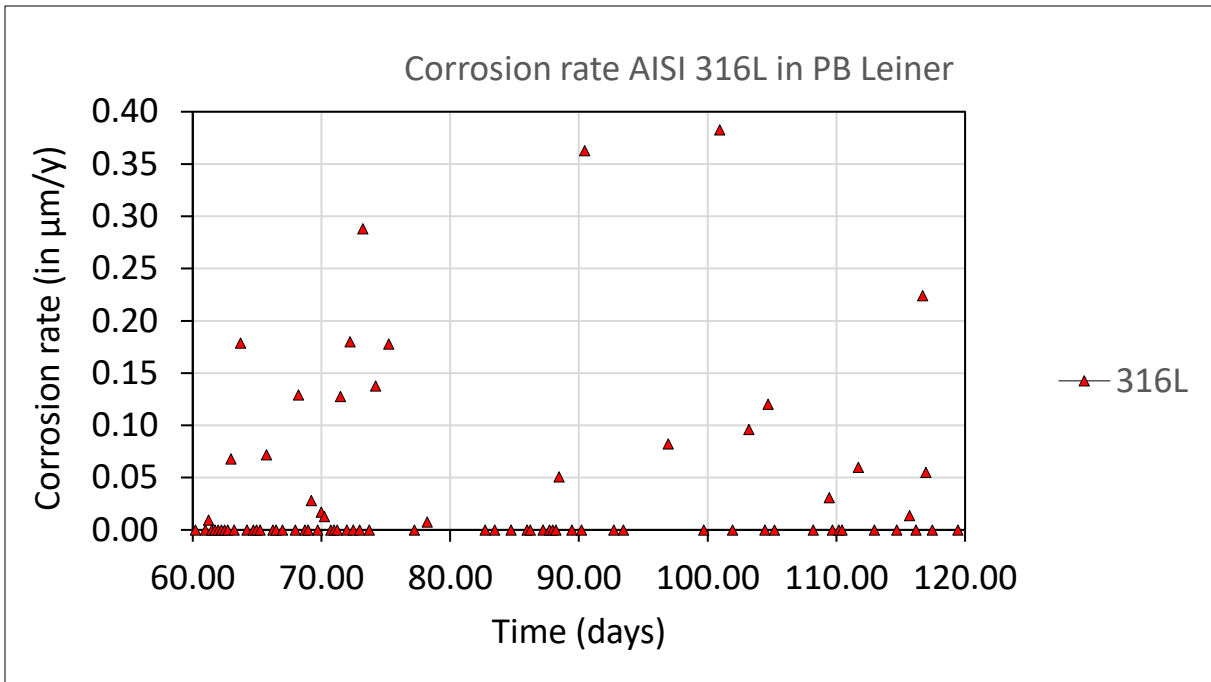
Figure: Corrosion rate of the LPR C-Cube sensor (AISI 316) in PB Leiner

The corrosion rates measured by the C-Cube LPR probe are shown in the figure below. The measured corrosion rates are expressed in $\mu\text{m}/\text{y}$, not unexpected because stainless steel will corrode much less than a steel grade because of its protective chromium-rich film. However, corrosion rates as low as $2.45 \cdot 10^{-19} \mu\text{m}/\text{y}$ were measured for AISI 316 in the PB leiner wastewater. Maximum values go up to $0.4 \mu\text{m}/\text{y}$. It should be emphasized that measured corrosion rates lower than $0.1 \mu\text{m}/\text{y}$ are not realistic. C-Cube LPR sensors with their electrical properties are normally not able to measure corrosion rates lower than $0.01 \mu\text{m}/\text{y}$. If such low corrosion rates need to be measured accurately, the electrochemical equipment should be able to measure a corrosion current of $1 \text{ nA}/\text{cm}^2$ accurately. These corrosion currents are only measurable when using a Faraday cage (like used in lab set-up), and not for electrochemical sensors for in-situ use. Another issue seen with the AISI 316 measurements is the strong fluctuation in corrosion potential within a few days. It is not normal that all environmental parameters are more or less stable and that the corrosion potentials shift more than 300 mV . This proves that the AISI 316 measurements are not good. Hence, it is not unusual that no correlations are found with the Pearson formula for all the measured environmental parameters (table). The PCA analysis does not agree with the Pearson test, however, it should
