Why this location

Newhaven Port, is an active commercial and passenger port facility on the mouth of the River Ouse, West Sussex, UK (Figure NH1). Bed sediment is dominantly of silt grade quartz and calcite, with kaolinite and illite clays and a significant organic content. The port area has at least 3km of steel pile wall. The sampling location was adjacent to the site office at $50^{\circ}47'02''\text{N}$, $0^{\circ}03'27''\text{E}$, within the intertidal zone accessible at low tide. Sediment samples were taken from the opposite side of the harbour accessible around fishing boat moorings. The SOCORRO monitoring system was installed on the East Pier at $50^{\circ}46'57''\text{N}$, $0^{\circ}03'28''\text{E}$. Additional access and support for sampling and installations was provided by the Port Authority through use of the port pilot boat.

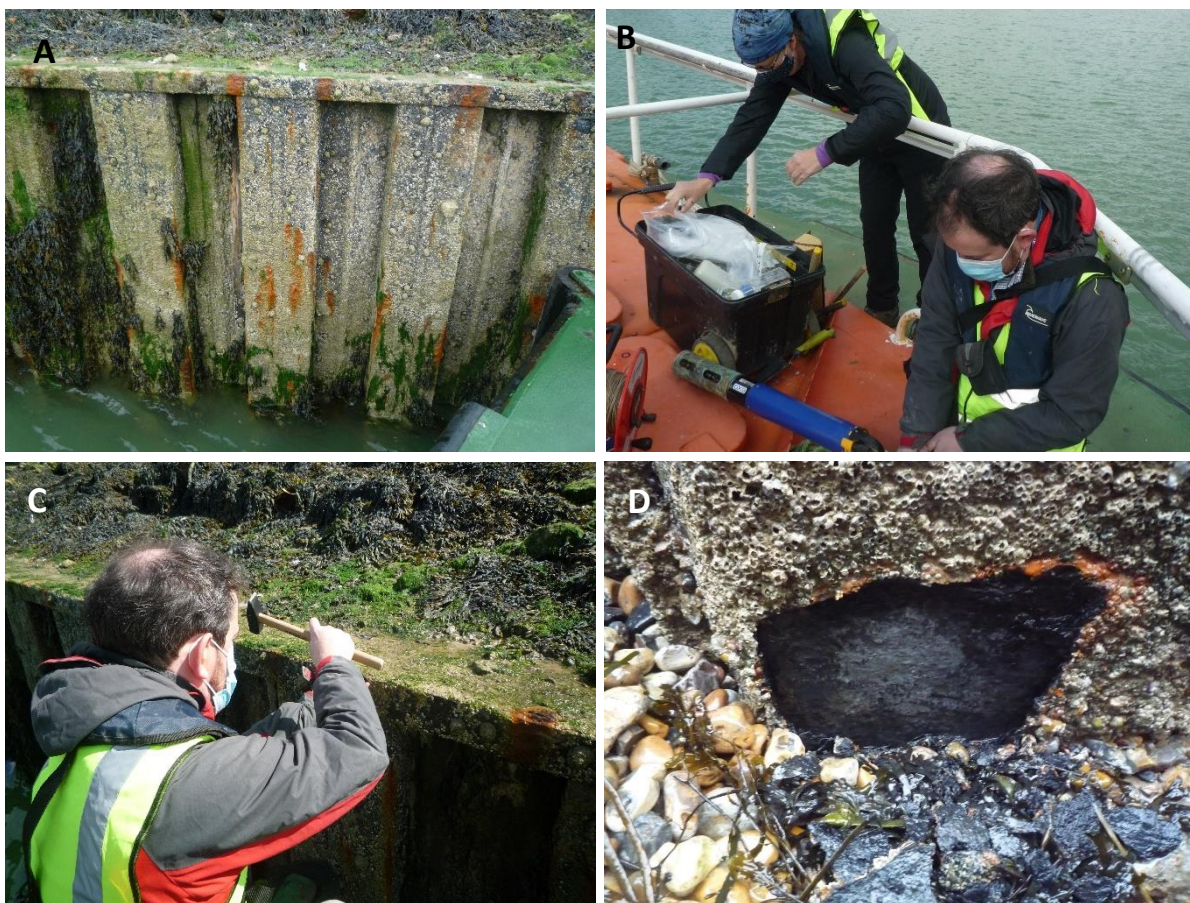
Figure NH2: Images of Newhaven Port environment and corrosion. (A) View of the steel pile wall. (B) Water and corrosion sampling from pilot boat. (C) Corrosion sampling from pilot boat. (D) Removed intertidal corrosion blisters show inner sulphidic layer and acid etched steel.

The Newhaven site had a program of baseline environmental sampling from November 2020 to July 2021. The sampling included corrosion, water and sediment cores used for solid sediment analyses, and pore water analyses. Sub-samples of each sample type were taken for microbial analyses (detailed in the Shoreham demonstration site report) as these sites are subject to microbiologically influenced corrosion (Accelerated Low Water Corrosion). Samples were collected either from intertidal sites, from the port side, or accessed via the Port Authority inshore pilot boat. Images of steel corrosion, the sampling procedure and corrosion are given in Figure NH2.

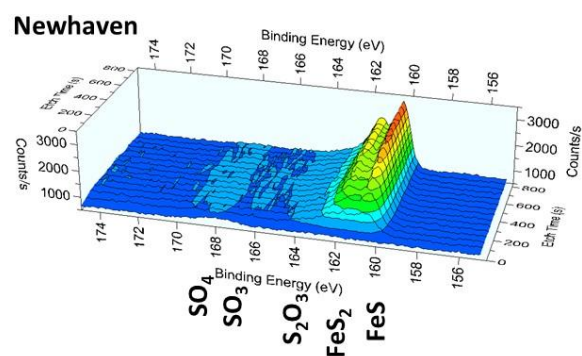
Figure NH3: Results of corrosion characterisation, Newhaven Port. (A) Fourier transform infrared spectra of corrosion products. In this case dominated by iron oxides and oxyhydroxides alongside sulphate. (b) X-ray photoelectron spectrum of intertidal corrosion products. Sulphides and sulphate are detectable in corrosion products.

The results of mineralogical and chemical analysis of corrosion samples are shown in Figure NH3. The FTIR spectra are characterised by a broad adsorption peak from $3000\text{-}3500\text{cm}^{-1}$ that can be attributed to O-H groups and H_2O , and multiple complex peaks in the range $600\text{-}1800\text{cm}^{-1}$. Analysis of FTIR spectra was concentrated in the latter range as these absorption bands can be related to corrosion products on the steel surface. Two areas of the spectra were interpreted in detail using the PeakFit 4.12 software to deconvolute composite absorption peaks. Peaks were identified using

gaussian amplitude deconvolution with a second derivative-based background fit, in separate windows from 750-1200 cm^{-1} and from 1250-1750 cm^{-1} . Deconvolution used a fixed full width at half maximum peak height of 18.1 cm^{-1} , except for visibly narrower peaks at 861 cm^{-1} and 874 cm^{-1} where FWHM was reduced to fit the visible peaks. Within the intertidal corrosion samples lepidocrocite absorbance peaks at 746 cm^{-1} and 1023 cm^{-1} were developed in all samples (RRUFF database). Within the Newhaven samples absorption peaks at 781 cm^{-1} , 841 cm^{-1} , and 874 cm^{-1} , can be attributed to Fe-OH stretching modes in sulphate green rust (Peulon et al., 2003). Peaks at 992 cm^{-1} , 1095 cm^{-1} , 1109 cm^{-1} , and 1156 cm^{-1} can be attributed to various SO_4^{2-} vibration modes in green rust ((Borda et al., 2004; Peulon et al., 2003; Rouchon et al., 2012) and that at 874 cm^{-1} may also be influenced by HSO_4^- (Usher et al., 2005). The sulphur species vibrational modes are not well developed in SE6, indicating a lack of sulphur compounds in this sample. The broad adsorption band from 1250-1550 cm^{-1} , can be deconvoluted to peaks from ferric and ferrous hydroxide gel at 1339 cm^{-1} and 1396 cm^{-1} (Chernyshova, 2003), those at 1435 cm^{-1} and 1473 cm^{-1} to the presence of carbonate from calcite or aragonite shell material (RRUFF database), and that at 1519 cm^{-1} to the O-H bond deformation. The peak at 1627-1637 cm^{-1} can be attributed to water (Shahabi-Navid et al., 2020). It should be noted that the presence of biofilms in intertidal samples means that spectra may be influenced by the presence of polysaccharide biofilms on the surface (Beech et al., 2005; Zinkevich et al., 1996). We have tested for this using the spectra of reagent grade alginic acid and sodium alginate (both components of marine biofilm extra cellular polymeric substances (EPS) (Beech and Sunner, 2004; Sachan and Singh, 2020). These have characteristic absorption bands at 1244 cm^{-1} and 1598 cm^{-1} respectively which are absent from the samples (Figure NH3 A). The sulphate adsorption bands arise from the formation of sulphate green rust by sulphide oxidation as part of the MIC mechanism and could be used as a rapid diagnostic tool of accelerated microbially influenced corrosion types.

Infrared spectroscopy was been supplemented by X-ray photoelectron spectroscopy on selected samples to confirm the detailed corrosion mechanism. This technique is not suited for rapid diagnosis of corrosion type and hazard due to complexity and cost, but provides detailed information on the chemistry of corrosion products which can be used to confirm interpretations of corrosion mechanism from other techniques. This gives a firm basis for the utilisation of rapid low cost mineralogical techniques in the analysis of corrosion type. This is particularly useful for instances of microbially influenced corrosion which may lead to high corrosion rates with significant hazard to infrastructure. XPS depth profiles show the red outer surface of corrosion blisters have lower Fe content compared to the interior. In the outer, red portion Fe varies from 10-30 atom %, and in the inner, black portion it varies from 3-6 atom %. Detailed interpretation of the sulphur 2p_{3/2} peak indicate sulphur is dominated by sulphate on the corrosion surface, with minor components of sulphite and thiosulphate developed with depth into the sample. The interior of the sample is dominated by iron sulphides (Figure NH3 B). This confirms the accelerated low water corrosion mechanism as the production of hydrogen sulphide at the steel surface by sulphate reducing bacteria. This reacts with iron to produce iron sulphides. These are then oxidised by iron oxidising and sulphur oxidising bacteria, ultimately producing sulphate compounds. Acidity is generated at every stage, account for the highly corrosive microenvironment. A strong conclusion from this is that sulphur compounds detectable by simple spectroscopic techniques can be used as diagnostic of microbially influenced corrosion, which can then inform the SOCORRO corrosion risk assessment methodology.

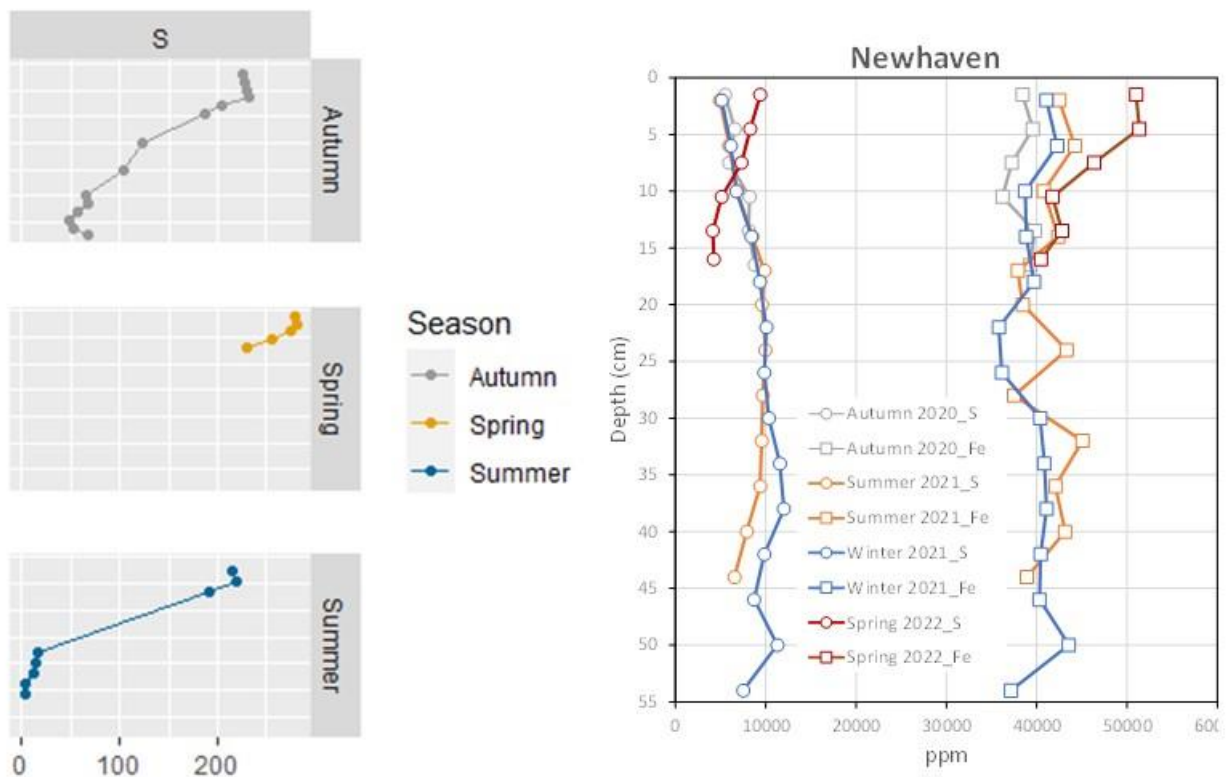
Figure NH6: Depth profiles of pore fluid (left solid phase iron and sulphur content (right) from sediment cores at Newhaven.

Analysis of sediment cores included solid phase iron and sulphur, and porewater iron and sulphur, sampled over 4 seasons. During all seasons the sulphate content in pore water declines rapidly with depth (Figure NH6). In autumn, winter and summer the solid iron and sulphur contents increase with depth. Taken together with the pore water chemistry these are an indicator of the action of sulphate reducing bacteria in the bed sediment, using sulphate from pore water and generating iron sulphide minerals, and support bed sediment anoxia as a potential risk factor for MIC. This has further been confirmed by comparison of sediment and corrosion microbiology detailed in the demonstration site report on Shoreham Port. A reduction in solid state sulphur and iron in summer 2022 can be related to high freshwater flows at the end of the winter period resulting in sediment redistribution.

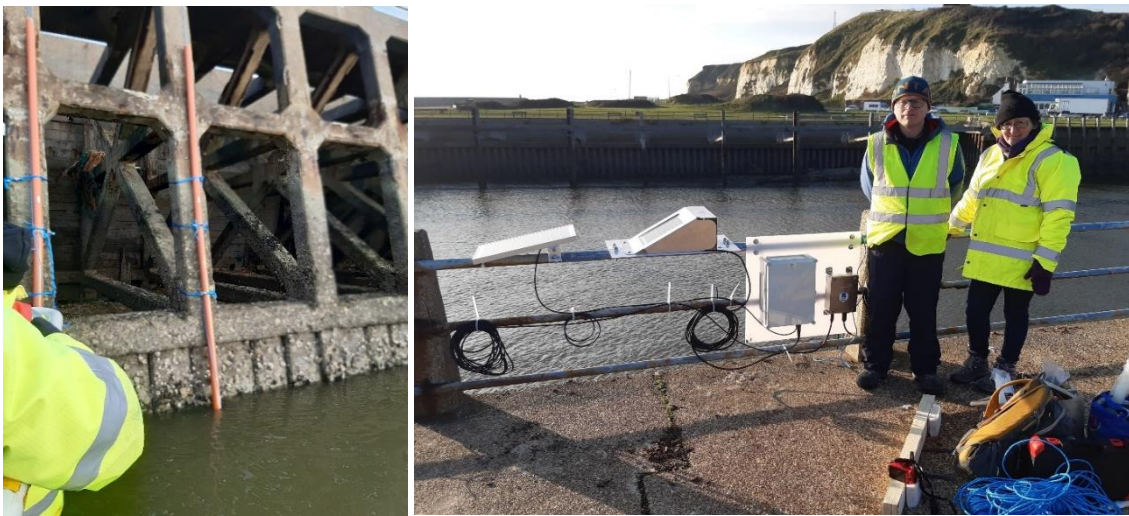
Figure NH8: Photographs of the final installation, Newhaven Port.

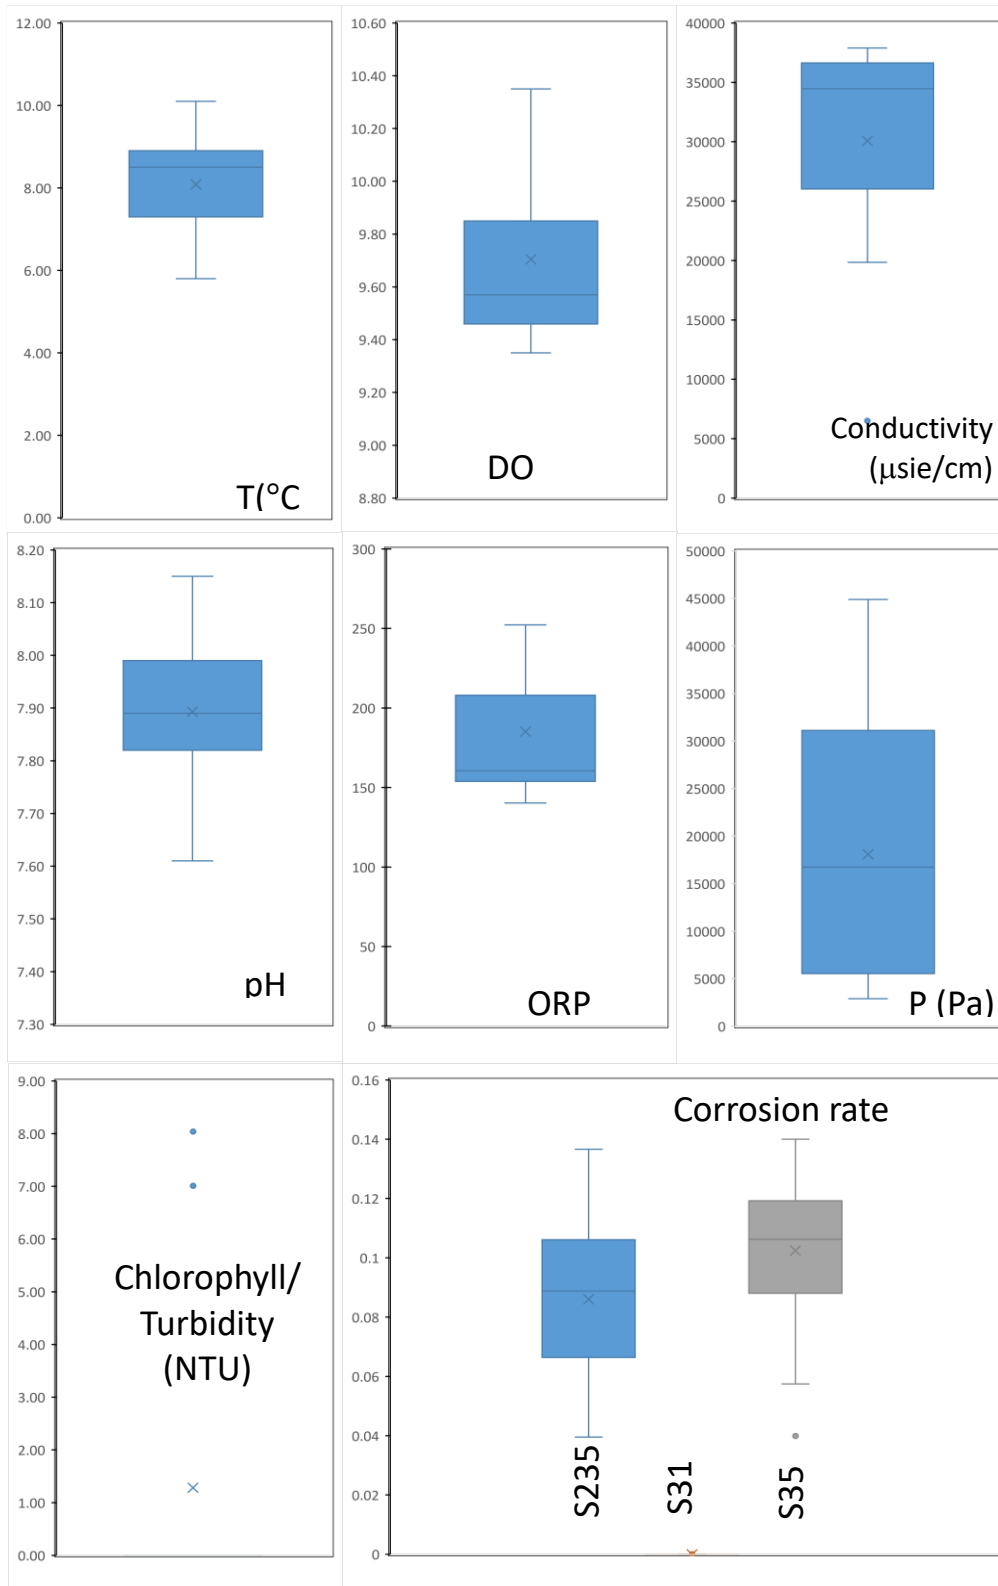
Figure NH11: Box and whisker plots indicating median, upper and lower quartiles and outliers for environmental parameters and corrosion rate.

Time series plots from 8th to 22nd December of all monitored data are shown in Figures NH9 and NH10. The means and ranges of data are shown in Figure NH11. The data are strongly tidally influenced, and a portion of one spring to neap tidal cycle in water depth (calculated from water pressure) was captured by the monitoring period. These cycles influence all other variables. In terms of depth notably on spring low tides the steel piling and the monitoring point can be exposed to atmosphere. Temperature varied between 0-10°C, with low T corresponding to exposure to atmosphere at night time. Dissolved oxygen also varied tidally, but only to minor extent except for when the steel was atmospherically exposed on low tide (Figure NH11). Oxidation-reduction potential (ORP) shows variation in relation to the diurnal and monthly tidal cycle, with relative highs on sub-aerial exposure, and lows at high T and low conductivity (high freshwater input). pH is relatively constant between 7.6 and 8.15, with some slight bimodality with the changing tide. Conductivity varies bimodally in relation to the relative input of marine and freshwater through the tidal cycle in an estuarine environment. Chlorophyll is typically close to the detection limit of the sensor system, except for isolated peaks presumed to relate to the resuspension of algal material at spring low tides.

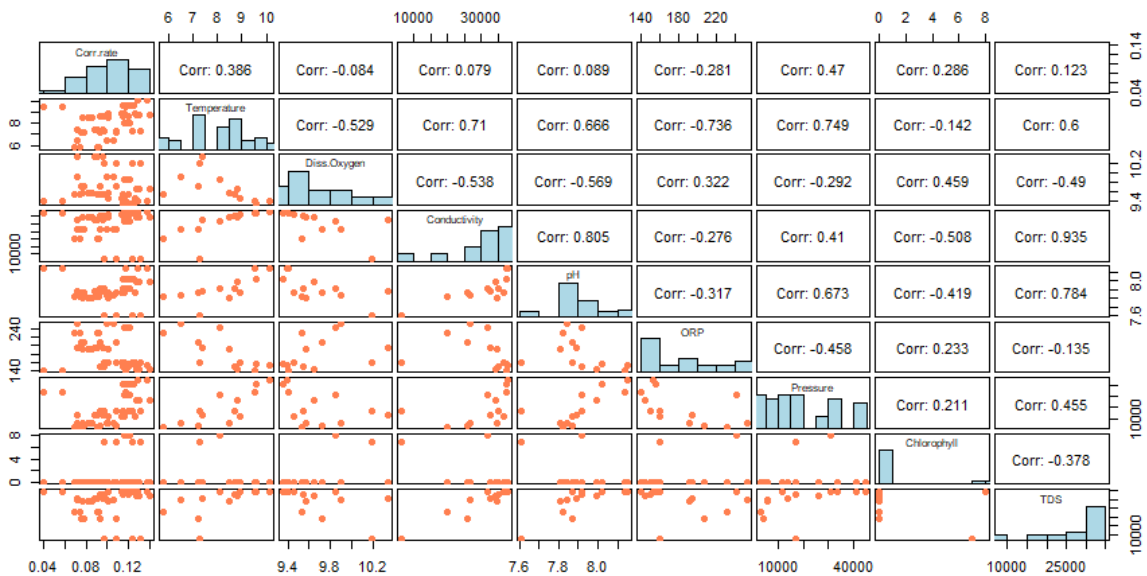
Figure NH12: Bivariate correlation plots and Pearson correlation co-efficients for S235 and S355 steel with environmental parameters.

The Corrosion rate at Newhaven varied between 0.04 to 0.14mm/year for S235 steel, from 0.05 to 0.14mm/year for S355 steel, and was typically below 0.01mm/year for S316L (stainless) steel. Bivariate correlation between corrosion rate and environmental parameters is particularly apparent with dissolved oxygen, temperature and depth (which drives variation in other parameters in a tidal environment) in both S235 and S355.
