## DEMONSTRATION AT AN OFFSHORE FOUNDATION

### *SOCORRO test setup*

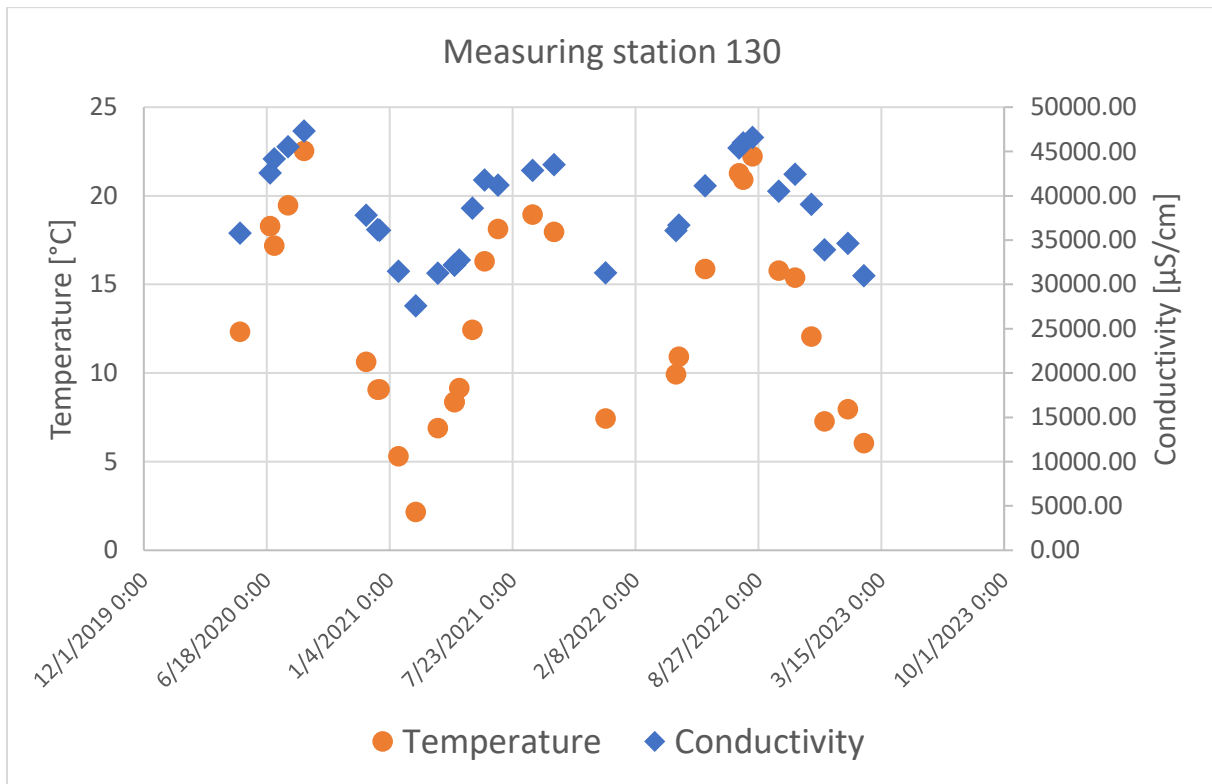
Figure 2: Temperature and conductivity data collected by the Flanders Marine Institute.

The baseline information given below in this section is largely based on the 'Environmental Effects Report' for the installation of the Blue Accelerator, as well as data obtained from the Flanders Marine Institute<sup>1</sup>. More specifically, conductivity and temperature data from measuring station 130 is given below in Figure 2.

The average water temperature in the Belgian part of the North Sea is around 11 °C. Seasonal variations occur with an order of magnitude of 8 to 9°C compared to the mean temperature, with the largest variations being observed in the first months of the year. Seawater temperature has an interannual variability of 1 to 4°C (Ruddick & Lacroix, 2006). Data from measuring station 130 of the Flanders Marine Institute is given in Figure 2.

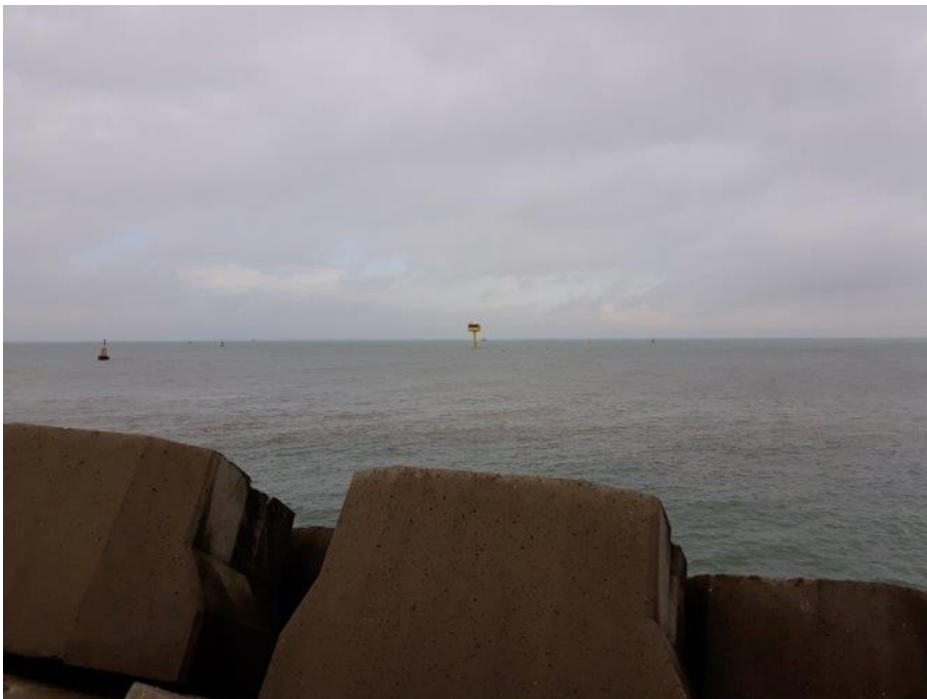
Figure 4: Picture of the Blue Accelerator, taken from the location indicated with the blue star in Figure 3.

The Blue Accelerator test site is located approximately 500m from the shore, in front of the harbour of Ostend, as is illustrated in Figure 3. A picture taken from the location indicated with the blue star is shown in Figure 4. A close-up picture of the Blue Accelerator test site is shown in Figure 5. The Blue Accelerator test site is owned and operated by POM West-Vlaanderen. More information on the Blue Accelerator can be found online (<https://www.blueaccelerator.be/>).

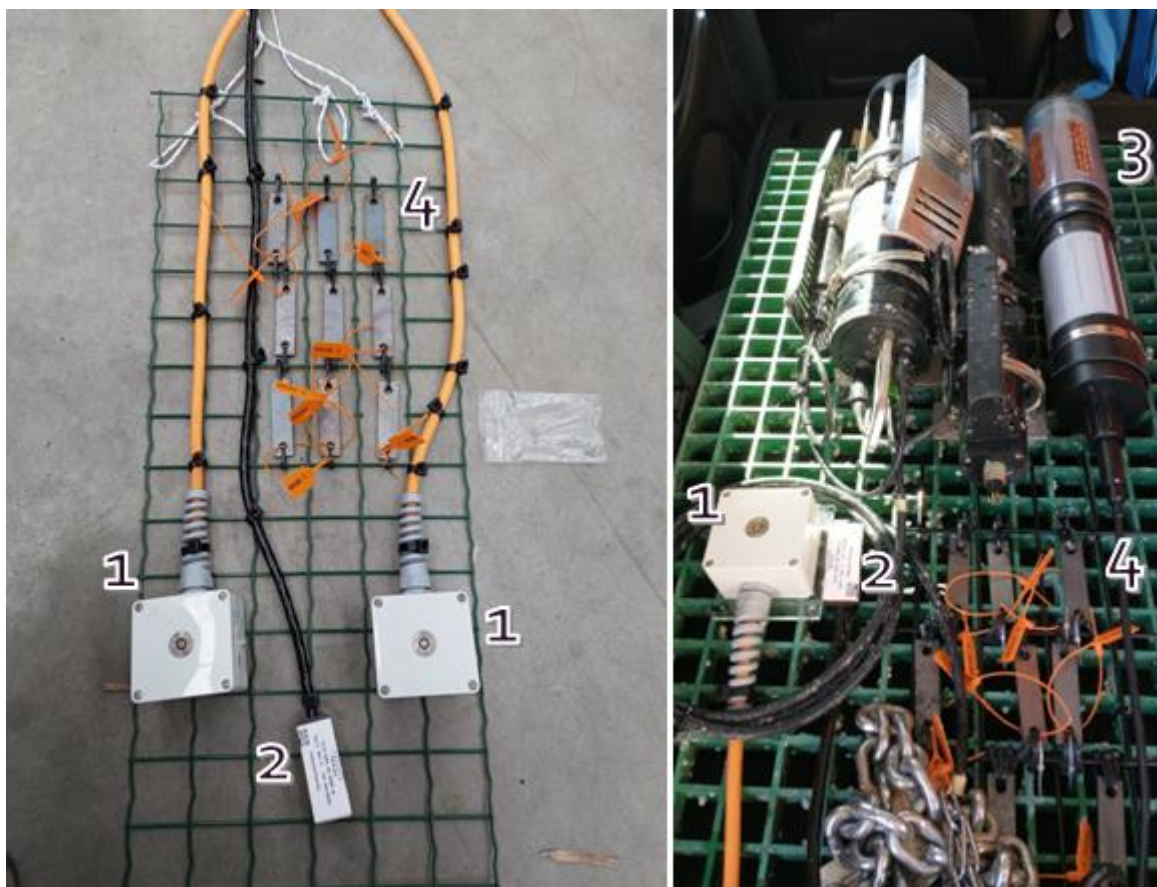
Figure 8: Left: Frame with corrosion coupons and sensors for installation on the inside of the MP. Right: Sensors and corrosion coupons installed on the outside of the MP. (1) C-Cube sensors, (2) COSASCO sensors, (3) Manta Multisensory probes and (4) corrosion coupons.

The external sensors were attached directly to the frame shown on (Figure 6, right). A multisensory probe was secured to the frame using 316 stainless steel cable binders. Corrosion coupons and corrosion sensors were fixed to the frame using plastic zip ties (black, UV resistant). The entire frame with sensors is shown on Figure 8, right.

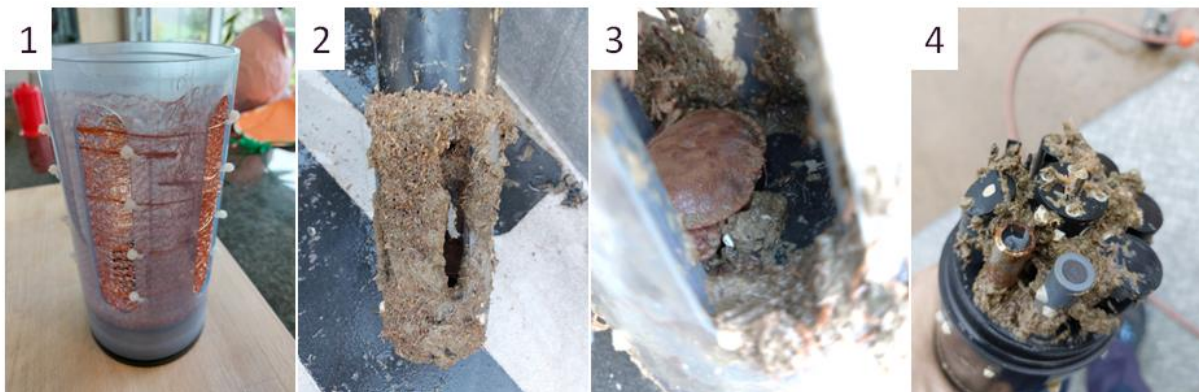
Figure 9: [1] Picture of a new protection cap with copper mesh present (fortified version for measurement campaign 2). [2] Presence of fouling on sensor during inspection on 10/10/2022 (BLUE2), with copper mesh clearly missing. [3] Presence of a large crab within the sensor protection cap. [4] Significant fouling on the sensors themselves.

To clarify point 3, some pictures taken during the inspection of BLUE2 sensor on 10/10/2022 are shown in Figure 9. It is clear from picture 1 and 2 that the copper mesh which is meant to protect the sensors inside the protection cap is missing.

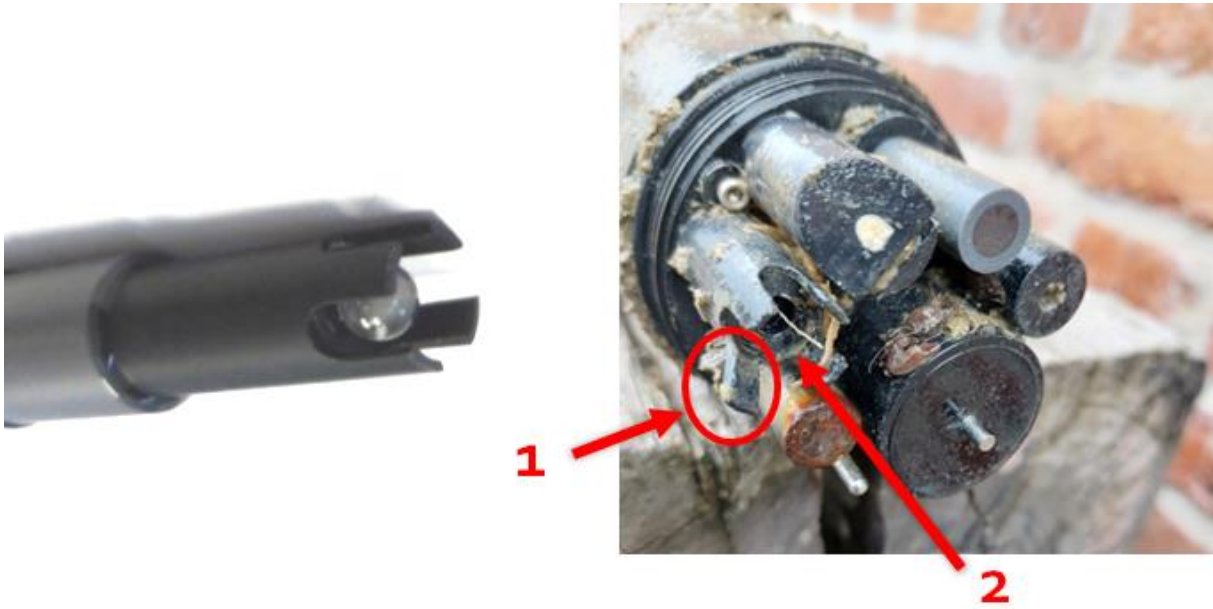
Figure 10: Left: pH probe in new condition with clearly visible glass sphere as sensor element. Right: Multisensory probe after retrieval on 10/10/2022. [1] Bent plastic protection leg. [2] Glass sphere missing.

As an addition to point 3, it's good to point out that 'anti-fouling' may also include the actions of larger organisms like crabs. During inspection a large crab was found in each of the multisensory probes. It is not impossible that these crabs are responsible for some of the mechanical damage observed to the probes. It is for example possible that the crab is feeding on smaller organisms attaching themselves to the probes, and in trying to get a hold of them, the crab damages some of the more fragile components of the probe, such as the glass sphere and plastic protection legs of the pH sensor (Figure 10). As another example, scratch lines are clearly visible on the Chloride ISE sensor (Figure 11). The picture in Figure 10 are from the BLUE1 sensor, i.e. on the inside of the monopile. The pile itself is almost completely sealed off, except for a small opening for cables at the bottom. This means that there is very little water movement, nor any presence of floating debris in the monopile. The sensors were further more at all times covered by the protection cap. No damage from external sources can therefore occur during either operation or retrieval. This has led to the suggestion of the crab living in the sensor causing the damage.

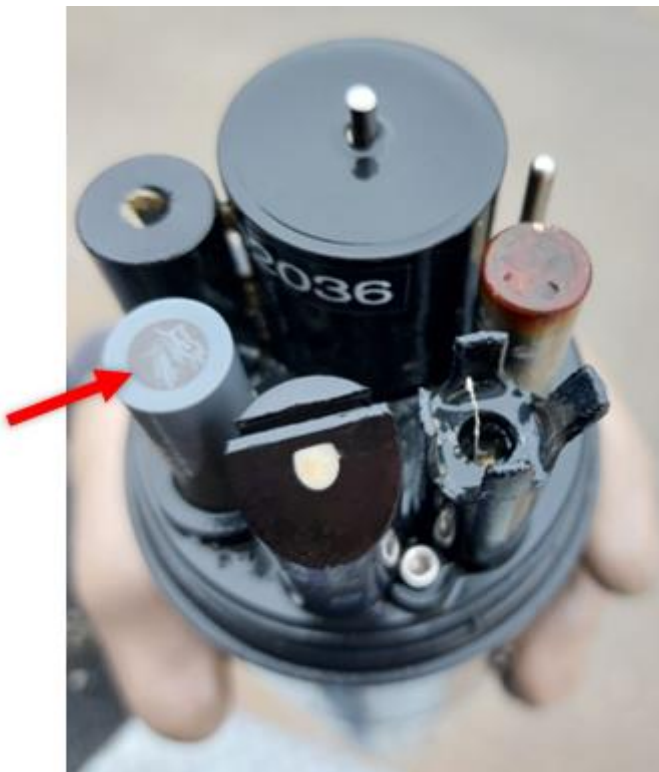
Figure 11: Scratch marks on Chloride ISE sensor.

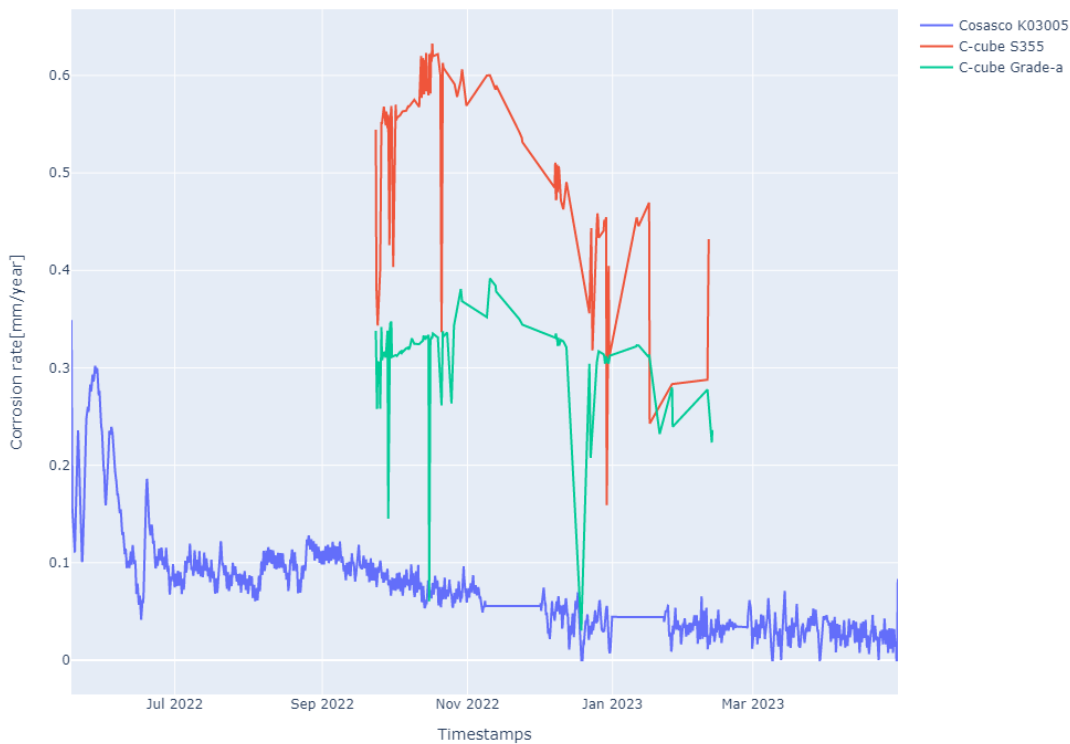
Figure 12: BLUE1 – Corrosion rate

From the COSASCO data in Figure 12 and Figure 13 it can be seen that the initial corrosion rate is high, followed by a gradual decrease in the corrosion rate. This can be related to the build up of a corrosion product layer on the sensor coupons, which reduces the accessibility to oxygen. Starting from September a second decline in the corrosion rate can be observed for BLUE1, this is probably linked to decreasing water temperatures. During the summer period an average corrosion rate of approximately 0.1mm/yr is obtained using the COSASCO probes. During the winter period the corrosion rate drops to approximately 0.025-0.030 mm/yr.

From the graphs, it can clearly be seen that the corrosion rates as measured using the C-Cube sensor are significantly higher than the corrosion rates from the COSASCO sensor. By comparing to the results from mass loss coupons, it can be concluded that the C-Cube sensor is overestimating the corrosion rates, especially for the internal corrosion. The coupons were installed on 17/05/2022, at the same time of the COSASCO and C-Cube sensors. Coupons from the outside of the monopile were retrieved on 10/10/2022 and coupons from the inside of the monopile on 25/01/2023. The corrosion rate was determined from mass loss measurements and are shown in Table 1. Three coupons were measured for BLUE2, two coupons for BLUE1. For comparison, the corrosion rate calculated based on the mass loss given by the COSASCO probes on the same day is given. The corrosion rates from the mass loss coupons are in line with the corrosion rates from the COSASCO probes, although the COSASCO probes are somewhat underestimating the corrosion rate.

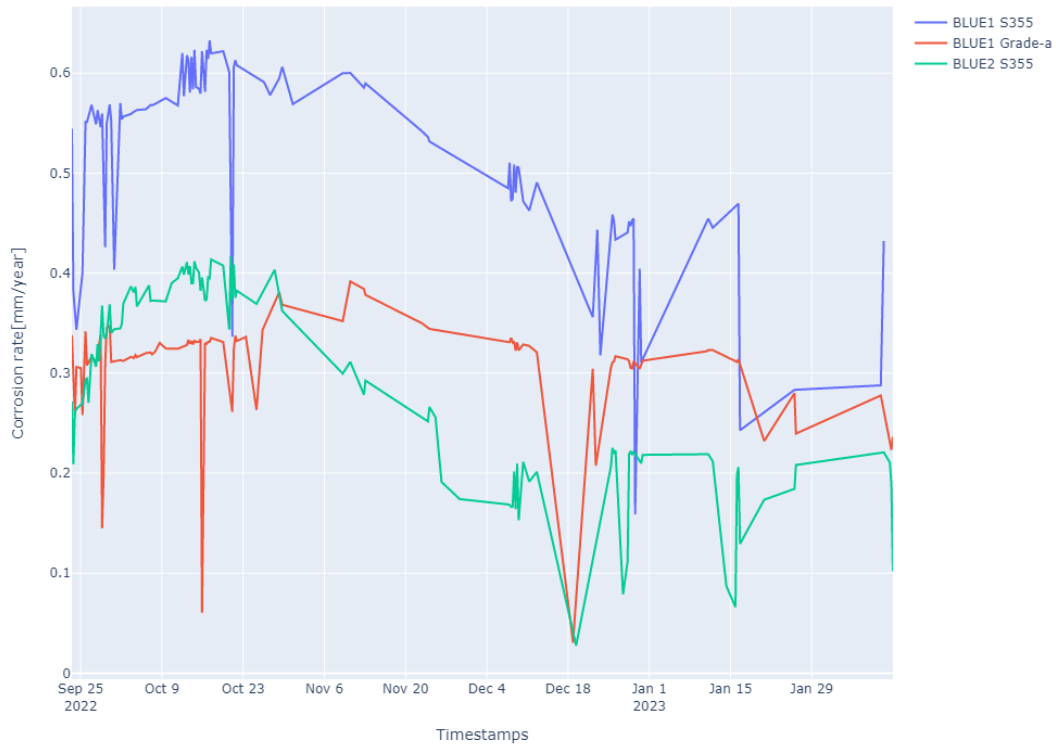
Figure 15: C-Cube corrosion rates. Internal (BLUE1) vs. external (BLUE2) corrosion.

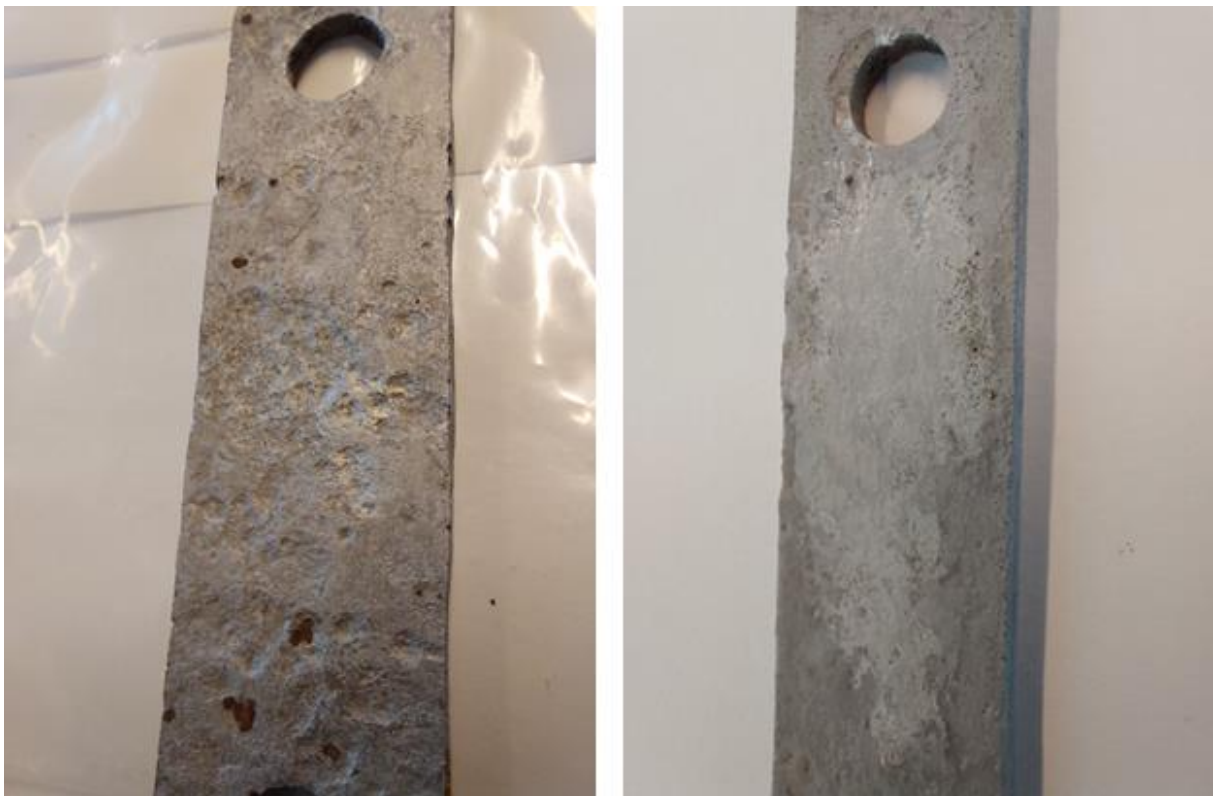
*Figure 18: Left: coupons exposed on the outside of the monopile for 147 days. Right: coupons exposed on the inside of the monopile for 254 days.*

The corrosion coupons from external exposure exhibit a much more pronounced pitting profile than the internal coupons, as can be seen from Figure 18 and Figure 19. In addition, the amount and type of fouling found on internal and external coupons is different. The fouling layer on external coupons is not only thicker, it also contains more macro-organisms, i.e. larger organisms like mussels, types of worms, etc. The difference in fouling is illustrated in Figure 20.

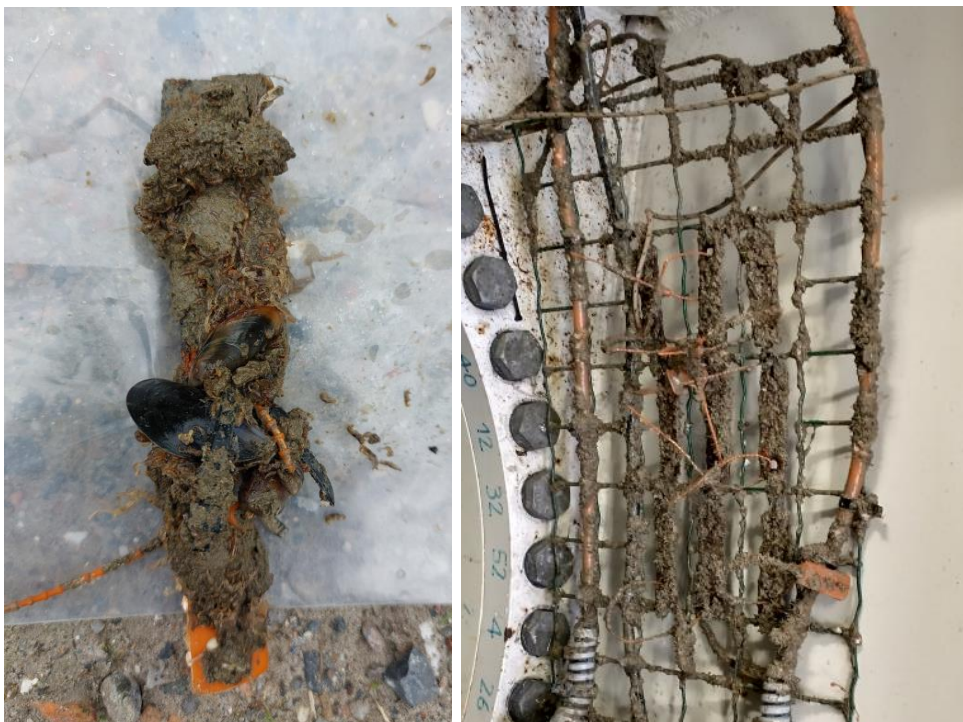
Figure 20: Illustration of fouling on corrosion coupons. Left: external; Right: Internal.

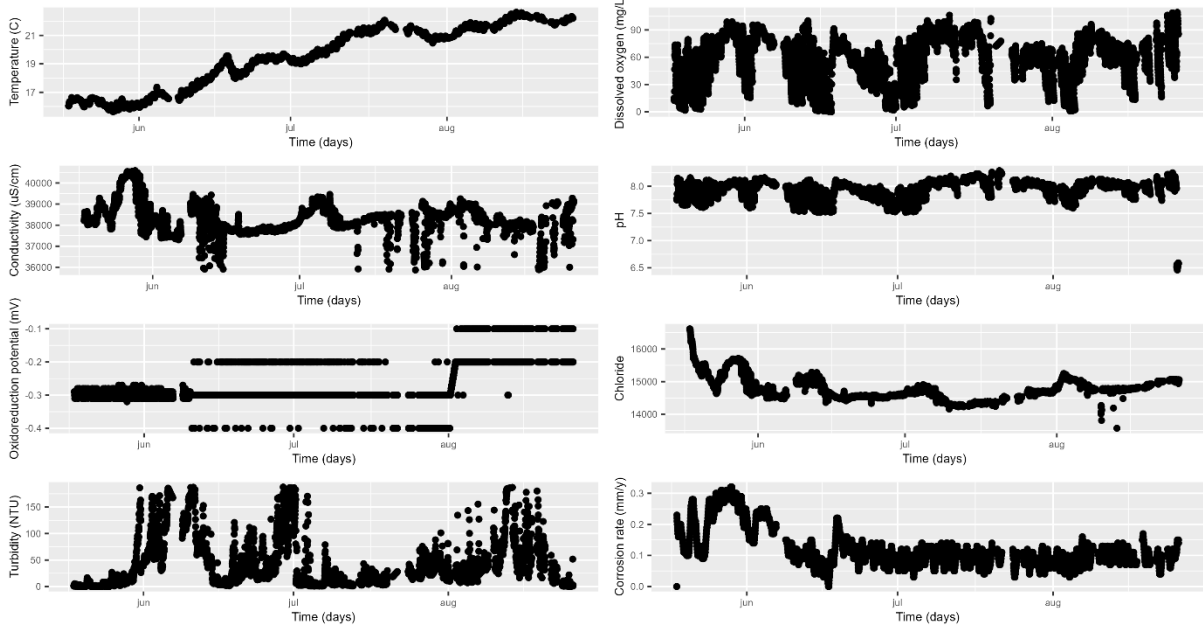
Figure 21: Timeseries of measured parameters at the Blue Accelerator, location BLUE1 (i.e. inside of the monopile). Data is shown from 18/05/2022 till 25/08/2022.

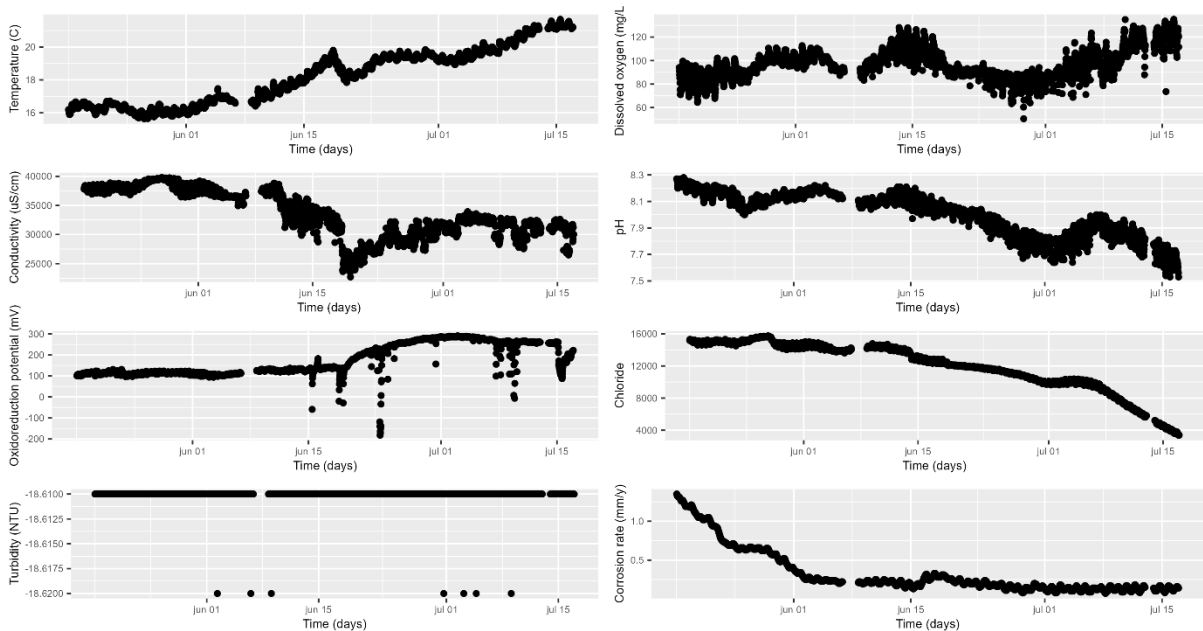
Figure 22: Timeseries of measured parameters at the Blue Accelerator, location BLUE2 (i.e. outside of the monopile). Data is shown from 18/05/2022 till 16/07/2022.

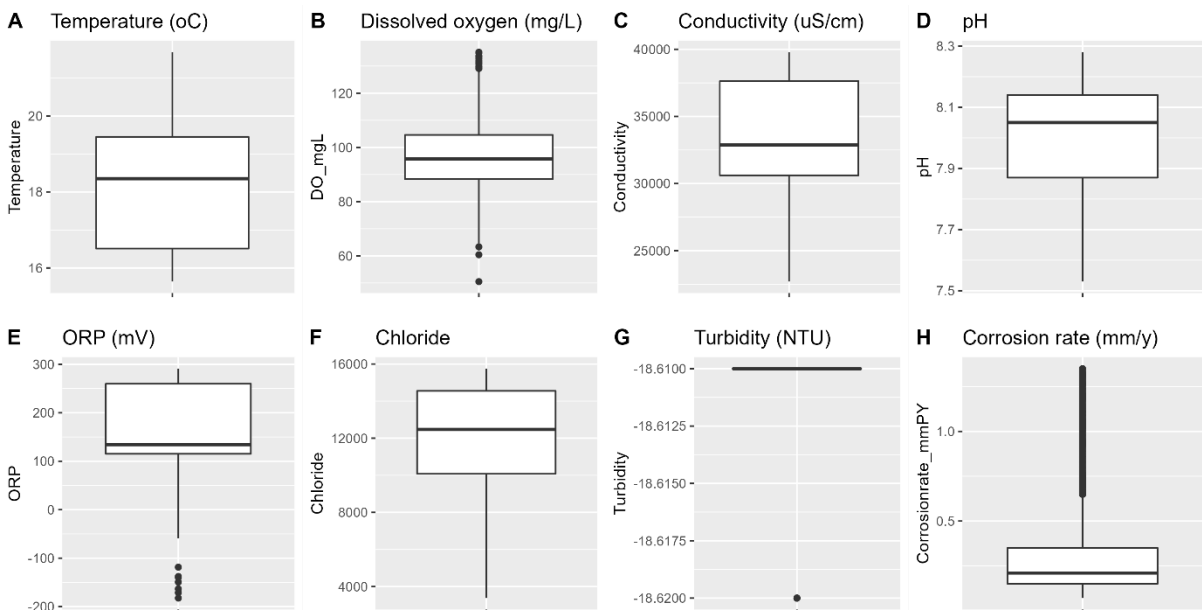
Figure 24: Boxplots of measured parameters at the Blue Accelerator, location BLUE2 (i.e. outside of the monopile). Data is shown from 18/05/2022 till 16/07/2022.

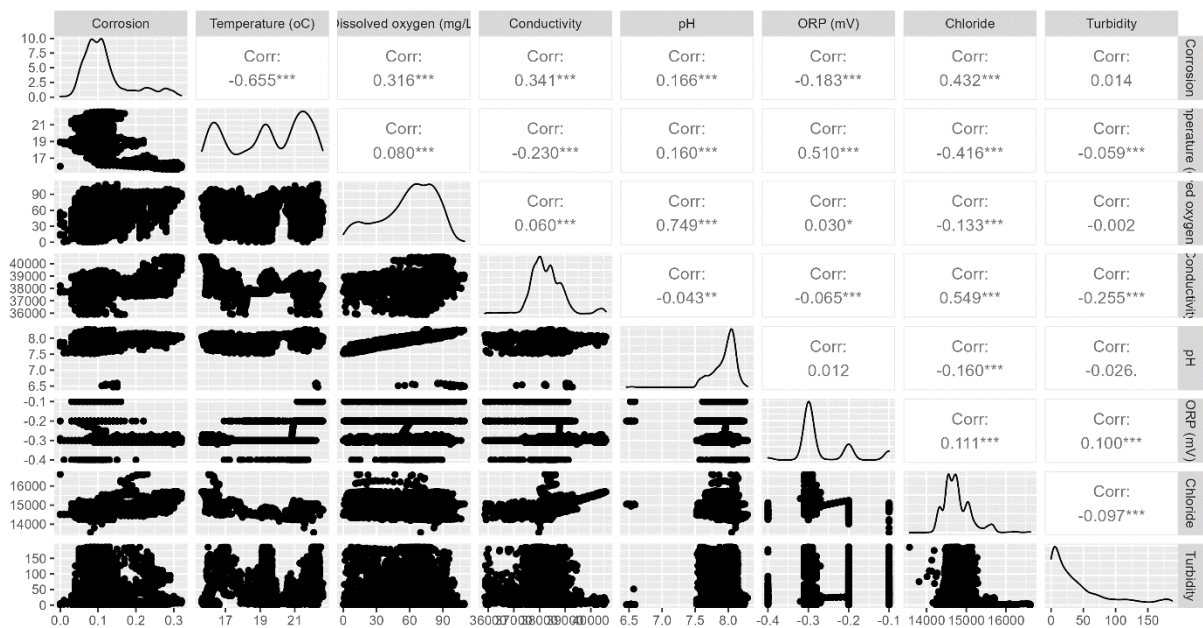
Figure 25: Pair-wise correlation factors and plots for BLUE1. Calculation for correlation factors according to Pearson.

An overview of pair-wise correlation factors and plots is given for BLUE1 in Figure 25 and for BLUE2 in Figure 26. Correlation factors are calculated according to Pearson.

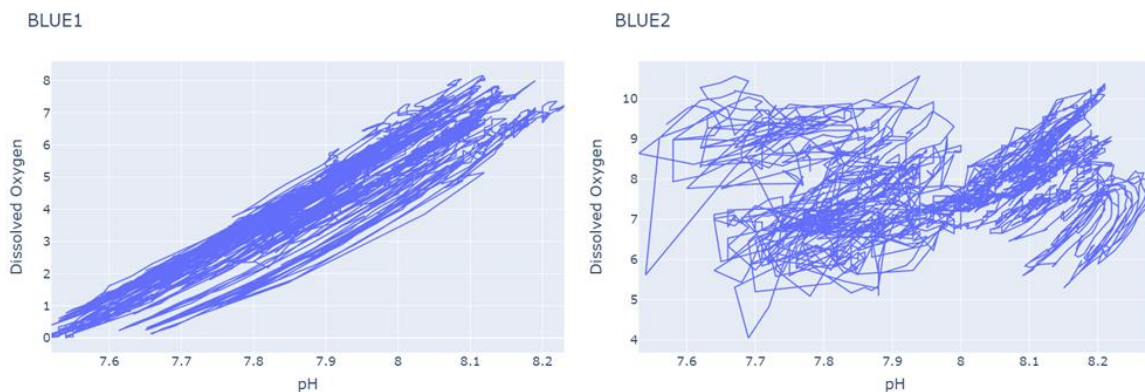
Figure 27: Pair plots of DO vs. pH for BLUE1 and BLUE2 in the period 18/05/2022 to 16/07/2022.

From the plots and correlation factors, it can be seen that there is one very high correlation factor, namely between Dissolved Oxygen and pH for BLUE1. The pair plots in Figure 27 clearly demonstrate this correlation for the inside of the monopile (BLUE1), while it is entirely absent for the outside of the monopile (BLUE2). In addition Figure 28 shows that both DO and pH exhibit 12 hour cycles at BLUE1. Taking the data of July 3<sup>rd</sup> and 4<sup>th</sup> as an example, it can be seen from Figure 29 that the changes in DO follow the same periodicity as the changes in tidal level. The observed 12 hour cycles in DO and pH are therefore most likely linked to the tidal cycles. A possible explanation is given below. The synchronisation is not perfect. Why the DO is not perfectly synchronised with tidal levels is not yet understood and requires further study.

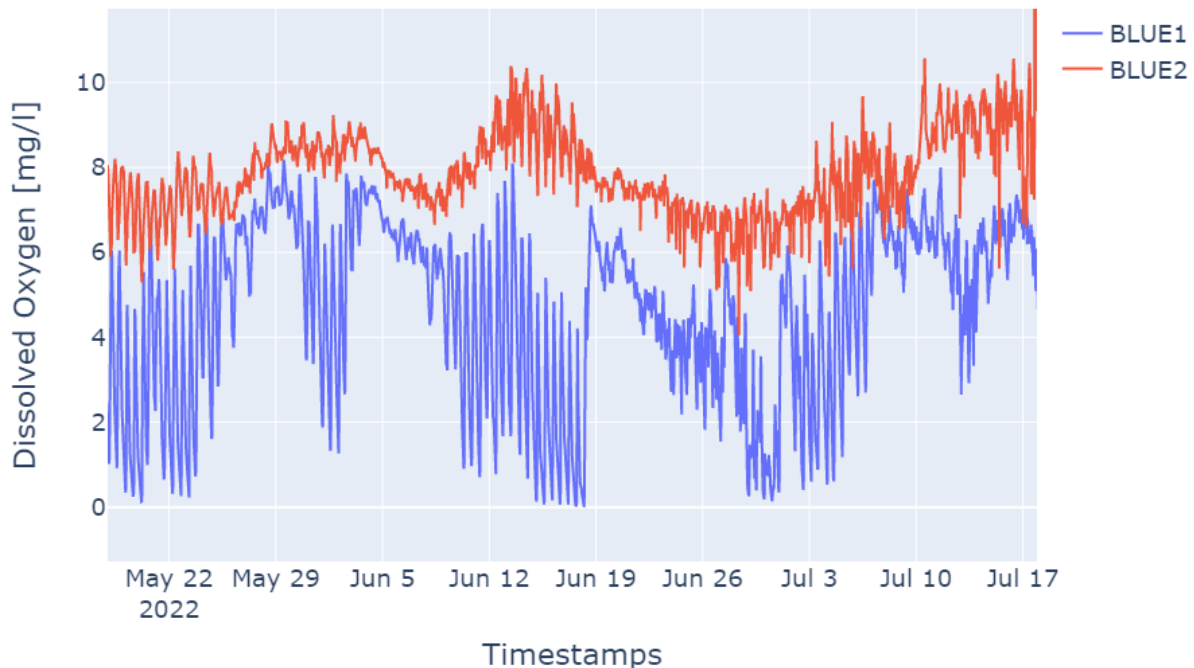
Figure 31: Time plots of Dissolved Oxygen for BLUE1 (internal) and BLUE2 (external).

The pH and DO inside the monopile are lower than that on the outside of the monopile, as can be seen in Figure 31 and Figure 32. The difference at the time of low tide is higher than the average difference given in Table 2. As a result, when the tide starts to rise, water with a higher DO and higher pH is flowing into the monopile, resulting in an increase in DO and pH levels. In the time between high tide and low tide, no new water flows into the monopile. During that time, oxygen is consumed by the organisms living inside the monopile. At the same time, bacterial live likely produces acidic substances, resulting in the observed drop in pH.

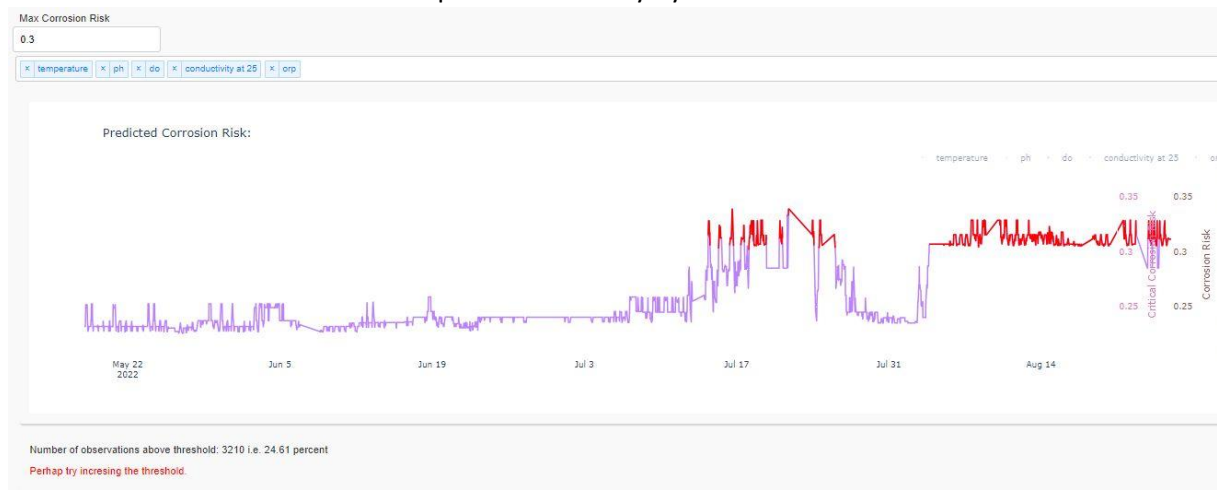
Figure 36: BLUE1, Measurement Campaign 1, Corrosion Risk as calculated using the SOCORRO Application (model trained using Lab data). Threshold set at 0.3.

Another conclusion is that the corrosion rate for BLUE1 is slightly higher than for BLUE2 when averaged over the entire period. This is also clear from the accumulated corrosion risks (not shown here). This does not agree with the experimental observations, which show that the corrosion rate for BLUE2 is twice that for BLUE1. The main reason for the difference in corrosion rate is a different dissolved oxygen content. It should be notes that in the Field data set, there were only very small differences in dissolved oxygen content in the training data set. Similarly, the lab data set also contained only very limited data points for different oxygen content. As such, it is not surprising that the difference between BLUE1 and BLUE2 is not captured accurately by the models.

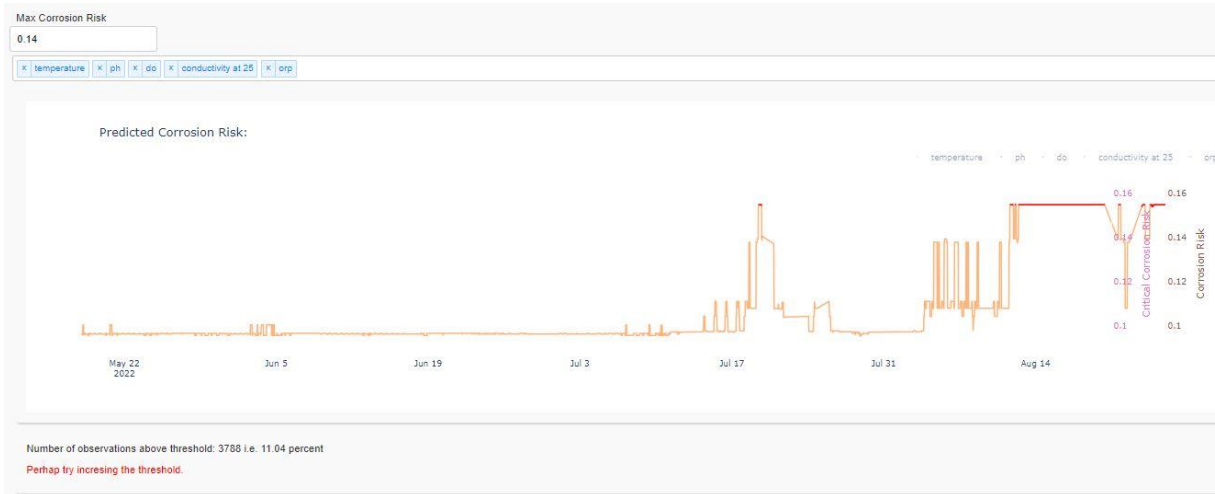
Figure 37: BLUE1, Measurement Campaign 1, Corrosion Risk as calculated using the SOCORRO Application (model trained using Field data). Threshold set at 0.14.

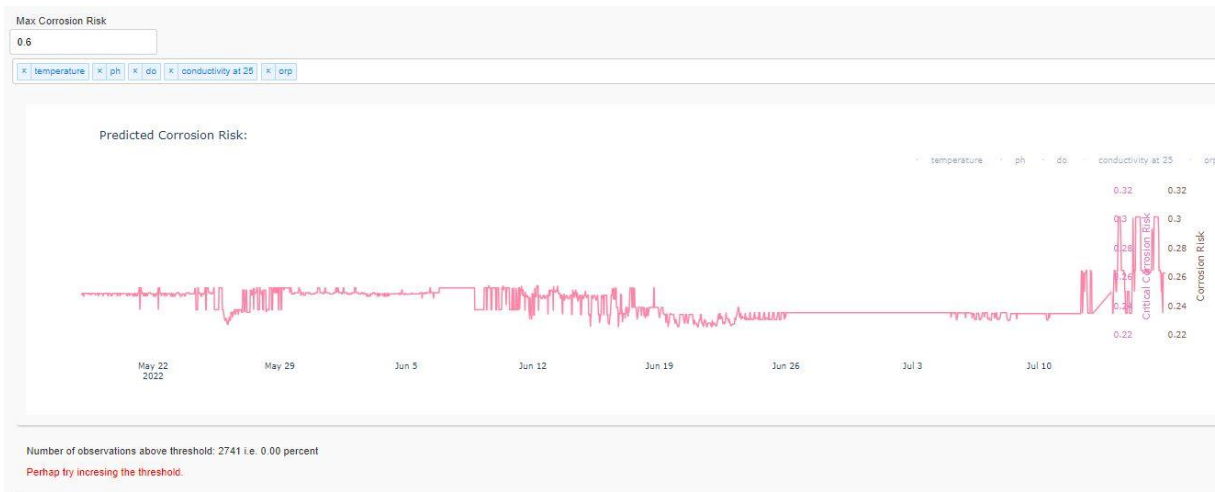
Figure 38: BLUE2, Measurement Campaign 1, Corrosion Risk as calculated using the SOCORRO Application (model trained using Lab data). Threshold set at 0.6.

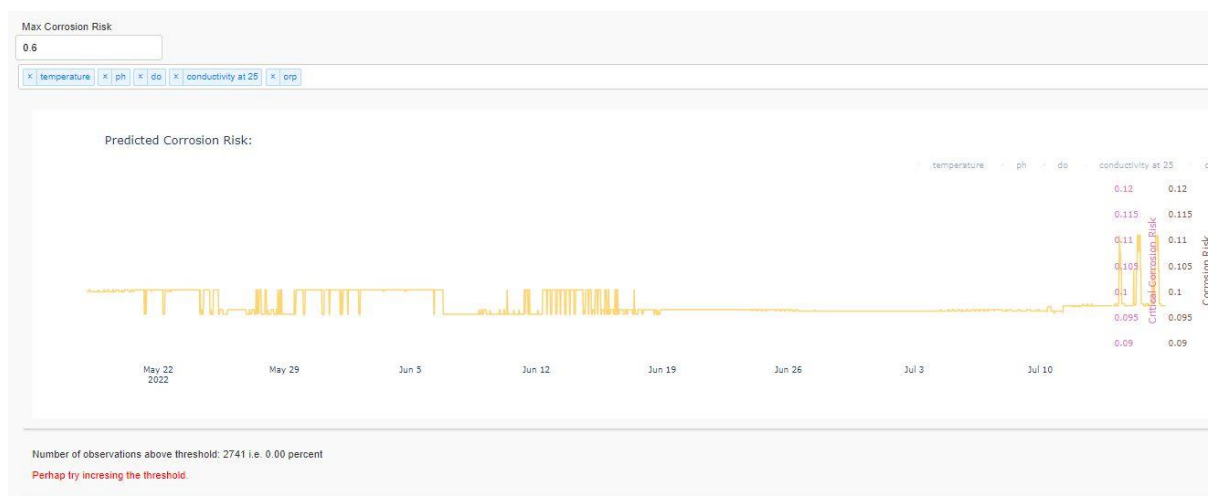
Figure 39: BLUE2, Measurement Campaign 1, Corrosion Risk as calculated using the SOCORRO Application (model trained using Field data). Threshold set at 0.6.
