DEMONSTRATION ON A SHIP

Written by Wikke Witteveen, Rik Geysen and Geert Potters – Antwerp Maritime Academy

The MV Kruibeke

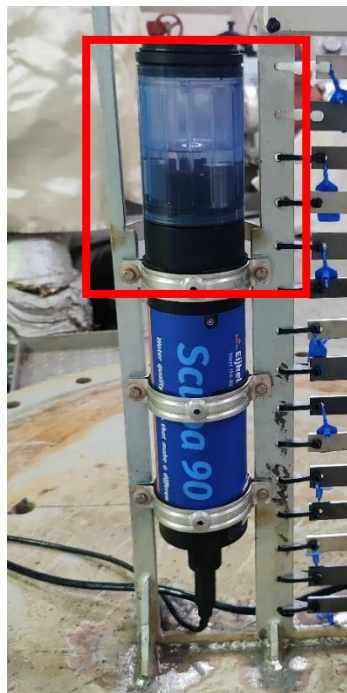
Figure 2: Storage cap on the Scuba probe.

The Scuba sensor is constructed out of a plastic cylinder, housing the sensors on one end and a cable connection point on the other end. Different caps can be screwed on the end of the sensors. For transportation and storage, a closed and watertight capsule (Figure 2) is provided. Since the sensors are preferably kept in a humid atmosphere, a small amount of water is to be hold in the capsule.

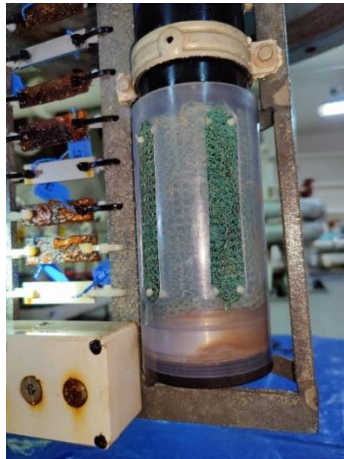
Figure 3: End cap with openings on the side.

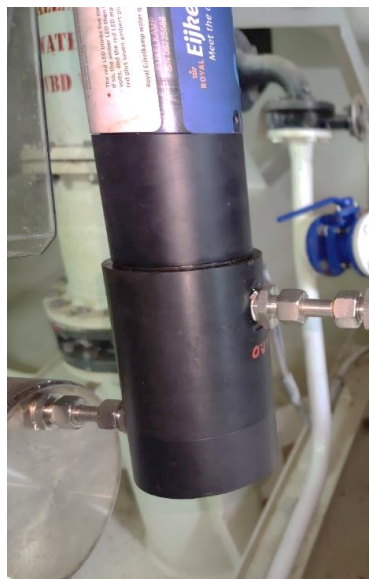
Figure 4: Specially designed flow cell (end cap).

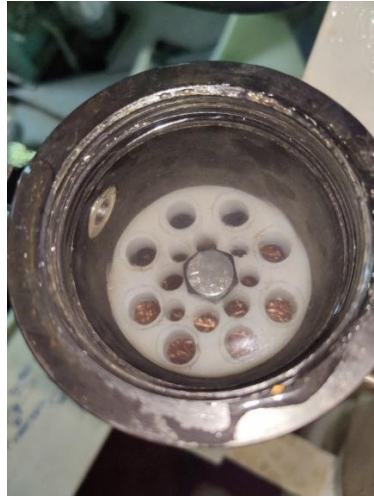
Figure 5: Copper mesh in the flow cell.

outlet. As in the sea chest strainer setup, a copper mesh was fitted in the flow cell to prevent fouling (Figure 5).

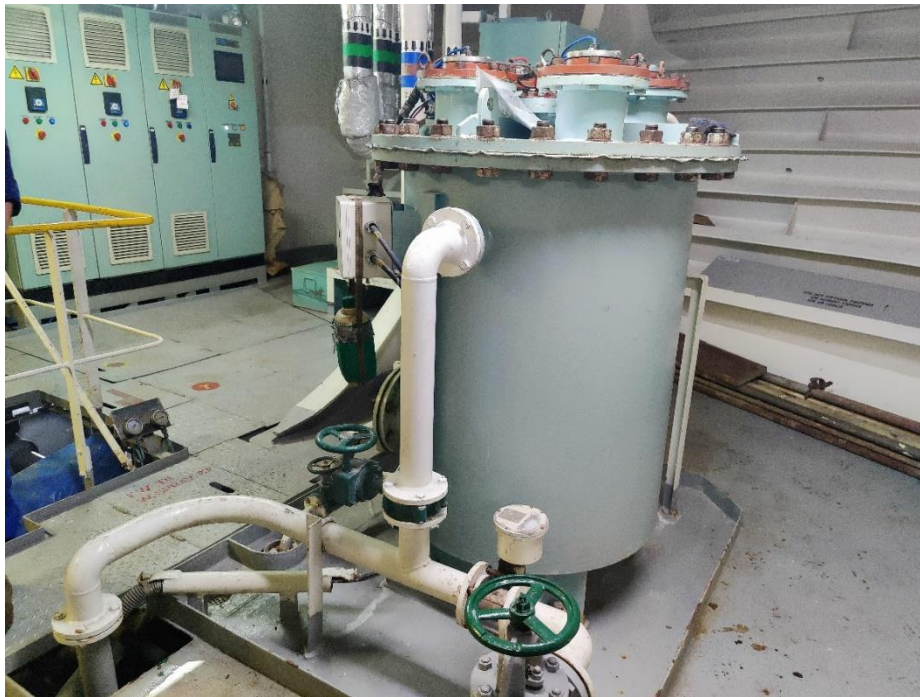
Figure 12: Antifouling (MGPS) anode treatment tank

The MGPS is made up of an anode treatment tank containing 2 copper anodes, 2 aluminium anodes and 1 stainless steel (SUS) cathode. Power is supplied from a control panel. A number of flow meters are fitted to check that the system is operating correctly. The treated water is supplied to the sea chests by means of injection nozzles (Figure 13).

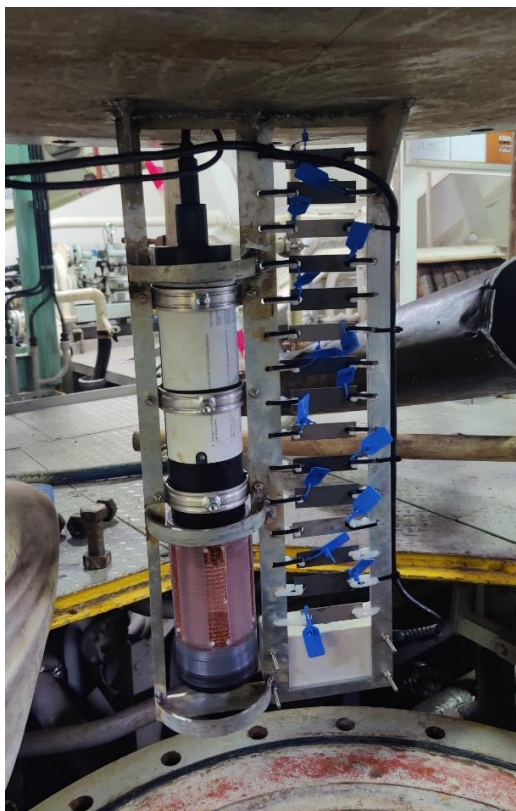
Figure 14: Sensor rack with Scuba sensor, C-Cube sensor and corrosion coupons, lifted out of the strainer.

The sensor rack (Figure 14, Figure 15) is designed to hold the Scuba sensor, C-Cube sensor and 15 corrosion coupons. Because of the steel bar fitted in the middle of the filter, there was not a lot of space left to fit the sensor rack. Because of this, the rack had to be fitted perpendicular to the direction of the incoming flow of seawater. Naturally, this creates a strong force on the rack, requiring it to be designed as strongly as possible. The rack does not touch the strainer.

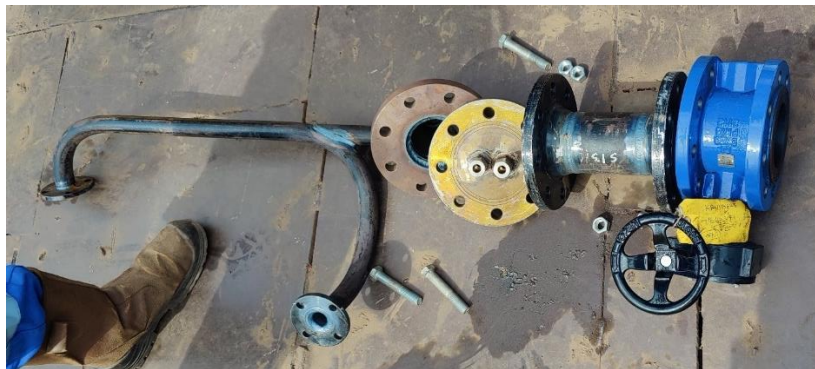
Figure 16. The various parts of the modified vent pipe.

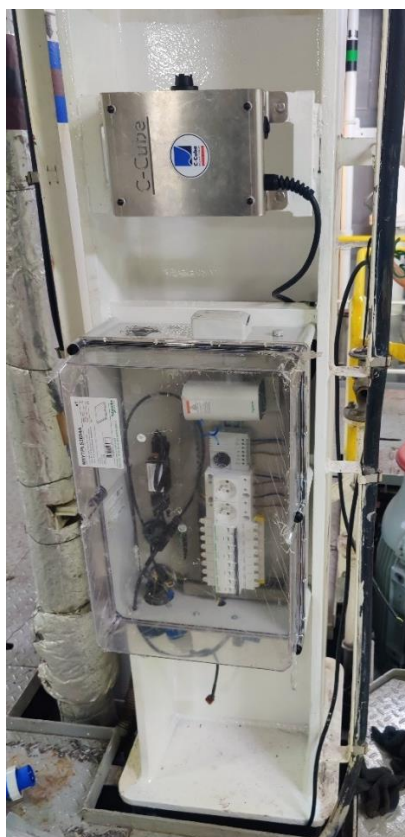
Figure 19: Mounting of the electrical cabinet and C-Cube logger box.

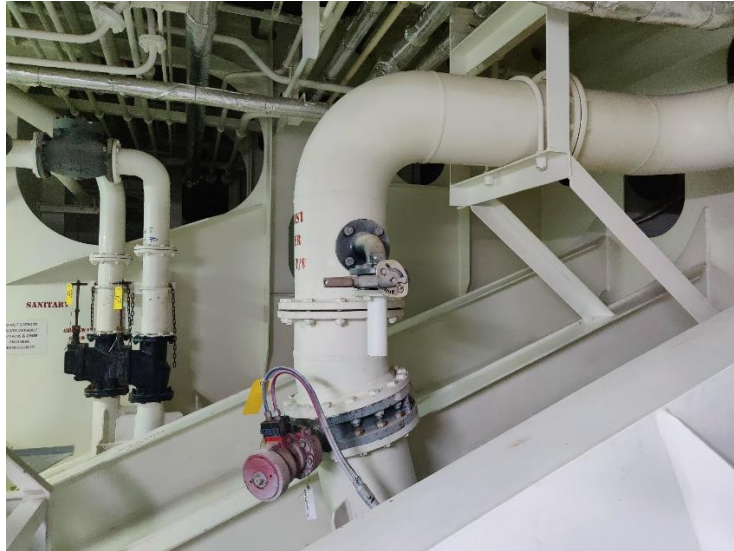
Figure 20: Ballast water discharge line

The ballast water discharge line (Figure 20) is the outlet of the ballast water system (Figure 22). After the ballast water has been treated in the ballast water treatment plan in accordance with the International Convention for the Control and Management of Ships' Ballast Water and Sediments, it is pumped overboard through this pipe.

The pipe is made of carbon steel pipe (STPY400) with a diameter of 350 mm (schedule 60 pipe 14 inch). It has a polyethylene lining on the inside to protect the pipe from corrosion and is painted with standard paint on the outside (Figure 21). The pipe can be closed off by means of a hydraulically operated butterfly valve.

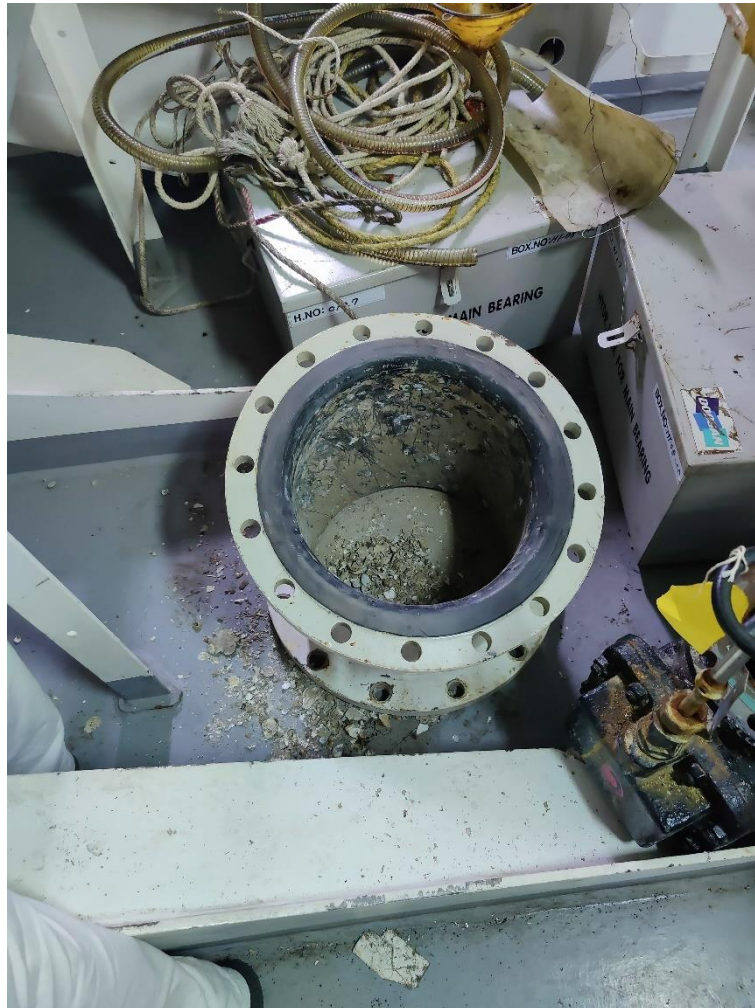
Figure 21: Polyethylene lining in a piece of pipe

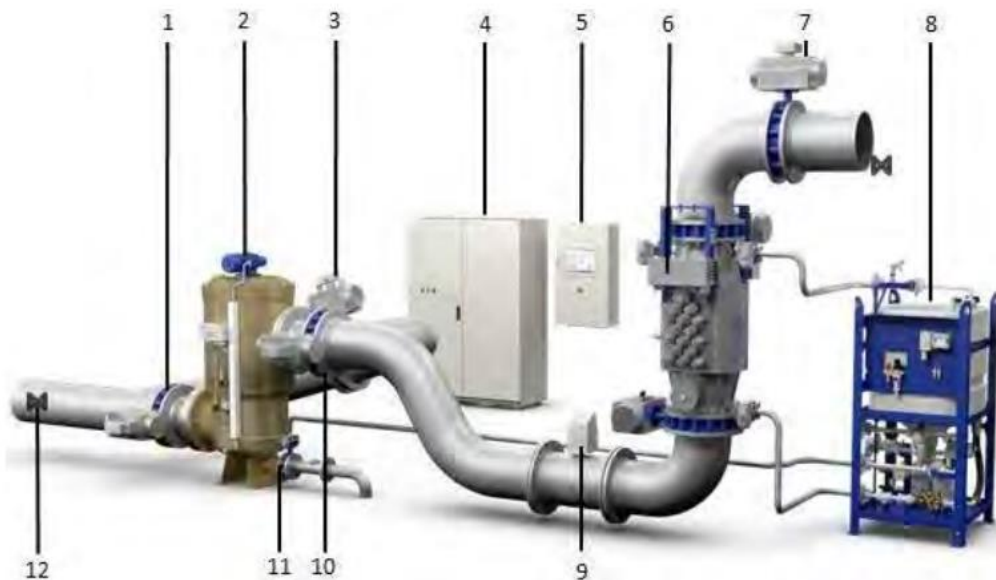
- The filter is used to remove the larger particles from the water, after which the main treatment process takes place in the AOT reactor. This reactor uses UV light and advanced oxidation technology to eliminate all biological organisms in the water.
- The UV light inactivates the DNA of the cells. This prevents the organisms from growing again. In addition, UV light produces free radicals. These radicals react instantly with micro-organisms and other organic contaminants, causing their cell membranes to be destroyed. The radicals are extremely short-lived, existing for only a few milliseconds. As no chemicals are added to the process, there are no toxic residues. This means that there is no impact on the environment.

2 System overview Filter

Example of layout with 1 AOT reactor.

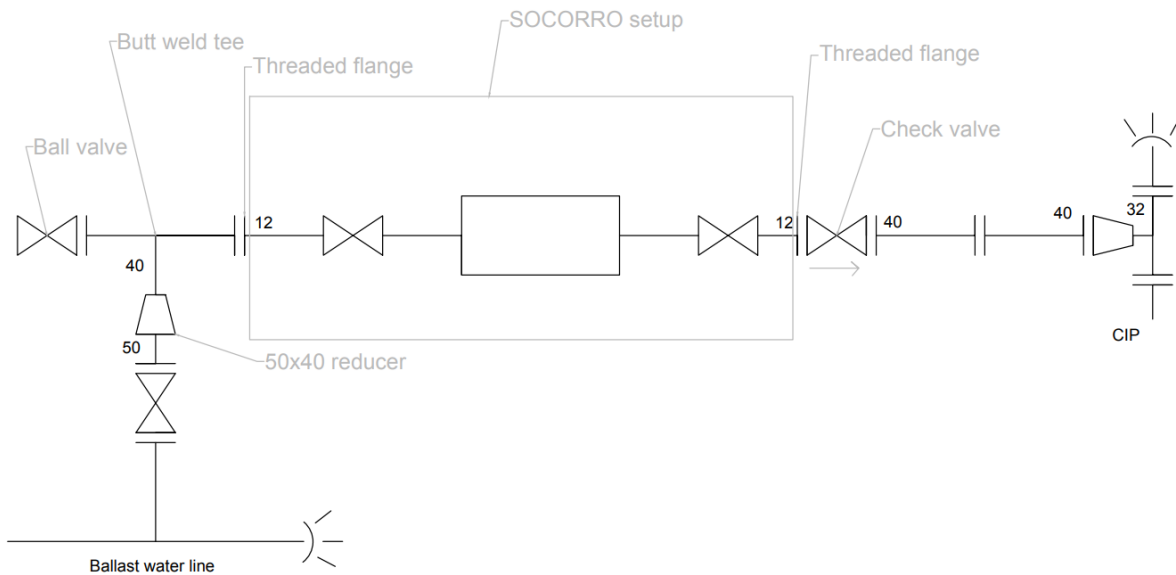
Figure 25: Schematic overview of the piping arrangement for the ballast water setup.

safer than fitting a new spool piece into the discharge line. It is also easier to re-use this system on any other pipeline.

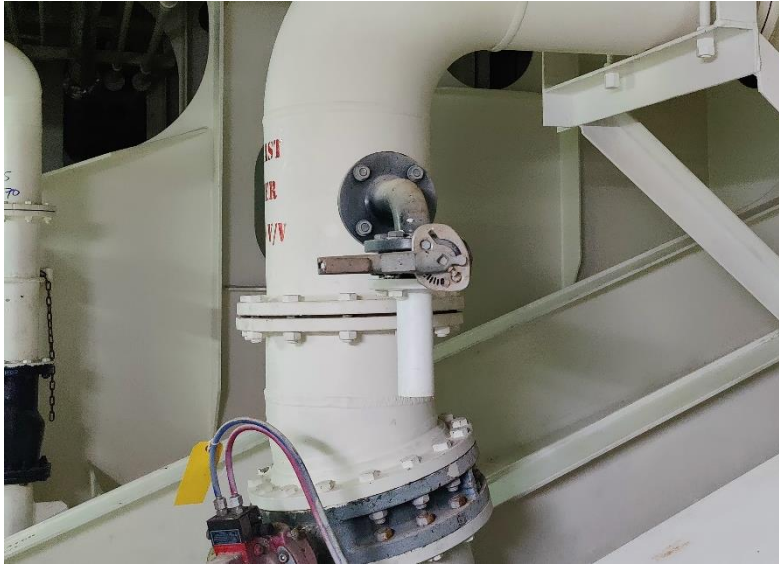
Figure 26: The original sample point on ballast water overboard line

To provide a supply of water to the sensor system, the sample point on the ballast water discharge line (Figure 26) was modified. Originally, it was only an elbow piece of pipe with a valve attached to it.

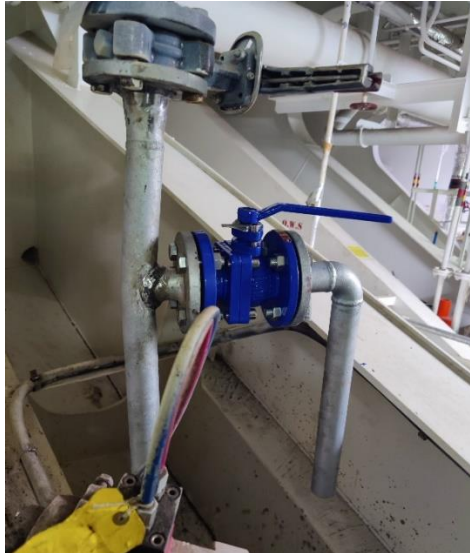
Figure 27: The T-piece attached to the original valve (top) and the new sampling point (right).

All the piping, except for the stainless-steel press tubes, were coated using a two-component white paint.

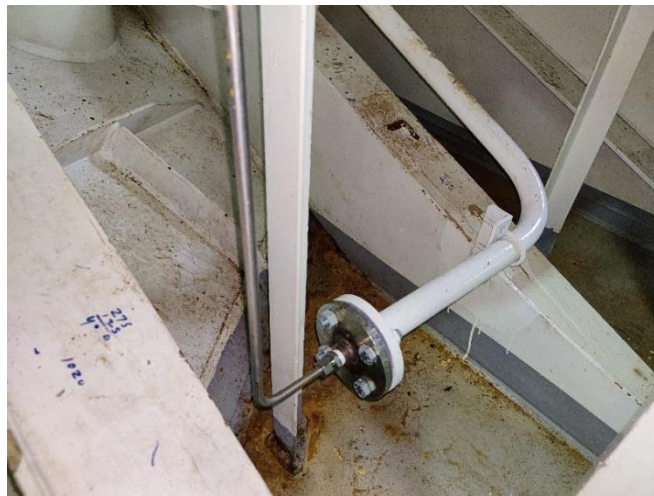
Figure 28: Reducer in the supply line for the flow cell.

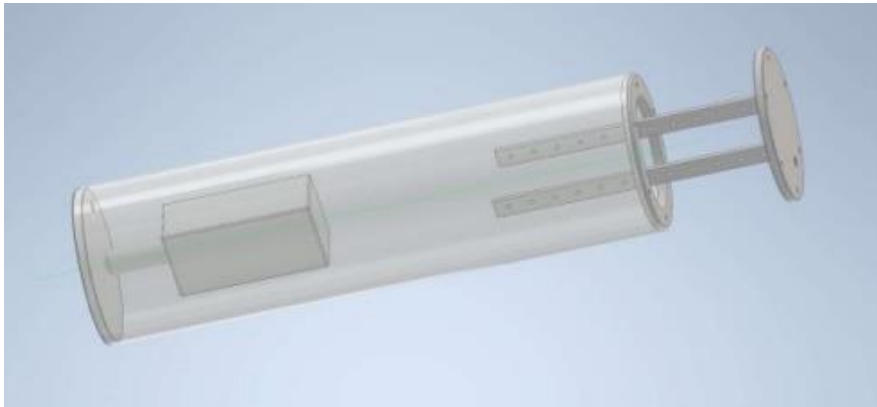
Figure 29: Flow cell for the C-Cube sensor and corrosion coupons.

On the other side of the flow cell, the blind flange is welded to the pipe. A hole is provided to be used the connection point for the discharge pipe. This point was placed higher in order to prevent sediment from entering and clogging the discharge pipe.

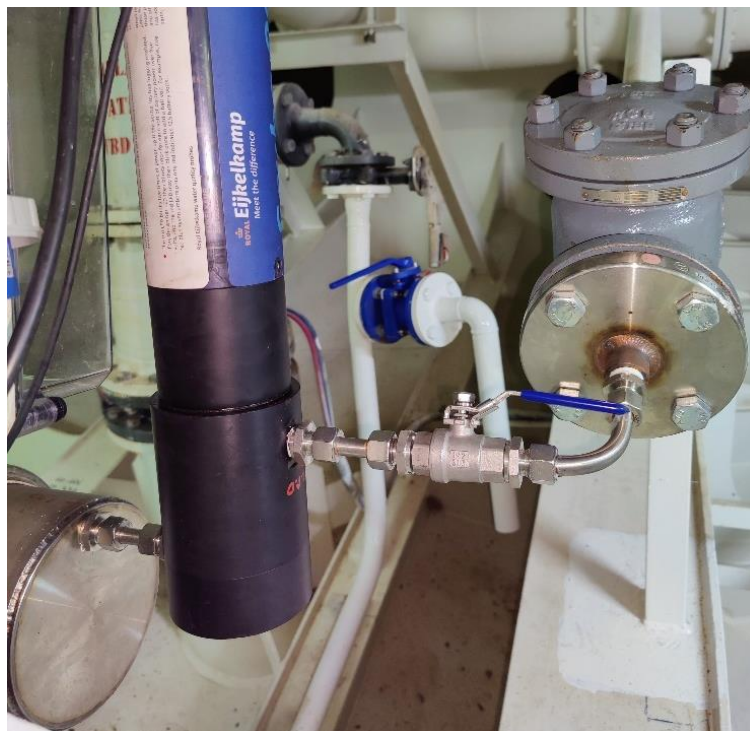
Figure 31: Flow cell of the Scuba sensor (left), reducer and check valve (right).

After this, the water flows through a reducer and a check valve. This check valve is necessary to prevent water flowing from the CIP discharge line into the sensor system. Because the CIP discharge water contains chemicals that could potentially damage the Scuba sensor or C-Cube sensor, it was necessary to install a check valve on the discharge line of the sensor system. The chemicals in the CIP system are not dangerous for the marine environment and are not polluting.

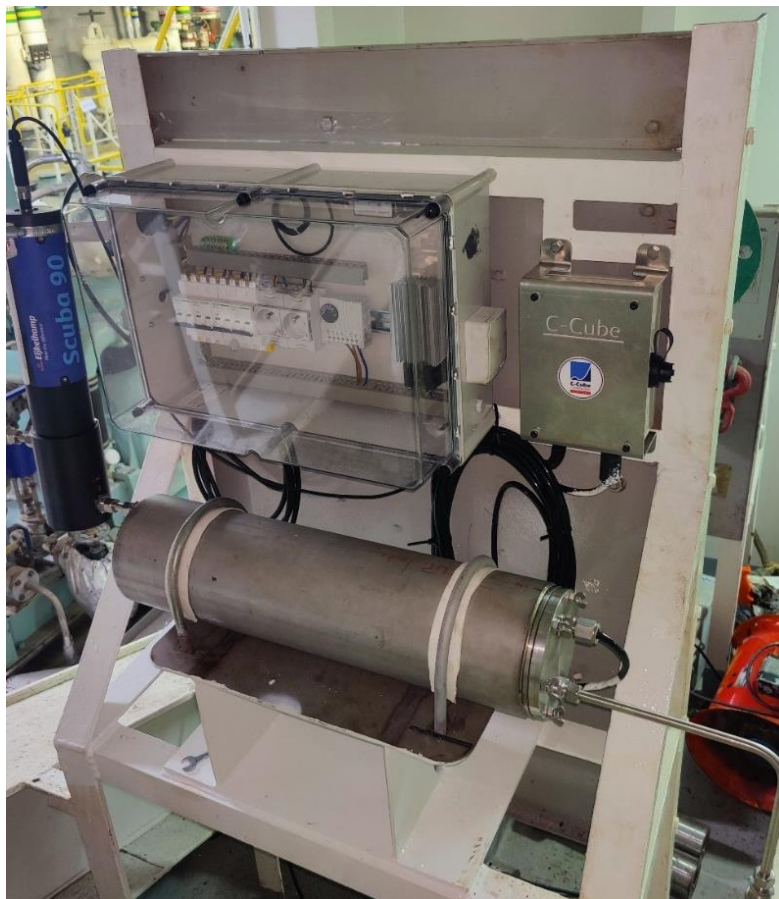
Figure 32: Electrical cabinet ballast water sensor system and C-Cube controller.

Holes were drilled in these bars so the electrical cabinet could be mounted on it. Next to the electrical cabinet space was provided to mount the C-Cube controller box. Both cabinets were secured using bolts and nuts.

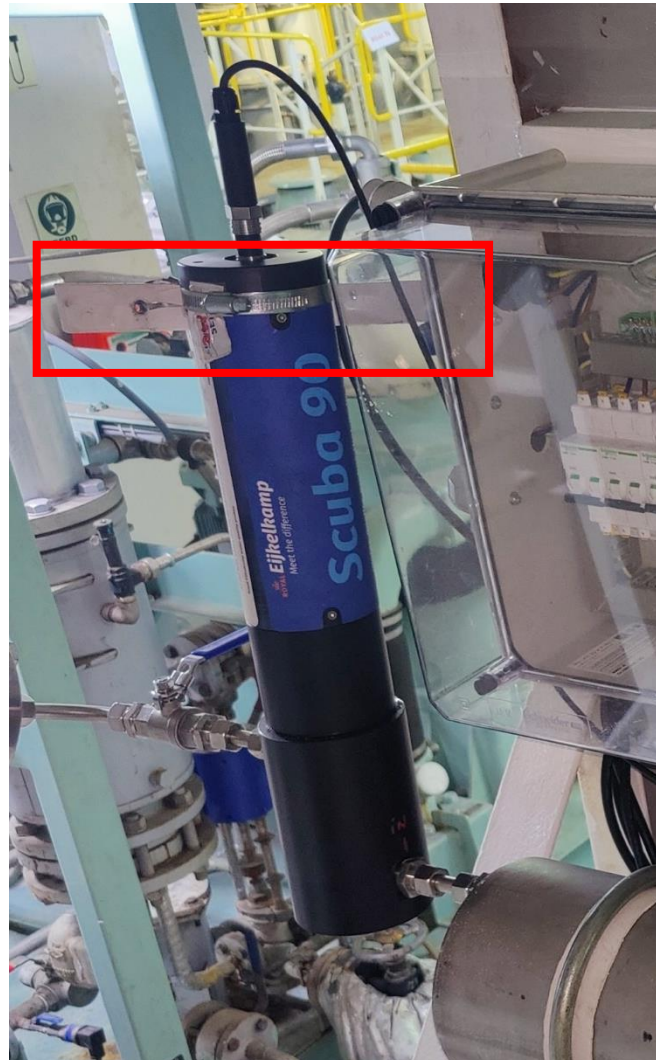
Figure 33: Scuba sensor mounting method.

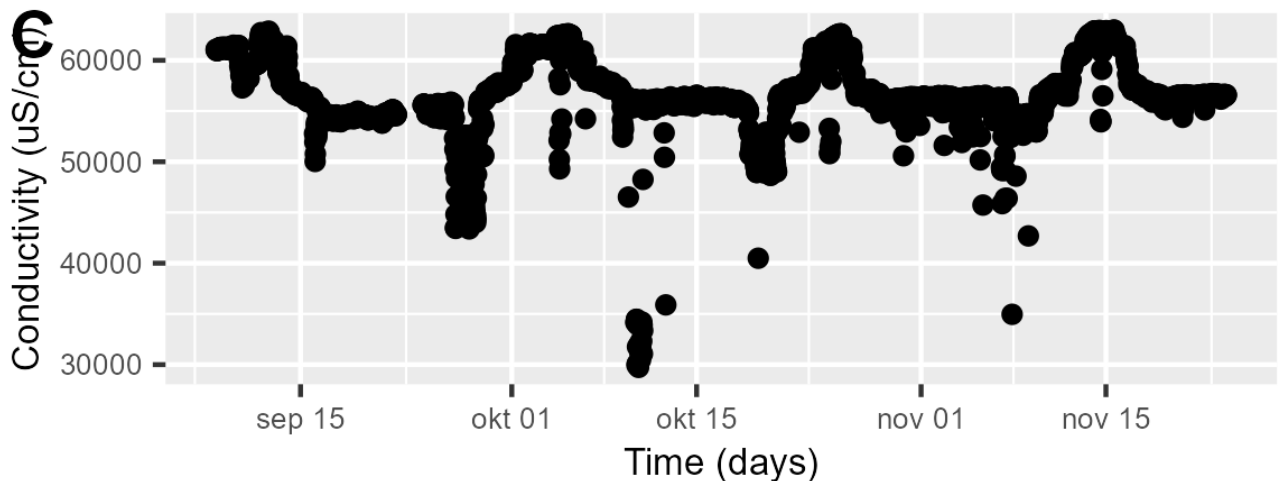
Figure 36: Timeplot conductivity Scuba data sea chest strainer.

It is very obvious that when the ship sailed from the Persian Gulf to India, the conductivity decreased. We can conclude that the conductivity of the seawater in the Persian Gulf is higher than that of the seawater in the Arabian Sea and near the port of Kandla.

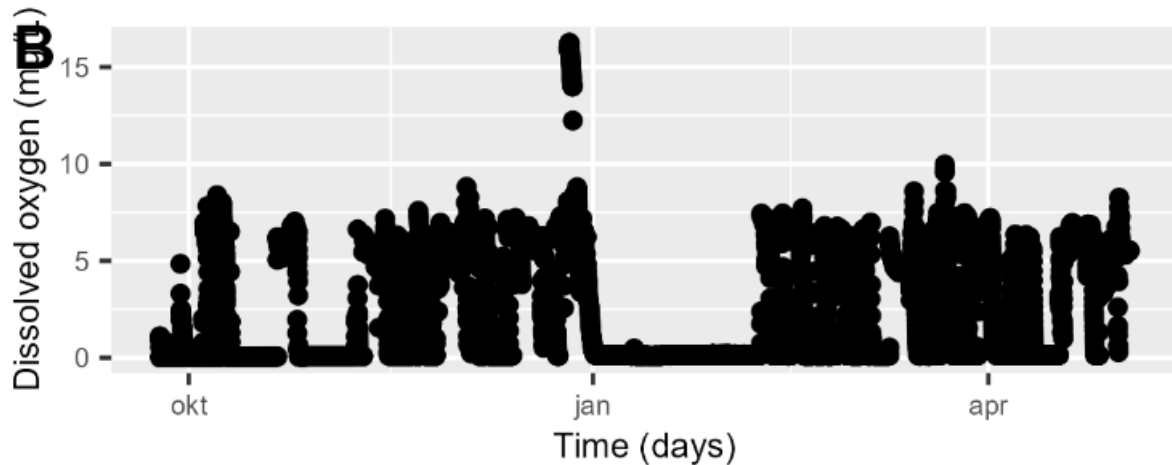
Figure 43: Timeplot dissolved oxygen Scuba data ballast water setup.

After leaving the port of Ras Tanura, dissolved oxygen decreased rapidly. Low levels were recorded until the ship sailed from Porbandar to Sohar on February 8, 2023. During this period, the vessel had only visited Indian ports, which are likely to be ports of discharge. It had entered the port of Sohar on January 22, 2023. However, no change in dissolved oxygen was observed on this date. It is possible that only a small amount of cargo was loaded at that time, or that only spare parts or supplies were taken on board. After this period, the dissolved oxygen measurements were as expected, according to the evolution of the temperature and the position of the vessel.

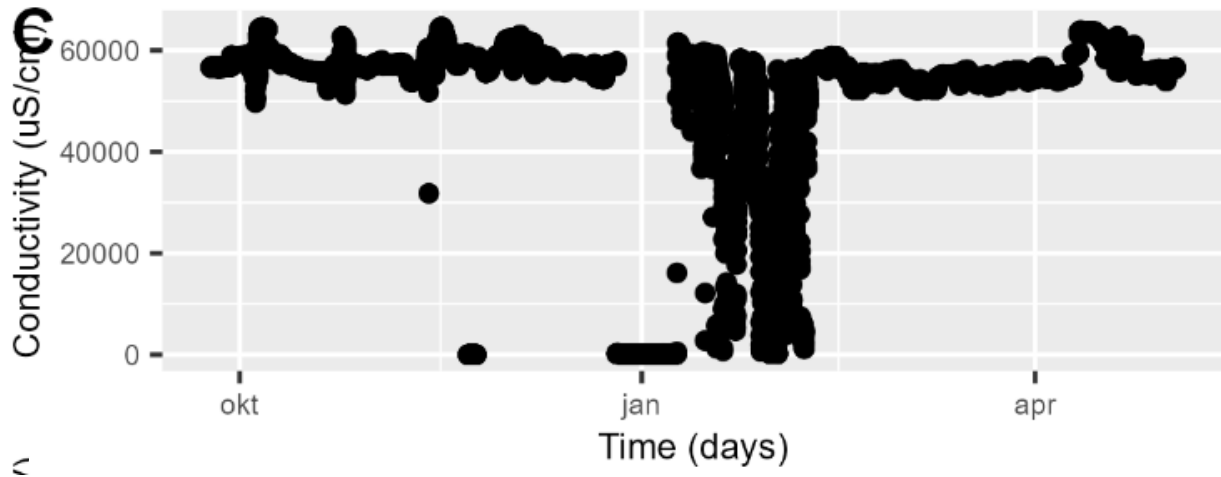
Figure 44: Timeplot conductivity Scuba data ballast water setup.

deballasting operation had probably taken place. At the time, the vessel was anchored off Kandla.

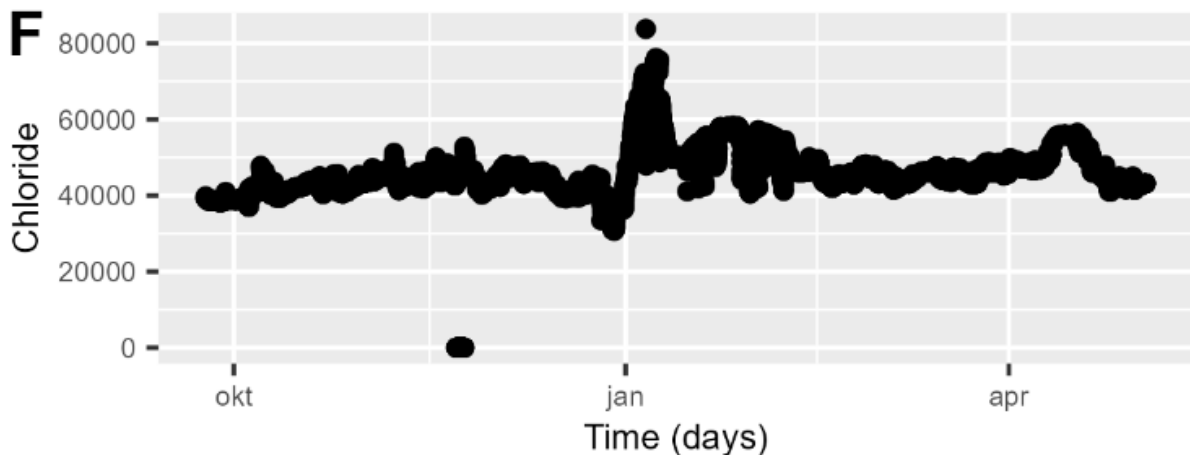
Figure 47: Timeplot chloride Scuba data ballast water setup.

The chloride concentration readings continue to fluctuate excessively until the sensor is cleaned on February 8, 2023. After that, the readings show a more expected trend.

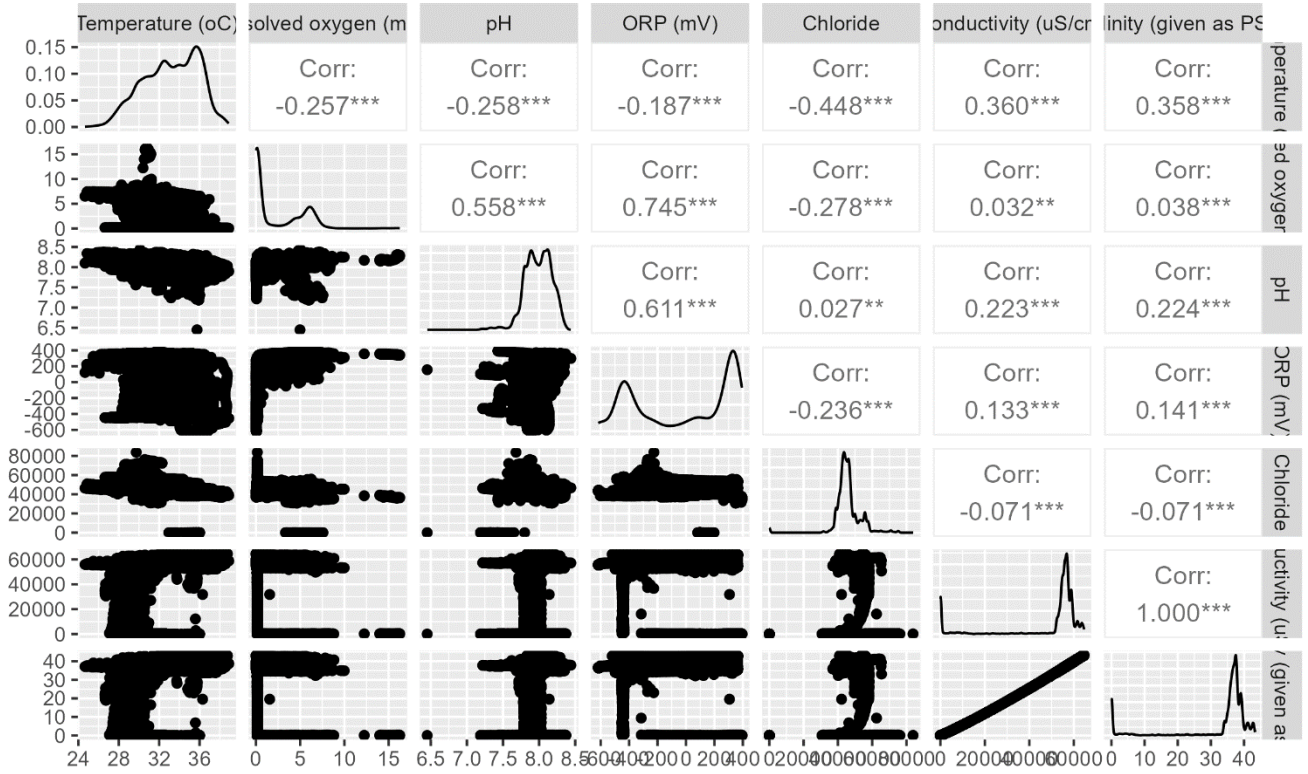
Figure 49: Pairwise correlation matrix Scuba data ballast water setup.
