## DEMONSTRATION AT GREENHOUSE

### Why this location

The wastewater treatment installation is located at a greenhouse in Putte (Flanders, Belgium). Tap water is mixed with different fertilizers to maximize plant growth, together with the optimal environment parameters which are well-controlled. The greenhouse in Putte is growing different types of lettuces crops. The water is intensively re-used by the farmers. However, if the water quality is poor (by the presence of bacteria ect.), a part of the water will be drained. Most of the Belgian farmers do not have a wastewater treatment and hence, the wastewater is immediately released into the environment. To avoid problems with eutrophication, the Belgian government introduced a new rule. Wastewater cannot contain more than 50ppm NO<sub>3</sub>. Farmers who still exceed those values can be fined if a check is performed at their site. A cost efficient and ecological way to remove excess of nitrate in wastewater is by the implementation of a MBBR; a Moving Biofilm Bed Reactor. As a proof of concept, a scale-up of the labscale MBBR (used for generating data to train to AI model in WP<sub>1</sub>) was built next to the greenhouse (figur

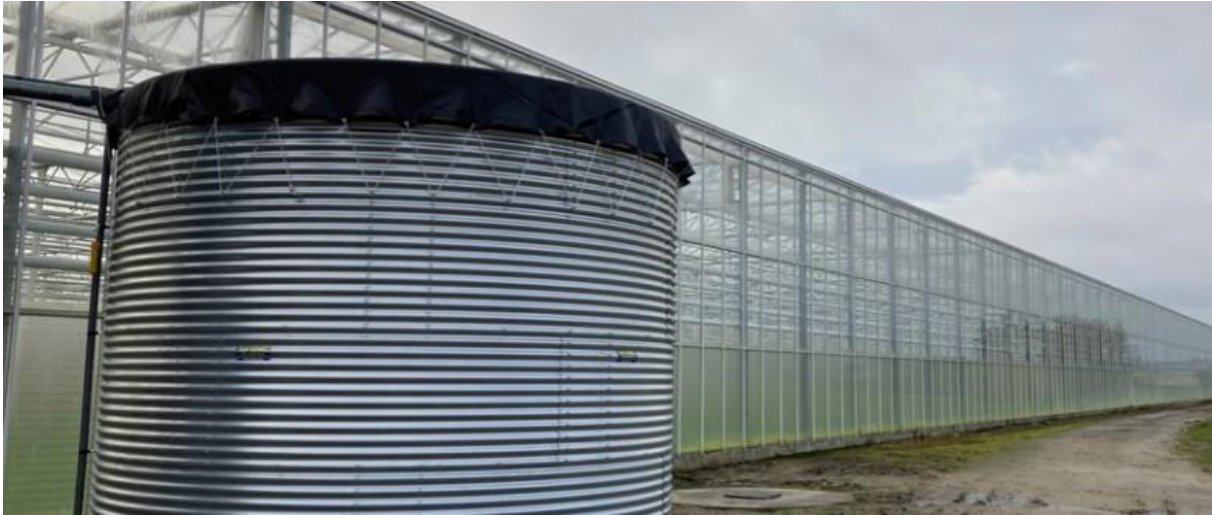
**Figure: the MBBR installation next to the greenhouse, in Putte (Flanders).**

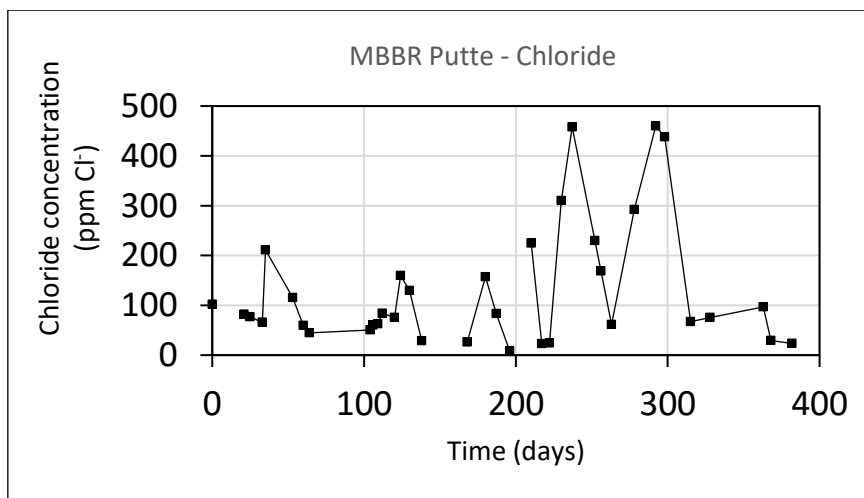
**Figure: Chloride concentration in the wastewater, before the inlet of the MBBR installation.**

The chloride concentration in the wastewater is not as high as in other demonstration sites (e.g. canal water, seawater). It (normally) varies between 50-200ppm chloride, and sometimes it peaks to values of 400-450ppm (figure). Even though the chloride concentration is relatively low, it can still be an aggressive environment. Especially if no new wastewater is send to the MBBR, because then, there is the possibility that other micro-organisms (such as Sulfate Reducing Bacteria) are grown by the carbon source (CarboSt). These bacteria are known to result into strong corrosion phenomena/effects that could not only affect the most common steel grades, but also stainless steels.

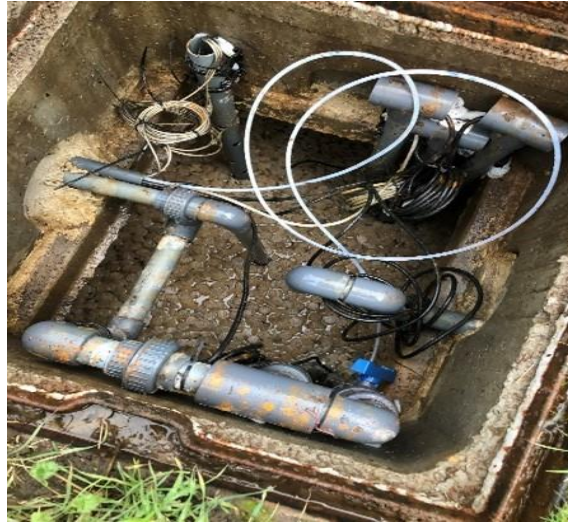
**Figure 1: The MBBR with the installed C-Cube and Manta probe**

Inside the MBBR, there are already a few probes that are measuring the water quality: a Hach-Lange chloride probe, an ORP sensor, a level sensor and a flow sensor (that measured how many wastewater was treated). To power all these probes (that are used for the Interreg Nuredrain), electrical connections were already foreseen. Extra power supplies were made to connect two probes for this demonstration site: 1) An Aquaread AP-800 environmental probe (that measures pH, conductivity, temperature, turbidity, salinity, pressure, ...) and 2) a C-Cube probe that continuously measures corrosion rate of S235, S355 steel and an AISI 316L stainless steel by conducting non-destructive LPR measurements. The environmental probe is connected to a Eijkelkamp modem that logs all the water parameters each half an hour. The C-Cube probe measures the corrosion rate each 6h.

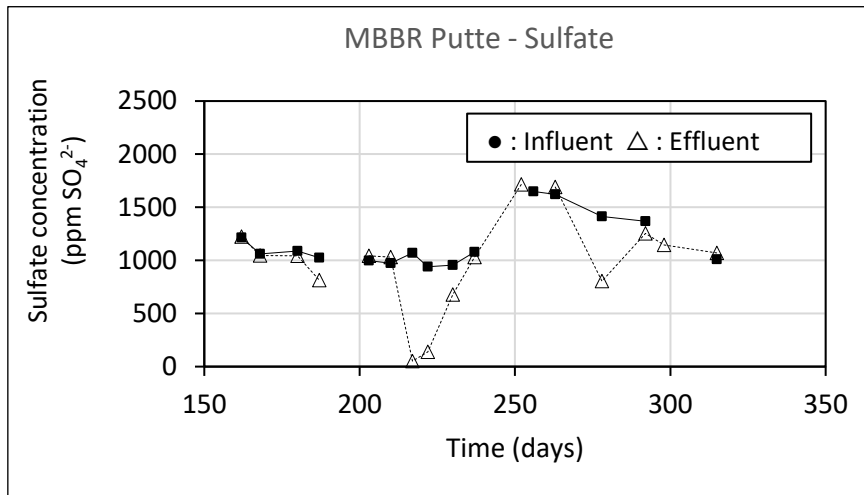
**Figure: Sulfate concentration in the wastewater, before and after the MBBR installation.**

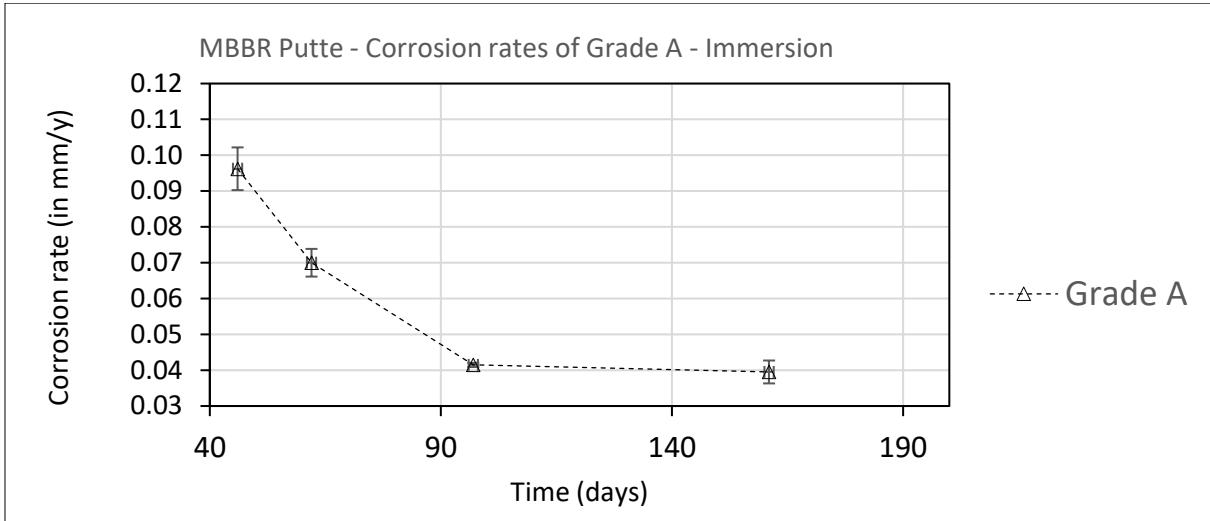
**Figure: Corrosion rate of Grade A steel by weight-loss determination of immersed coupons – MBBR Putte (Greenhouse)**

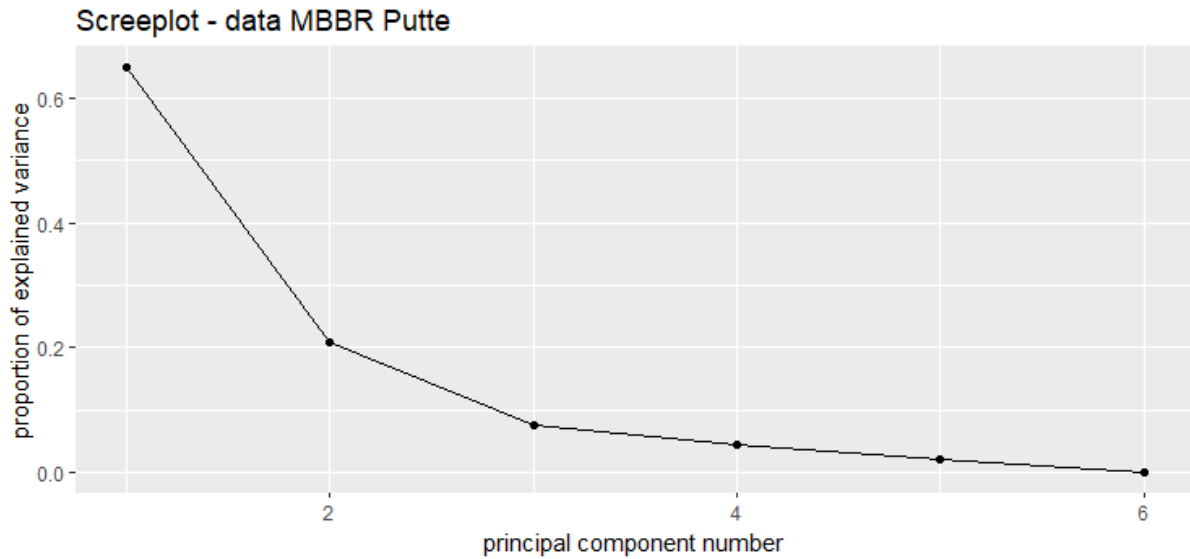
**Figure: Scree plot of the principal components – MBBR Putte**

Another way to look at correlation is by a Principal Component Analysis (abbreviated as PCA). A PCA reduces the dimensionality of large datasets by converting a large set of variables (environmental parameters + corrosion rate) to a smaller set (principal components) that still contains the most important information. In figure, a Screeplot was made with the data that was collected from the MBBR installation. It is clear that the two first principal components (PC1 and PC2) can explain more than 80% of the total variance seen in the original dataset. If PC3 is additionally included, more than 90% of the variance is included. PC1, PC2 and PC3 are used to generate a PCA plot. A PCA plot is a biplot with two principal components on the X- and Y-axis. All datapoints with their environmental parameters and corrosion rate are plotted on this new dimensional plot. Based on the values of the variables, different clusters with similar environmental parameters and/or corrosion rate can be defined. The PCA software draws vectors for all clusters based on their environmental parameter values. In the PCA plot (figure, lay-out FactoMineR), all arrows/vectors are representing 1 environmental parameter. If 2 vectors are laying close to each other (same direction + same sense), that means that a cluster was found were both environmental parameters are alike, hence, it is suggested that they are correlated. If two vectors have the same direction but the sense is different (arrows are pointing to a different side), a reversely proportional correlation is found. If the arrows are not close to each other and are making an angle of approximately 90°, this insinuates that, on the new dimensional biplot, no cluster were found were both parameters were varying in similar way. Hence, no correlation is expected between both parameters. The vector of corrosion rate (of grade A) lays close to the vector of ORP and resistivity. This is in agreement with the correlations found in table, where resistivity (inverse of conductivity) and ORP were found to be correlated to the measured corrosion rate. The vector "temperature" is not laying close to the vector of corrosion rate. Thus, the PCA analysis concludes that no (strong) correlation is found. Not in complete agreement with the findings of table, but still, temperature had the weakest proportional correlation with the corrosion rate (lowest correlation coefficient). Vectors "SSG", "Conductivity", "TDS" and "salinity" are laying close to each other. This makes sense, as these variables are all derived from the measured

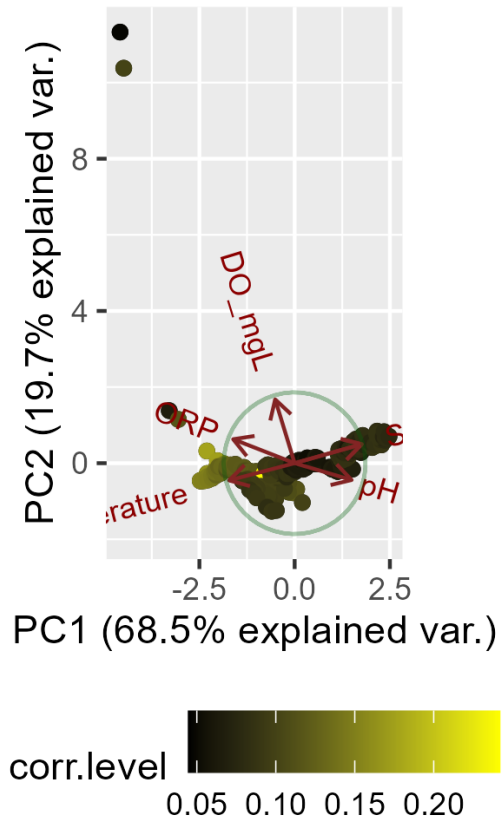
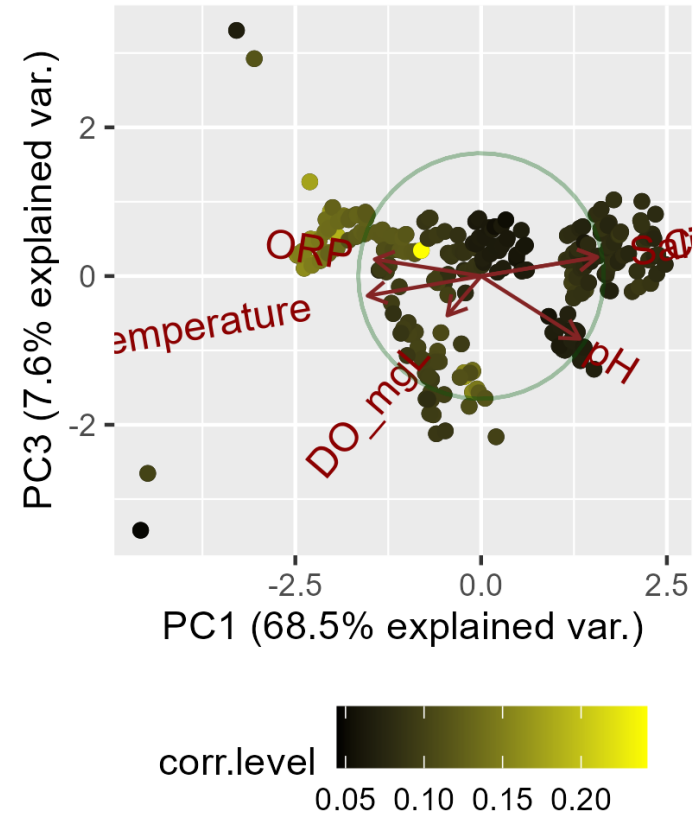
*Figure: PCA plots of PC1/PC2 (left) and PC1/PC3 (right) – MBBR Putte*

conductivity. The vectors make an angle of approximately  $60^\circ$  with vector "corrosion rate". It is therefore concluded that the correlation is not strong. The vector have a different sense, this means that the correlation is reversely proportional. A moderate reversely correlation was suggested by the outcome of the Pearson correlation tests (table), this is consistent with the result of the PCA biplot.

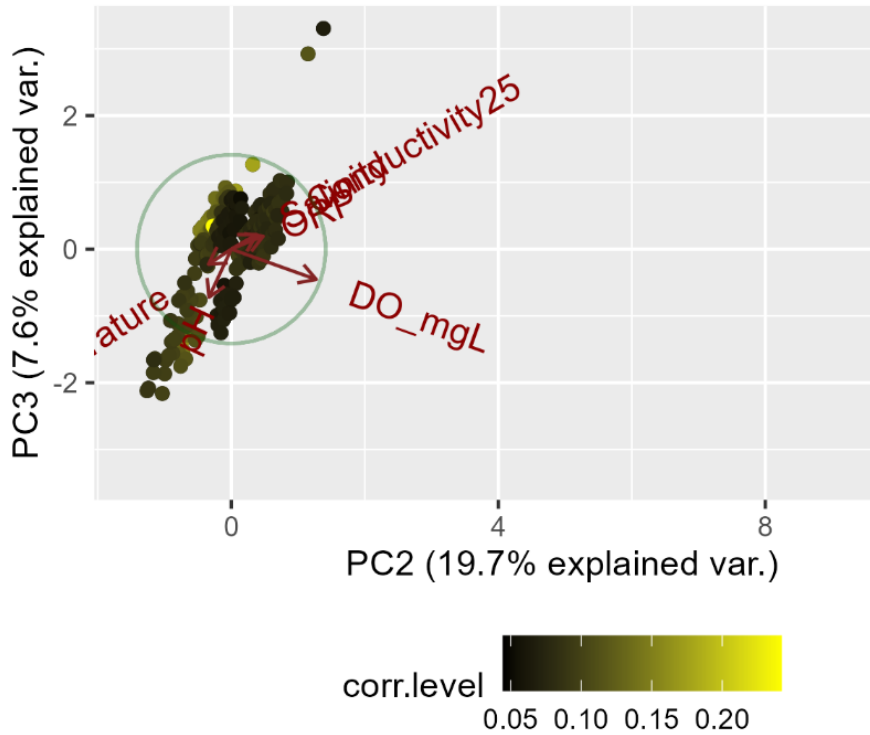
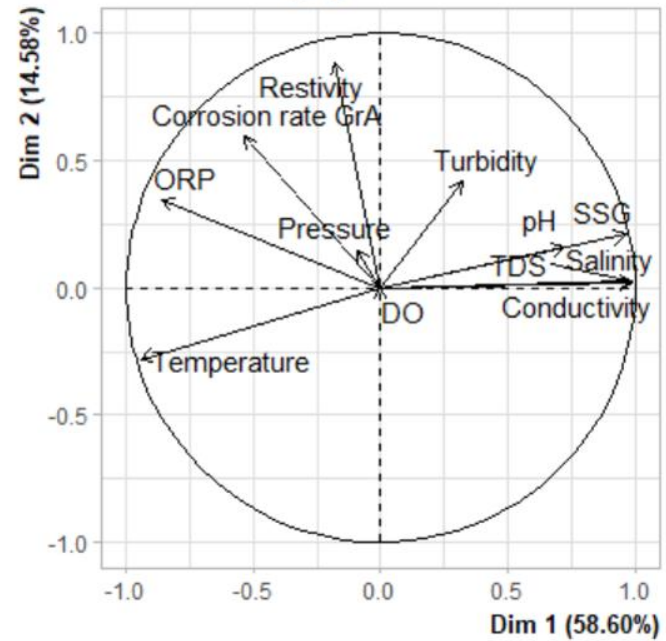
Figure: PCA plots of PC2/PC3 (left) and PC1/PC2 FactoMineR package (right) – MBBR Putte

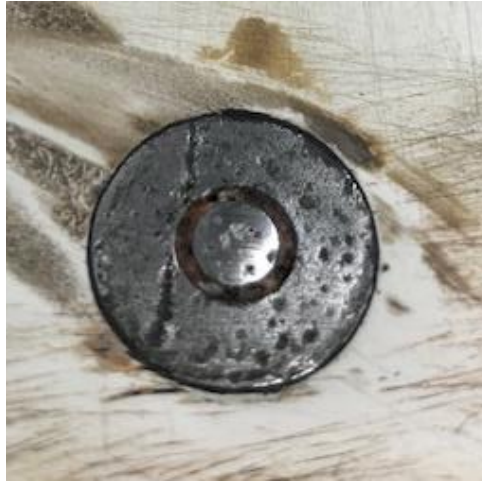
**Figure: Local corrosion attack (pits) on the S355 working electrode of the C-Cube LPR probe after 6 months of installation in the MBBR installation – Putte (Greenhouse)**

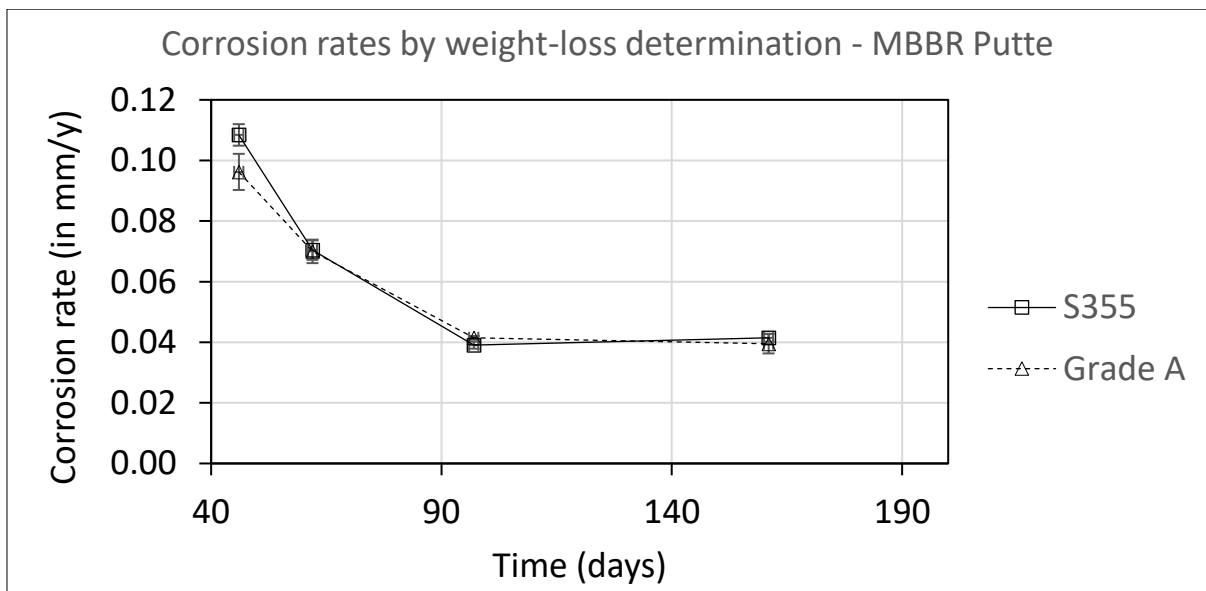
**Figure: Corrosion rate of S355 steel by weight-loss determination of immersed coupons – MBBR Putte (Greenhouse)**

Figure shows the corrosion rates of the S355 coupons determined by weight-loss. The coupons were cleaned according to the ASTM G31 standard. From the long-term immersion tests, that were analyzed after 1,2,3 and 6 months, it is clear that the corrosion rate of the S355 steel is not significantly higher than S235. The corrosion rate of the S355 stabilizes after 3-6 months to a value of  $\pm 0.04$ mm/y. The inconsistency of the S355 corrosion data received from the LPR sensor and the corrosion rates from weight-loss determination should be discussed in further detail with manufacturer C-Cube.

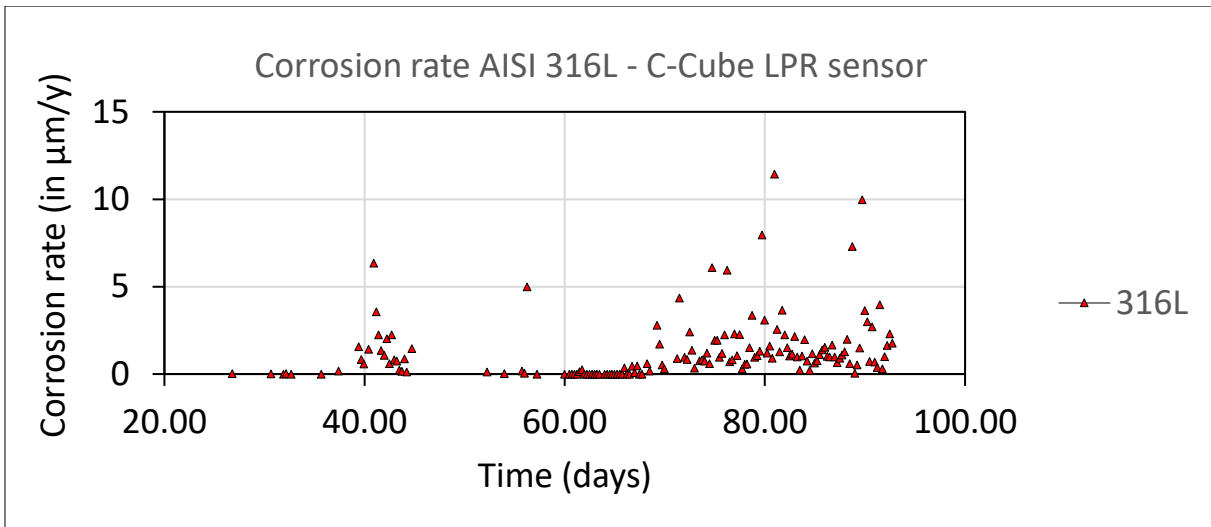
**Figure: Corrosion rate of the LPR C-Cube sensor inside the MBBR installation – Putte (Greenhouse)**

The most corrosion resistant material inside the C-Cube LPR probe is the AISI 316L. This austenitic stainless steel contains 10-12% of nickel as austenite stabilizer, 16-18% of chromium to improve its corrosion resistance, 2-3% to increase the pitting resistance in chloride-rich media and a lower carbon content to improve weldability (and its corrosion behavior after welding). The AISI 316L is commonly used for wastewater treatment plants, to build storage tanks, pipelines and process equipment. Because the AISI 316L is widely investigated in chloride-containing environments, most of the manufacturers of wastewater treatment installations consider it as a safe choice to ensure corrosion resistance and to guarantee its designed life time. Because MBBR installations are still investigated by many research institutes and the existing installations are relatively small (capacity of a few m<sup>3</sup>/day), the flow of wastewater and pressure inside such installations are limited. Because there is no necessity to use steel grades, because the pressure and flow is low, most of these installations are build out of concrete with PVC piping. This is also interesting to lower the installation costs, high costs for a wastewater treatment plant are often not feasible for a greenhouse/farmer like in Putte (Flanders). Still, it would be interesting to see how the AISI 316L performs in a wastewater with a lot of microbiological activity. Every 6 hours, the corrosion rate of stainless steel is logged. In figure, it is convenient that the AISI 316L material is more corrosion resistant as the found corrosion rates are expressed in  $\mu\text{m}/\text{y}$  instead of  $\text{mm}/\text{y}$  (for steel grades). Corrosion rates as low as  $3.9 \cdot 10^{-38} \mu\text{m}/\text{y}$  were found by the LPR fitting. Maximum values go up to  $12 \mu\text{m}/\text{y}$ . It should be emphasized that measured corrosion rates lower than  $0.1 \mu\text{m}/\text{y}$  are not realistic. C-Cube LPR sensors with their electrical properties are normally not able to measure corrosion rates lower than  $0.01 \mu\text{m}/\text{y}$ . If such low corrosion rates need to be measured accurately, the electrochemical equipment should be able to measure a corrosion current of  $1 \text{nA}/\text{cm}^2$  accurately. These corrosion currents are only measurable when using a faraday cage (like used in lab set-up), and not for electrochemical sensors for in-situ use. In figure, it

is clear that both steel plates had issues with corrosion product being formed while the AISI 316L remained unaffected (besides some dirt). The corrosion rates determined by weight-loss are also not giving more information than the sensor. The weight-loss after 6 months is still lower than 0.0001g per coupon. This means that if a corrosion rate is calculated for the AISI 316L coupons, the corrosion rate in theory returns a zero value (no corrosion occurred). However, taking into account the accuracy of the analytical balance, it is assumed that the corrosion rates of all AISI 316L coupons are lower than 0.03µm/y.
