DEMONSTRATION AT ZELZATE

Written by Wikke Witteveen, Kris De Baere, Joeri Horvath, Flor Stoops, Thomas Bas, and Geert Potters – Antwerp Maritime Academy

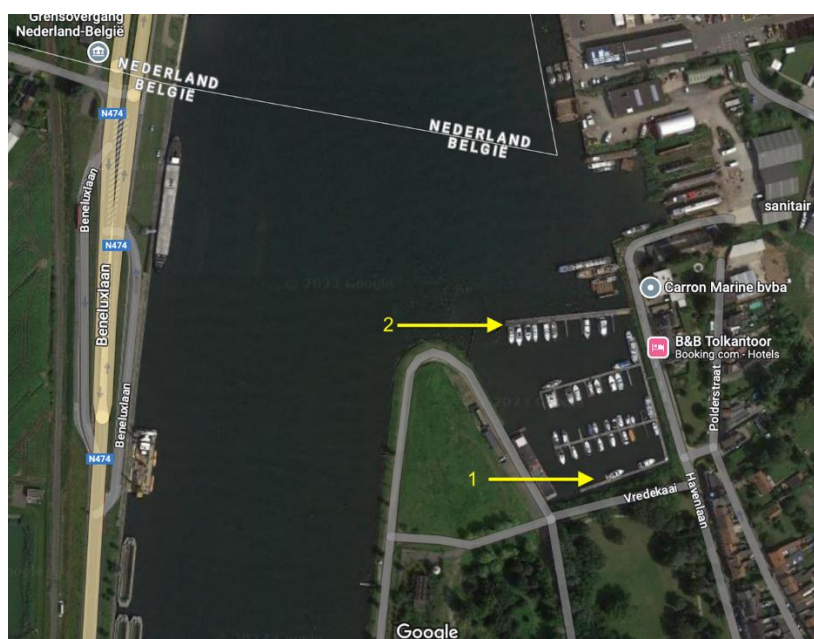
Figure 1. Location of the demonstrators in the marina of Zelzate

To investigate this effect, two identical setups were made to measure corrosion in the marina of Zelzate (Figure 1). One set-up was placed on the southern side of the harbour, indicated by number '1'. The other arrangement was placed on the northern jetty, indicated with number '2'. The arrangement on the south side is located on an overflow from which a constant stream of water comes. However, its origin is unclear. A pond south of the marina is believed to be responsible for this water supply. After all, there is less water circulation here because this part of the harbour is protected by the banks. The arrangement on the northern jetty, on the other hand, is more exposed to water circulation because there is clearly less bank protection here.

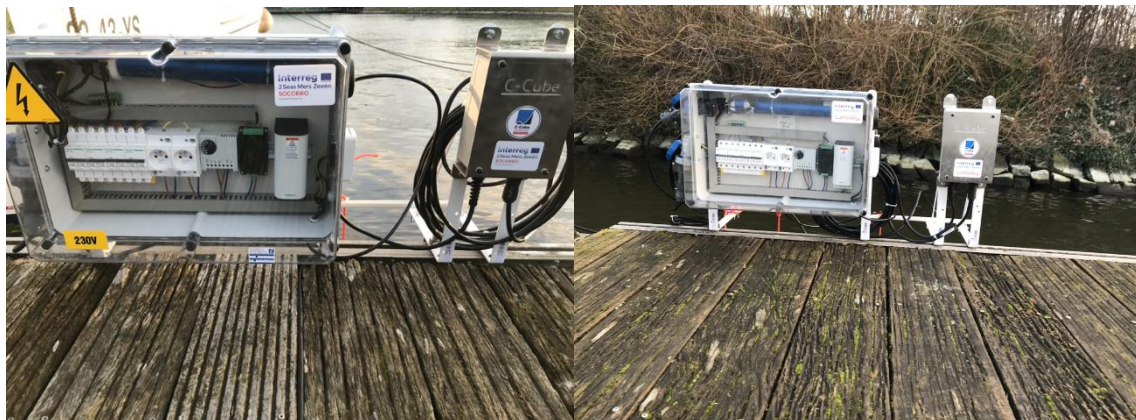
Figure 2. Sensor box on the north side (left) and the south side (right) of the Zelzate marina

Both an environmental sensor (Scuba90) and a corrosion sensor (C-Cube) were used. By means of a specially designed distribution box, which was developed for the SOCORRO project, the uploading of data was optimized.

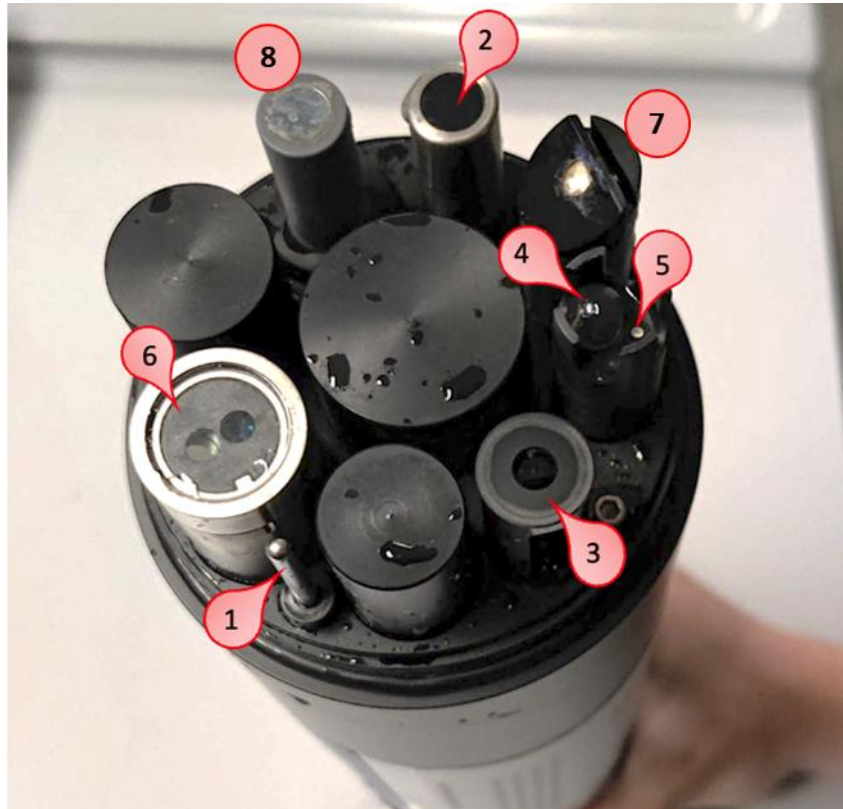
Figure 3. Different sensors of the Scuba Probe.

- The **temperature** (Figure 3, 1) was measured by means of a thermistor whose resistance changes with temperature. Thermistors are very stable over time and therefore do not require calibration.

- **Dissolved oxygen** was measured using an optical sensor (Figure 3, 2). This sensor consists of a blue light source, a detection surface and a red-light receiver. When the detection surface is exposed to seawater, a reaction occurs between the oxygen in the seawater and the detection surface. The measurement principle is based on the phenomenon of fluorescence, where the detection surface absorbs light of a specific wavelength and then emits light of a different wavelength. In this case, the surface absorbs blue light and emits red light. During a measurement cycle, the blue light is turned on for a short time, after which the red-light receiver measures the time it takes for the fluorescence to extinguish. This length of time is proportional to the amount of dissolved oxygen in the seawater. It is important to emphasize that the presence of an oxygen active coating on the optical sensor can lead to inaccurate measurements. This is comparable to situations in which photosynthetic algae create a specific microenvironment of oxygen.

- The specific conductivity of water is determined by the four-electrode method. The sensor (Figure 3, 3) is equipped with two sets of graphite electrodes carefully positioned for stable measurement. A constant voltage is applied to one pair of electrodes and the current required to maintain this voltage is measured. The current strength increases as the conductivity of the water increases. The Scuba usually displayed specific conductivity, which is standardized to 25°C, representing the conductivity of the water as if the water had been heated or cooled to exactly 25°C. Conductivity can be expressed in different units, such as total dissolved solids (TDS) and salinity, expressed in Practical Salinity Unit (PSU). The values of either parameter were always derived from the specific conductivity.

- The acidity was determined by means of a pH glass electrode (Figure 3, 4). As a result of the ion exchange between the water and the pH glass membrane, a charge separation occurs across the glass. This charge separation creates a voltage difference that can be measured and corresponds to the pH value of the solution.

- The redox potential is measured using an oxidation-reduction potential (ORP) sensor (**Error! Reference source not found.**, 5). This sensor is located next to the pH sensor and can be noticed as a grey dot of 1 mm diameter. The redox potential is determined by measuring the voltage drop between the platinum membrane of the ORP electrode and the reference electrode. Because platinum does not react with the ions in the water, the redox potential can be derived from this voltage drop.

1: temperature sensor, 2: optical sensor (dissolved oxygen), 3: conductivity sensor, 4: pH glass, 5: ORP sensor, 6: fluorometer for chlorophyll determination; 7: reference electrode; 8: chloride sensor.

- An extra fluorimeter (Figure 3, 6) can be used to measure the chlorophyll concentration in the water. This is a measure of the presence of microalgae and therefore an indicator of the biological activity of the marine ecosystem.
- A reference electrode (supporting the other electrode measurements; (Figure 3, 7) and a chloride sensor (Figure 3, 8) complete the setup.

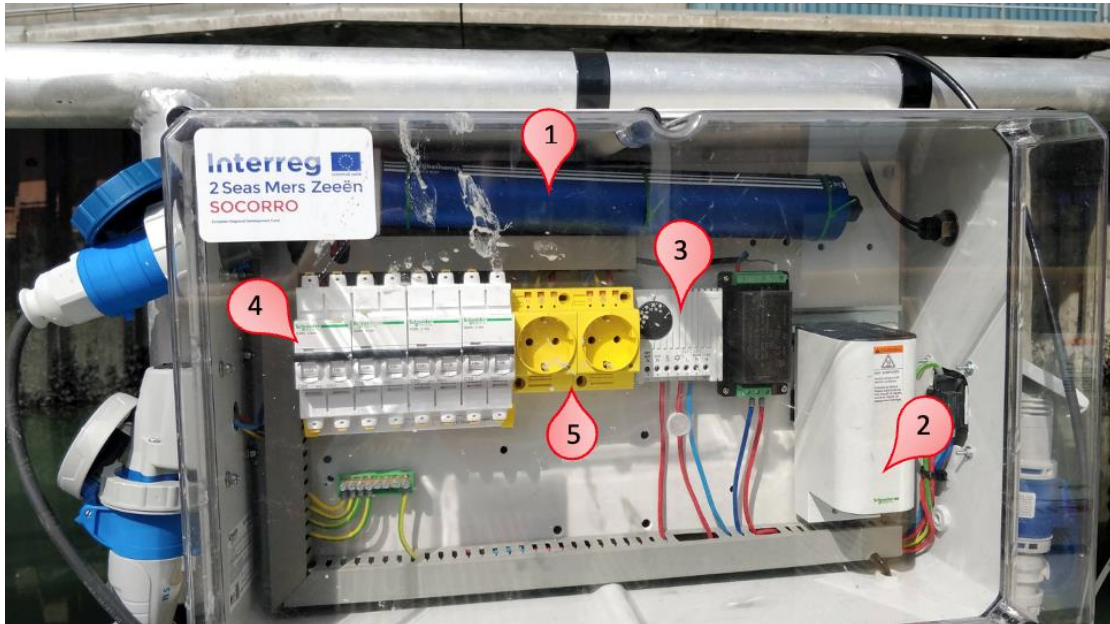
Figure 5. Electrical distribution box for sensors.
 1: 4G modem, 2: internal heating, 3: thermostat, 4: circuit breakers, 5: sockets

A sealed electrical distribution box was designed and built within the SOCORRO partnership to power the sensors and support the Scuba while uploading data. To this end, the distribution box is equipped with an internal heating element (Figure 5, 2) to maintain a constant temperature of approximately 15-20 degrees Celsius. This heating element is connected to a thermostat (Figure 5, 3) that controls the activation of the element when the temperature falls below the desired value and switches it off when the maximum temperature is reached. To prevent short circuits and electrical damage to the equipment, the entire distribution box is fitted with fuses (Figure 5, 4). In addition, two CEE 16A plugs (Figure 5, 5) are provided to connect a laptop or other electronic devices on site if necessary.

For this purpose, a 4G modem (Figure 5, 1), namely the GDT-S Prime Plus, is integrated in the system (Figure 46). This allowed the data generated by the Scuba sensors to be initially stored and then forwarded to the GDT server at time intervals set by the user. Via this server, users not only had the possibility to view the data via the internet, but also to adjust the settings of the modem and sensors. This could be done via the Eijkelkamp web portal.

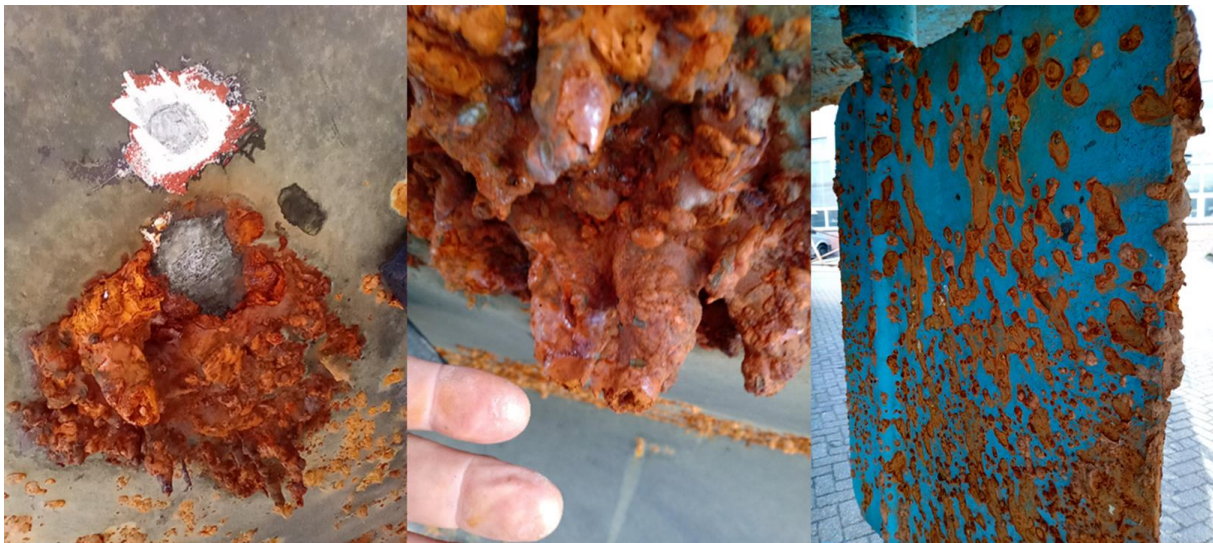
Figure 8. Microbiologically induced corrosion (left, middle) on the underwater hull of a ship docked in the marina of Zelzate, and (right) on the rudder of the ship

In the spring of 2021, LP1 was contacted by surveyors from insurance companies and pleasure craft owners following some remarkable damage patterns found on several yachts, all moored in the marina of Zelzate. These vessels showed the presence of orange-red tubercles below the waterline (Figure 1). The morphology of these tubercles led us, by elimination, to MIC (Juntao et al., 2015; Phan et al., 2020). After removing the tubercles with grinding wheels and cup brushes, invariably deep corrosions were revealed with a shiny metal surface underneath. Pitting corrosion was found with pits of 3-4 mm deep in several places, developed over a term of (max.) 12 months. The deepest pit was 8 mm deep and was found in a rudderstock that was exactly one year old. Such a high corrosion rate can only be associated with microbially induced corrosion or MIC (Little et al., 2020; Mahlouf, 2018; Yingshao et al., 2020). The morphology also corresponds to what Phan et al., (2020) describe on a series of sheet piles with accelerated corrosion.

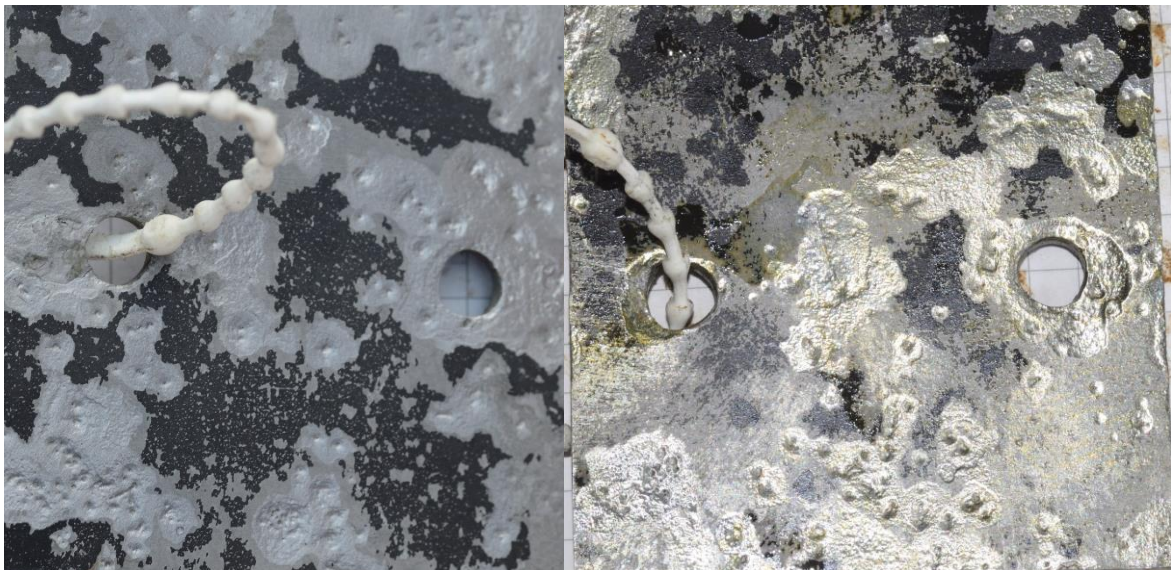
Figure 11. Pitting corrosion on S235 low carbon steel coupons in nearby Sas van Gent after (left) 3 months and (right) 6 months of exposure

Several hypotheses can be derived from this information (and the on-site observations): (1) it concerns an exceptional symbiosis of bacteria, (2) an as yet unidentified bacterium is responsible, (3) there may be components in the water responsible for the aggressive behaviour of the water, or (4) a combination of these factors. In order to explain the observed damage, the reaction mechanism behind it must be found. Further research will have to show which hypothesis(es) is (are) correct.

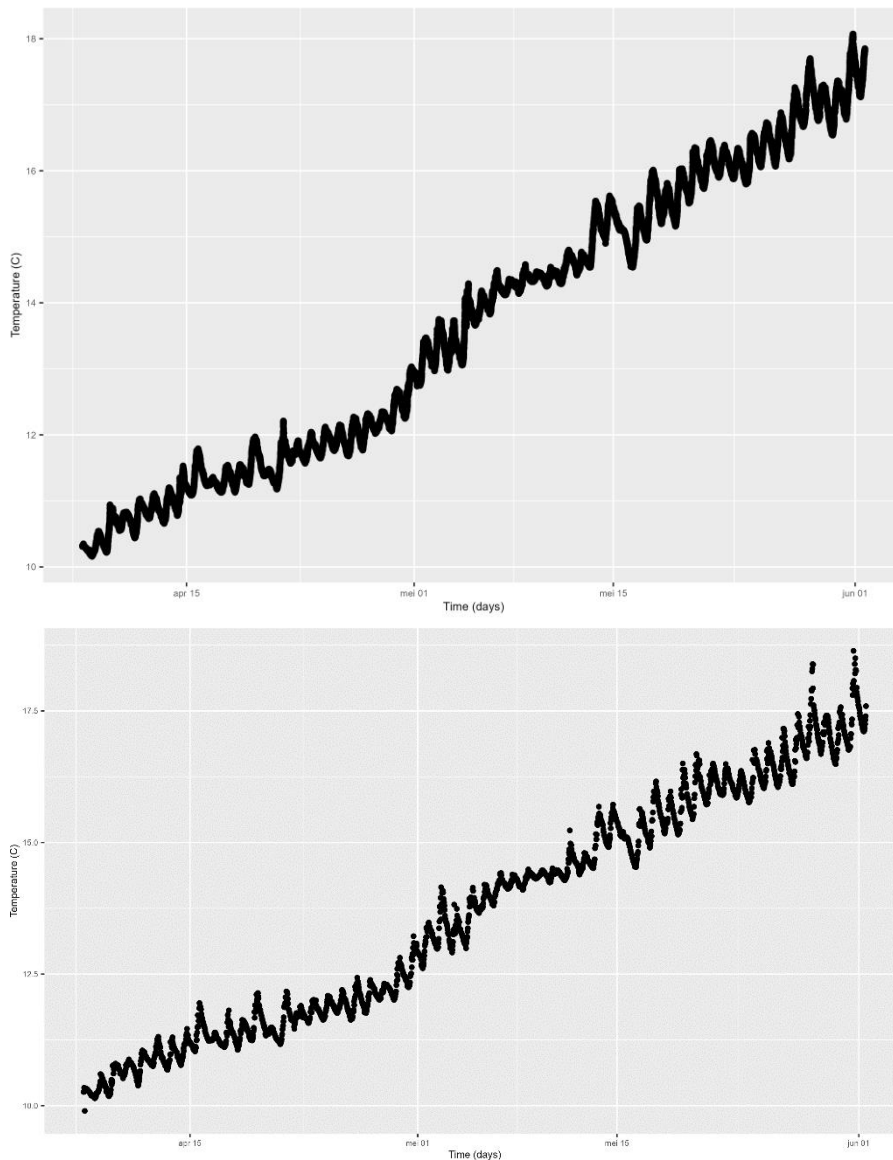
Figure 12. Temperature ,measured at the demonstrator at Zelzate North (top) and South (bottom)

Temperature (Figure 12) shows an (evident) increase during the measurements, from a value of 7.7°C in March 2023 to a maximum of 18.6°C at the end in June 2023. Both curves follow a similar course.

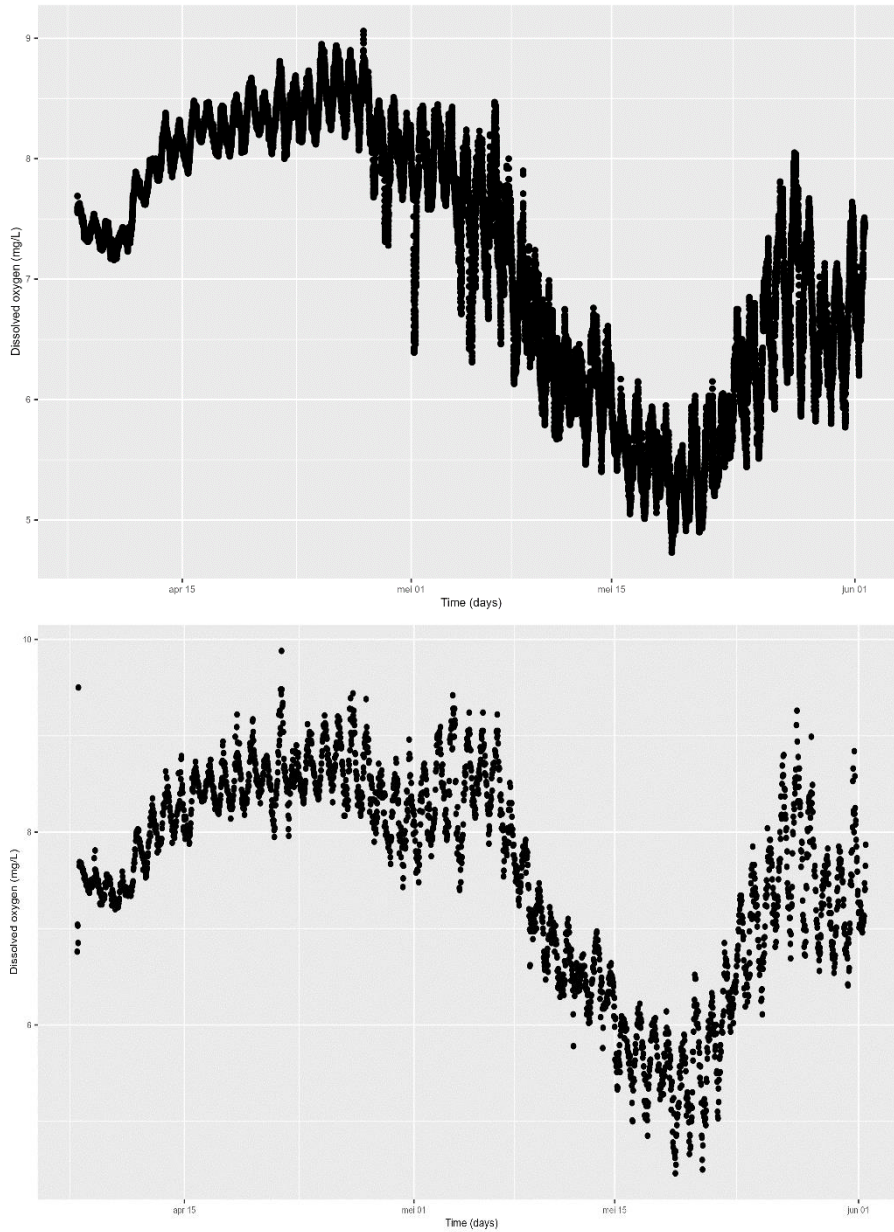
Figure 13. Dissolved oxygen, measured at the demonstrator at Zelzate North (top) and South (bottom)

The **dissolved oxygen concentration** (Figure 13) remains fairly constant in the first month, although parameter starts to drop during the month of May and shows a minimum around 20 May 2023 at which a saturation of less than 5 mg/L was reached.

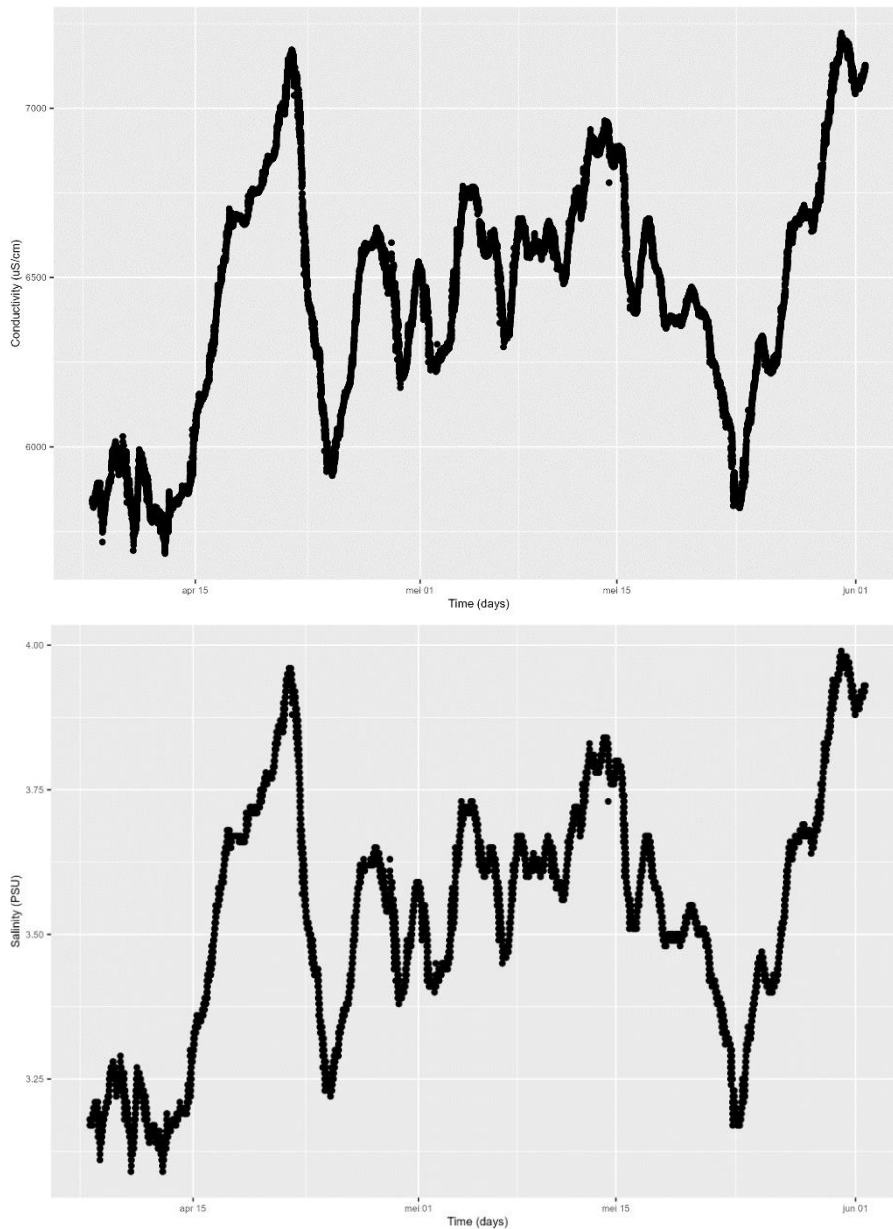
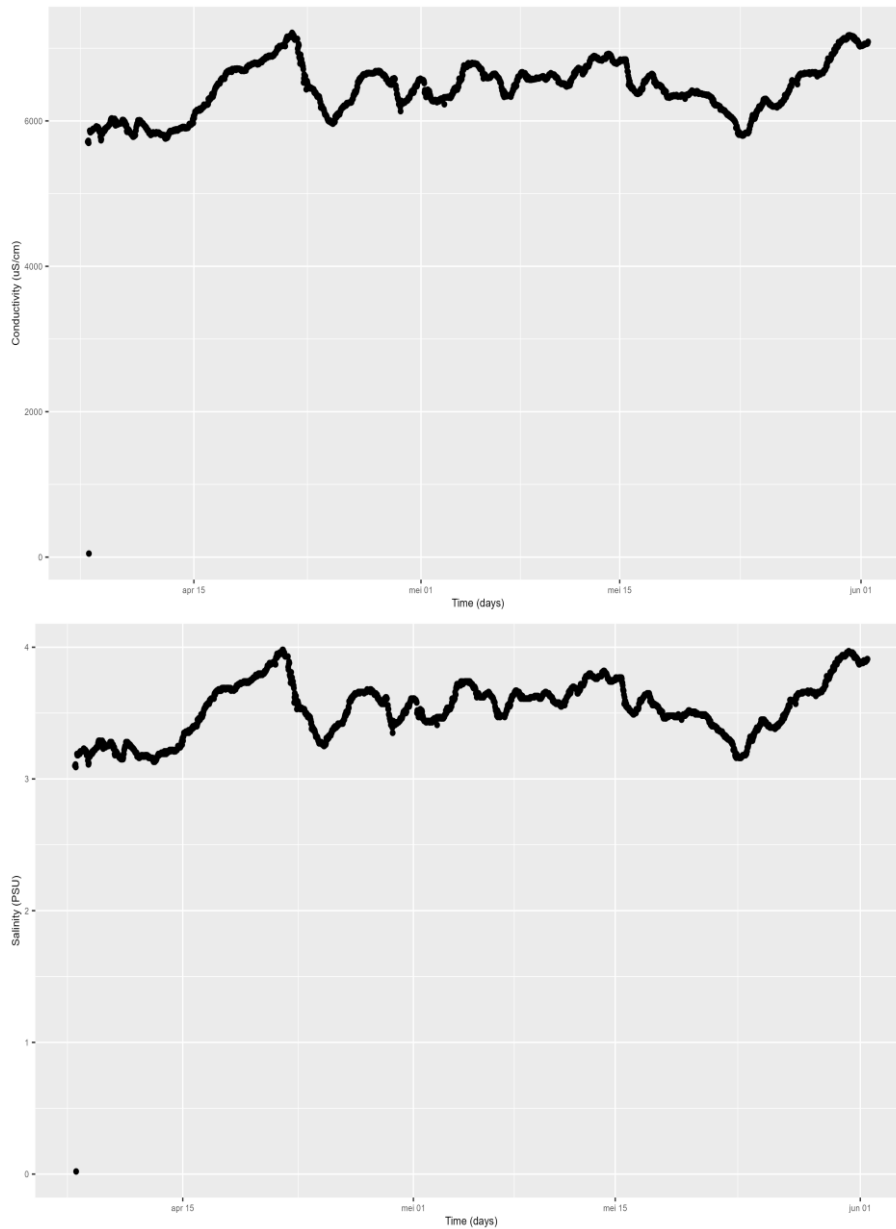
Conductivity (and the derived value for salinity, see Figure 14 for Zelzate North and Figure 15 for Zelzate South) The maximum of this graph is 9134 and always remains above 5500 $\mu\text{S}/\text{cm}$. The salinity fluctuates between 3.09 and 4. This indicates mainly fresh water.

Figure 14. Conductivity (standardised at 25°C; top) and salinity (bottom), measured at the demonstrator at Zelzate North.

Figure 15. Conductivity (standardised at 25°C; top) and salinity (bottom), measured at the demonstrator at Zelzate South.

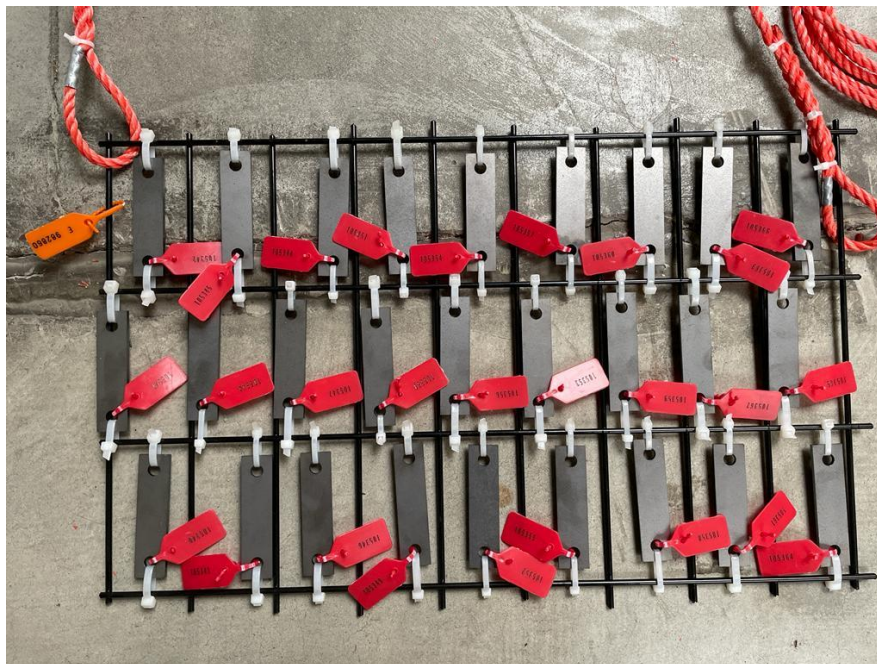
Figure 19. Rack of S355 coupons to be exposed

The racks themselves were constructed using cut wire panels (*Figure 19*). This created a rectangular rack consisting of a grid of 3 by 9 compartments, resulting in a total of 27 coupons that could be attached to the rack. The racks themselves were also tagged, which were linked to specific locations. These tags were of a different color so that locations where the racks were used could be identified later. This tagging method was instrumental in maintaining traceability and facilitating the accurate identification of both coupons and racks throughout the research process.

The racks were attached by means of an eye splice made of three-strand twisted polypropylene rope, whereby the corners of the rack were attached to this rope. To keep the rope from fraying, tie wraps and duct tape were used to hold the ends of the rope together (*Figure 19*). This specific construction method and fasteners ensured a firm and reliable suspension of the racks, allowing the coupons to be attached and submerged in the aquatic environment in a stable and consistent manner during the study.

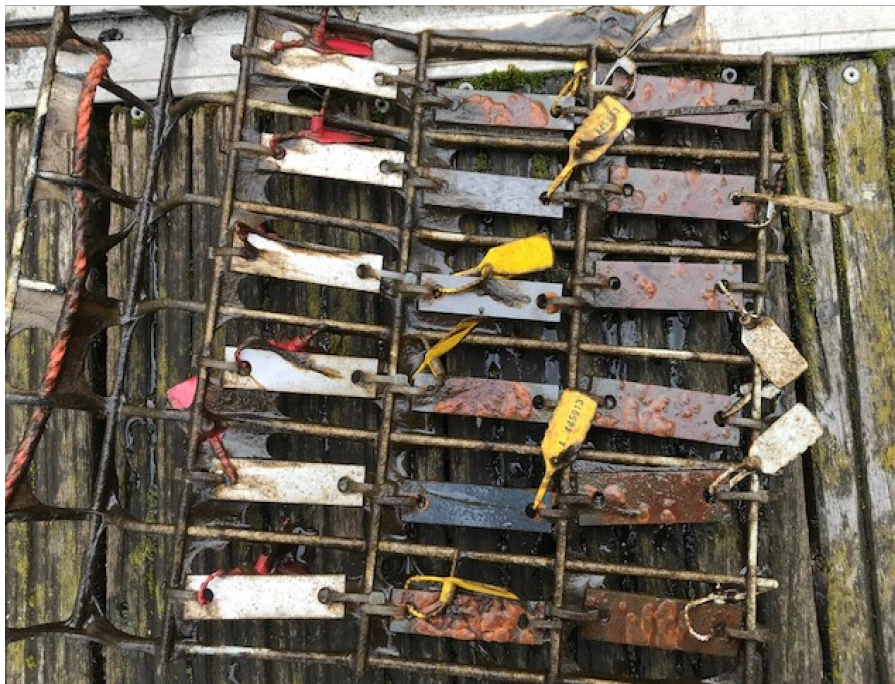
Figure 20 was taken on 8 March 2023 and shows the test coupons after one full month in the water of the marina of Zelzate. There is a dark colored slime layer on the rack, the rope and the pictures. On the plates with alloys S235 and S355 there is a clear orange-brown corrosion product. The 316L stainless plates show no corrosion.

Figure 20. Coupons after 1 month exposure in Zelzate North (February 2023). Yellow labeled plates are S355 alloy and white labeled plates are the S235 alloy. Red labels indicate 316L.

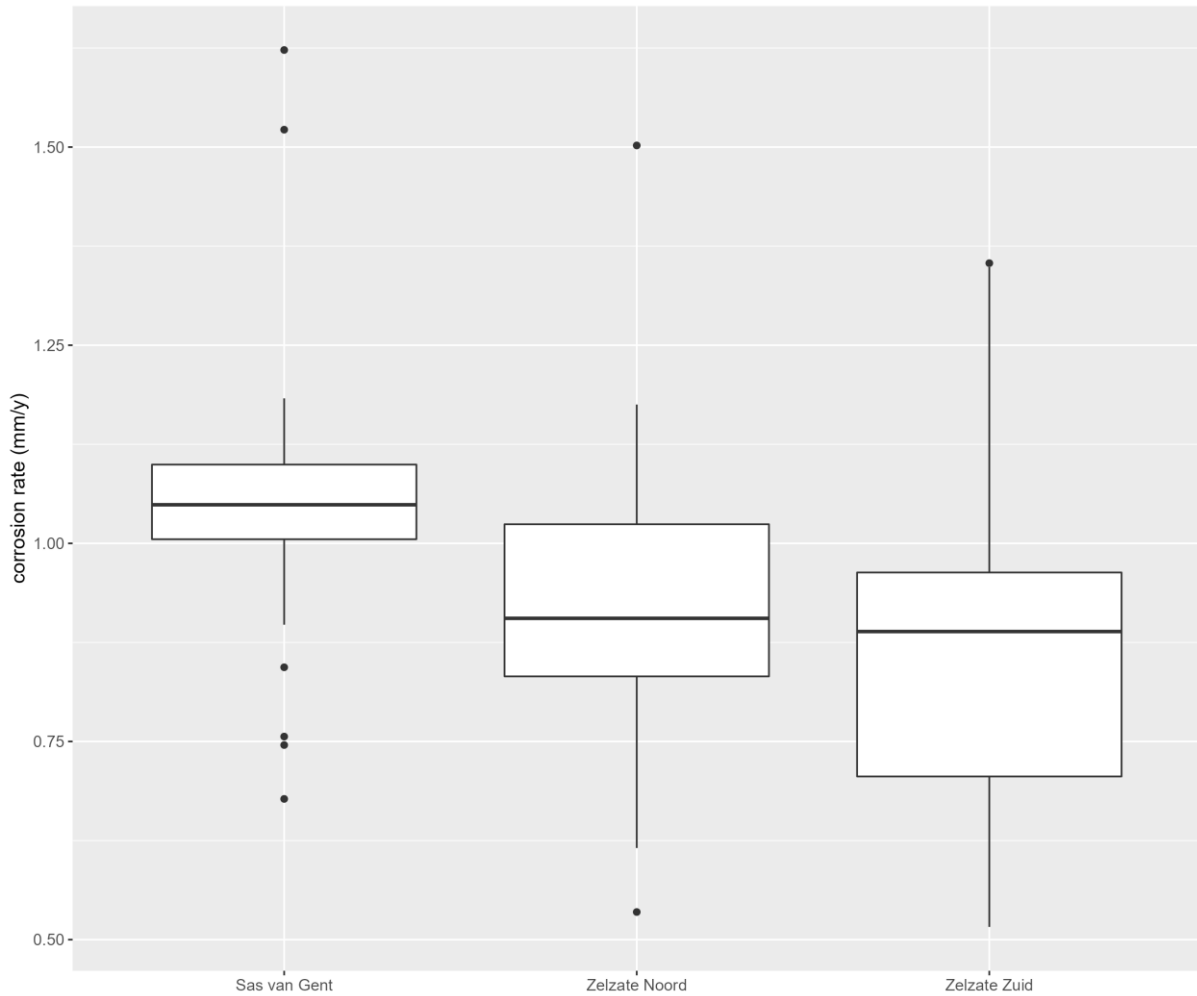
Comparison with different S235 coupons¹, in a separate experiment that was meant to look at differences in depth at both Zelzate locations and nearby Sas van Gent (Netherlands) indicates that coupons at Sas van Gent corroded significantly faster than the ones in Zelzate ($p < 0.005$), whereas here, there was no difference between both Zelzate locations.

A linear model analysis on these data, comparing the effect of both depth and location, indicated that depth of the coupons did not affect corrosion rate. However, we noted also that a few coupons, located right above the water, in the so-called splash zone, corroded faster than their submerged counterparts (data not shown).

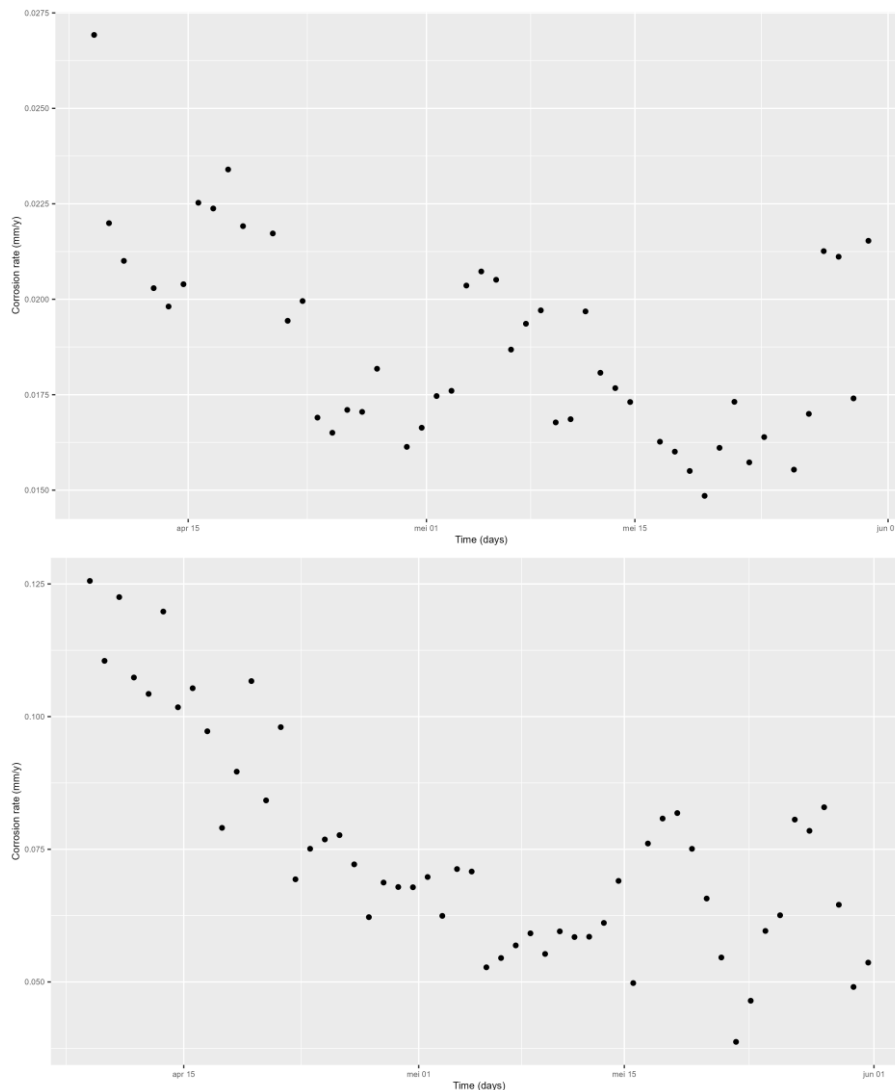
Figure 21. Corrosion of S235, measured at the demonstrator at Zelzate North (top) and South (bottom)

LP measurements in the brackish water of the Zelzate marina are generally underestimating corrosion rates, with an average of 0.0175 – 0.02 mm/year for S235 on the North side for April (Figure 21, top) compared to the 0.515 mm/year as determined by the coupon measurements (Table 2), or an average of 0.075 mm/year for the South demonstrator (Figure 21, bottom), compared to the 0.411 mm/year for coupons (Table 2).

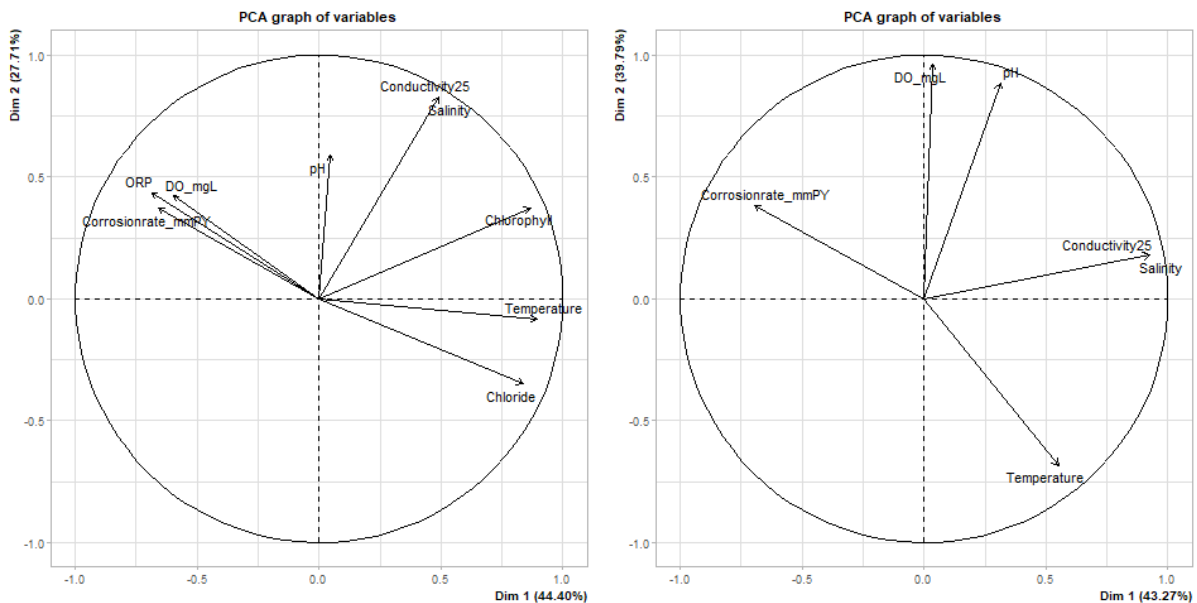
Figure 22. PCA analysis for the S235 corrosion rate and the environmental parameters measured at the demonstrator at Zelzate North (left) and South (right)

The principal component analysis for Zelzate North (Figure 22, left graph), where extra environmental parameters were measured, shows a close correlation between dissolved oxygen, ORP and S235 corrosion, confirmed (though not entirely) by the one-to-one correlations on Figure 23 (where we see a correlation of 0.408 between dissolved oxygen and corrosion, and a correlation of 0.565 between ORP and corrosion). We also see two inverse correlations between corrosion and temperature or chloride, confirmed (though again not entirely) by the one-to-one correlations on Figure 23 (where we see a correlation of -0.607 between chloride and corrosion, and a more curious correlation -0.496 between temperature and corrosion). Neither pH nor conductivity/salinity were correlated with corrosion at all at the Zelzate North demonstration (R values of resp. 0.069, 0.010 and 0.009). The inverse correlation (R = -0.714) between temperature and dissolved oxygen could be expected (as the solubility of oxygen in water decreases with temperature), as well as the correlation between biological life (indicated by the chlorophyll parameter) and temperature (R = 0.699). There is also a curious correlation between dissolved oxygen and pH (R = 0.728), between conductivity and chlorophyll (R = 0.700) and an inverse relation between ORP and chloride content (-0.963). These cannot be explained for the moment.

Analysis of the data at Zelzate South (Figure 22, right; Figure 24) show the same close correlation between dissolved oxygen and pH (R= 0.935) as well as the inverse relation between temperature and dissolved oxygen (R = -0.539). The corrosion rate is again curiously inversely related to temperature (R = -0.664) and conductivity measurements (R = -0.404). Corrosion is not correlated with dissolved oxygen and pH.

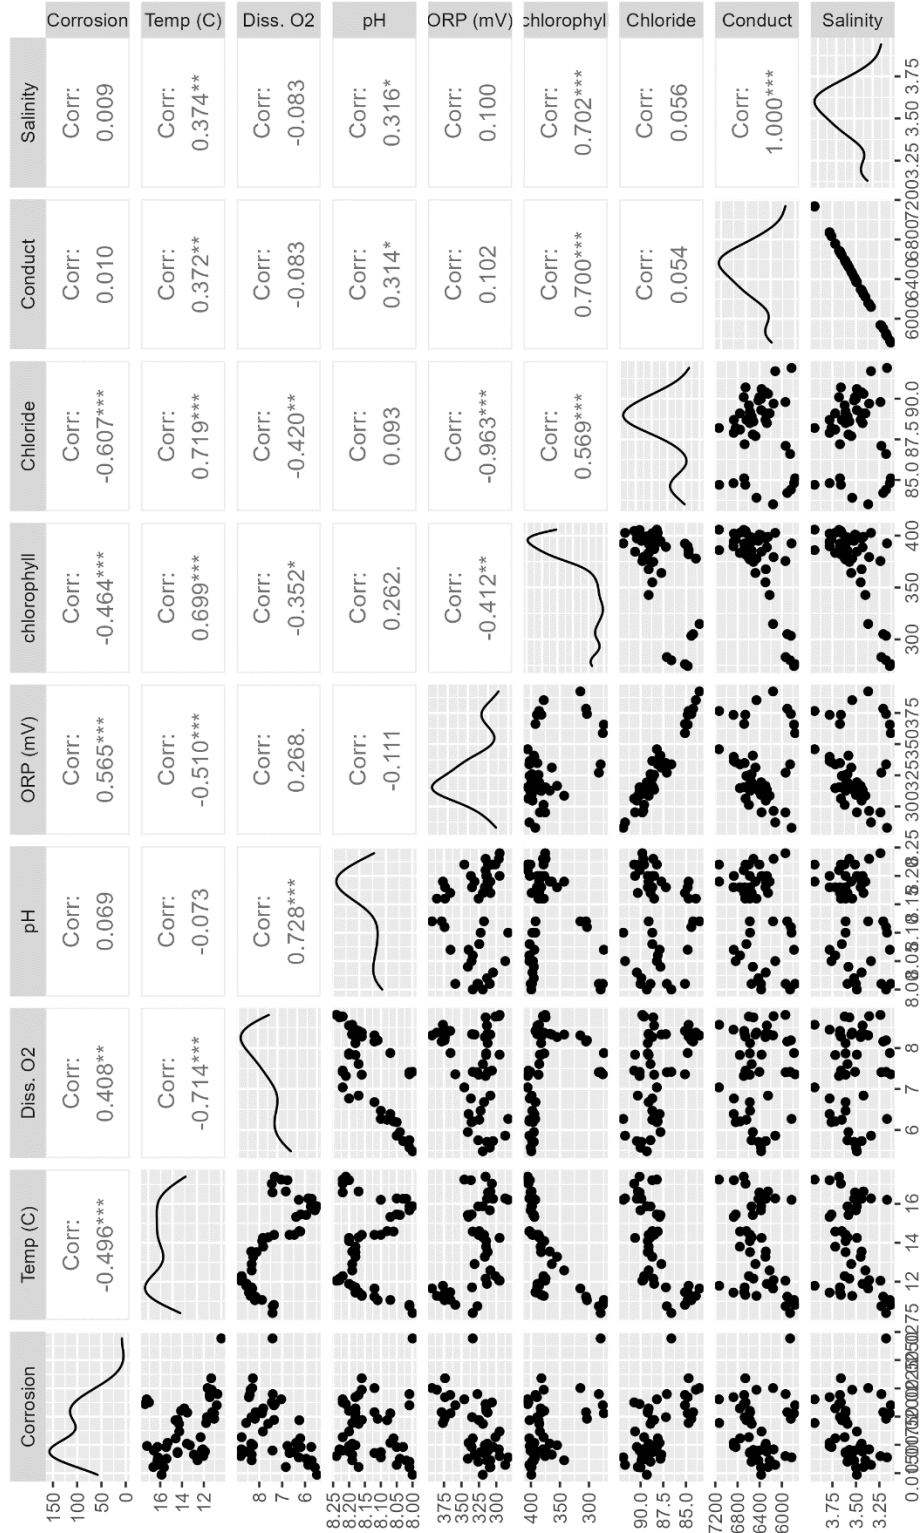
Figure 23. Pairwise correlations between the different environmental parameters and S235 corrosion (as measured by LP) for Zelzate North.

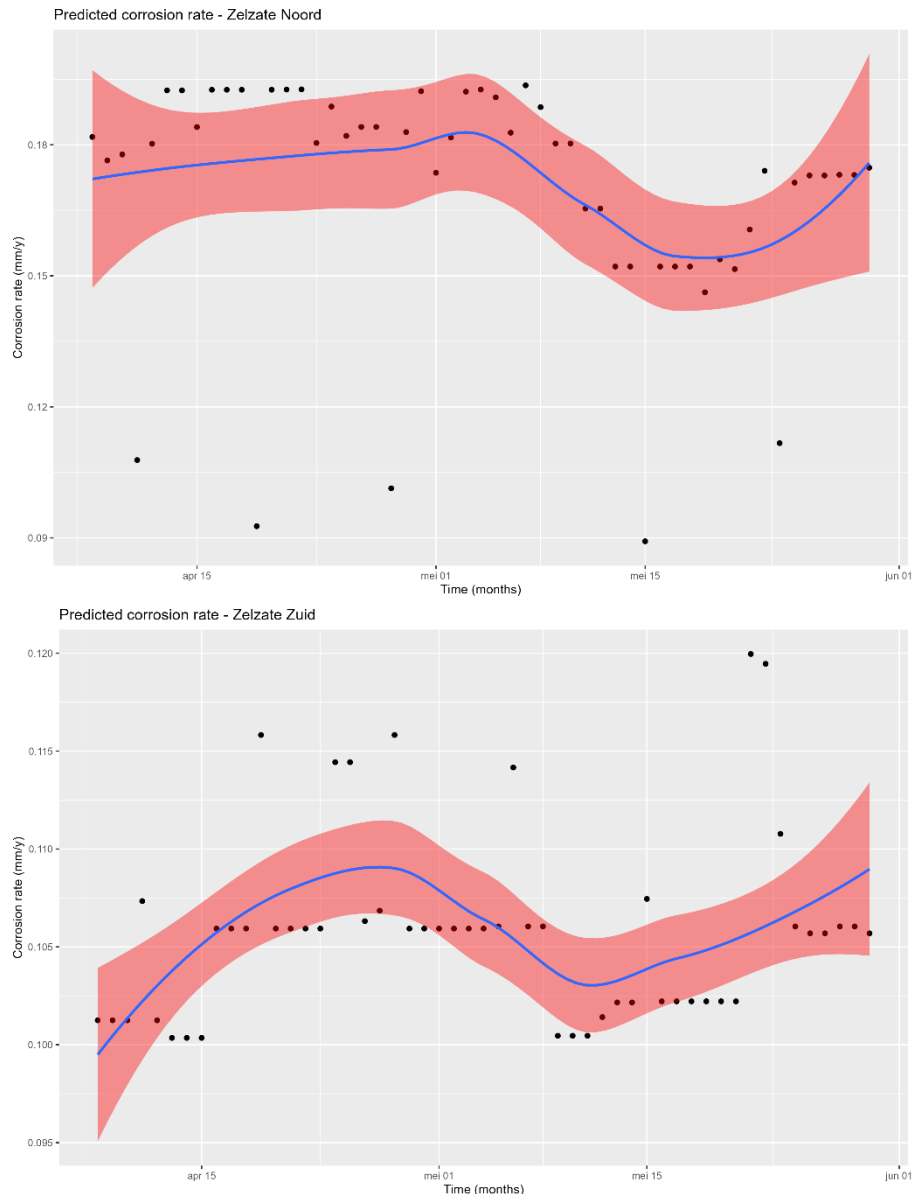
*Figure 25. Predicted corrosion rates at Zelzate North (Sea water, lab trained model, top) and Zelzate South (Sea water, Field trained model, bottom)
 Blue line gives a loess regression line for the dataset with a red 95% confidentiality zone.*

Both models gave essentially the same outcome for each of the locations. The outcome for Zelzate North (Sea water, lab trained model, Figure 25 top) is significantly higher than the outcome of the sensor data and still significantly lower than the coupon data.

On the other hand, the average corrosion rate predicted for Zelzate South (Sea water, Field trained model, Figure 25 bottom) fits nicely with the data as measured by the LP probe (again, still significantly lower than the coupon data).

To test the SOCORRO algorithm, the environmental parameters for Zelzate North and South were uploaded in the SOCORRO app (<https://app-c14q.onrender.com/>) and two models were chosen, the Seawater, Lab Trained model and the Seawater, Field Trained model.
